GEAR FAILURES

- *how to recognize them*
 - *what causes them*
 - *how to avoid them*

Reprinted from MACHINE DESIGN December 7, 1967
Copyright 1967 by The Penton Publishing Co., Cleveland, Ohio 44113

EUGENE E. SHIPLEY

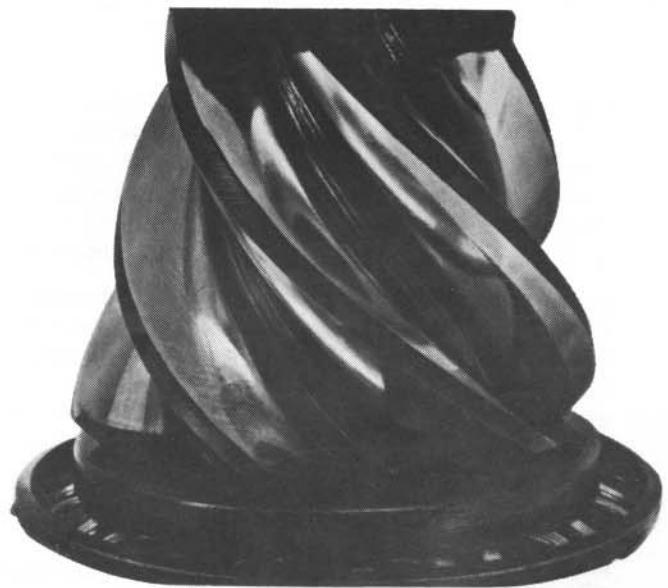
Polishing is a very slow wearing-in process in which the asperities of the contacting surfaces are gradually worn off until a very fine, smooth surface develops.

Cause: This condition is usually caused by metal-to-metal contact during operation. Generally, “polishing-in” occurs on slow-speed applications where the elasto-hydrodynamic lubrication film is not sufficiently thick and the gears are operating near the boundary-lubrication regime.

Polishing: Run-in under operating conditions, this hardened hypoid pinion has developed a highly polished surface. Undoubtedly the extreme-pressure additives in the lubricant had a tendency to promote polishing on the tooth surfaces.

Remedy: Often this condition need not be avoided unless the design life of the equipment is much longer than the predicted wear life based on polishing-in. Polishing gives good conformity of the surfaces.

After the gear is well polished-in, the surface can be protected by substituting a lubricant with a higher viscosity, by reducing the transmitted load substantially, or, in some cases, by increasing the operating speed to obtain a better elasto-hydrodynamic oil film.

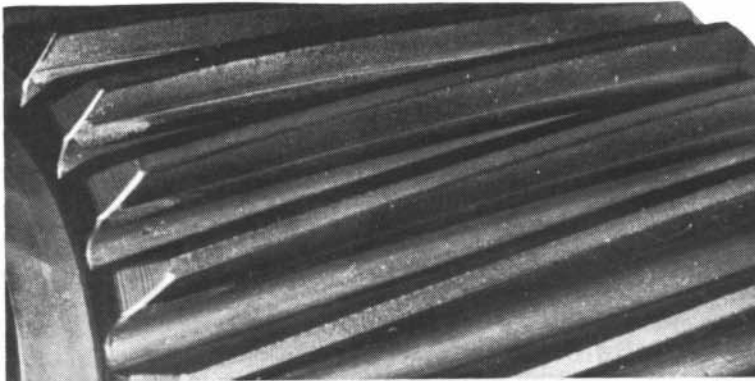
The type of wear classified as moderate takes place over a relatively long period of time. The contact pattern indicates that metal has been removed in the addendum and dedendum area; also, the pitch line begins to show as an unbroken line.

Cause: Moderate wear is most commonly caused by an inadequate lubrication film, with the film

Moderate Wear: The addendum and dedendum sections of these medium-hard gear teeth have worn, causing the operating pitch line to become visible because little if any material has been removed along this line.

thickness being too thin for the load. Dirt in the lubrication system can also cause this type of wear.

Remedy: One solution is to specify a lubricant with a greater film strength, or one with a higher viscosity. Also, the unit can be operated at a greater speed to build up the lubricating film. Finally, a gear material with a higher wear resistance can be specified.

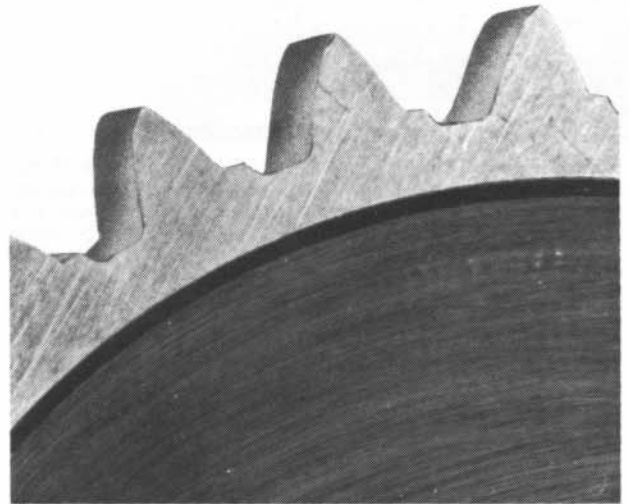
This is simply normal wear which has progressed to the point where a considerable amount of material has been removed from the surfaces. The pitch line is very prominent and may show signs of pitting.

Cause: This problem is usually caused by the failure to notice early enough that wear is in prog-

Excessive Wear: Material has been uniformly worn away from the tooth surface causing a deep step. The tooth thickness has been decreased and the involute profile destroyed. Some slow-speed gears can operate on such a profile until so much material has been worn away that the tooth fails under beam bending fatigue.

ress. When enough material has been worn from the tooth surface, the involute profiles are destroyed and the gears begin to run roughly. The situation is aggravated by the rough running, causing still

greater wear. Eventually the surface is such that the gears are no longer fit for reliable service.

Remedy: This condition could be avoided by using the same methods given for moderate wear—increasing lubricant film strength or viscosity, or increasing pitch-line velocity.

If the gear unit is splash-fed, changing to a positive spray lubrication system with a filter will help keep wear particles out of the gear mesh and ensure that adequate lubricating oil is delivered to the working surfaces.

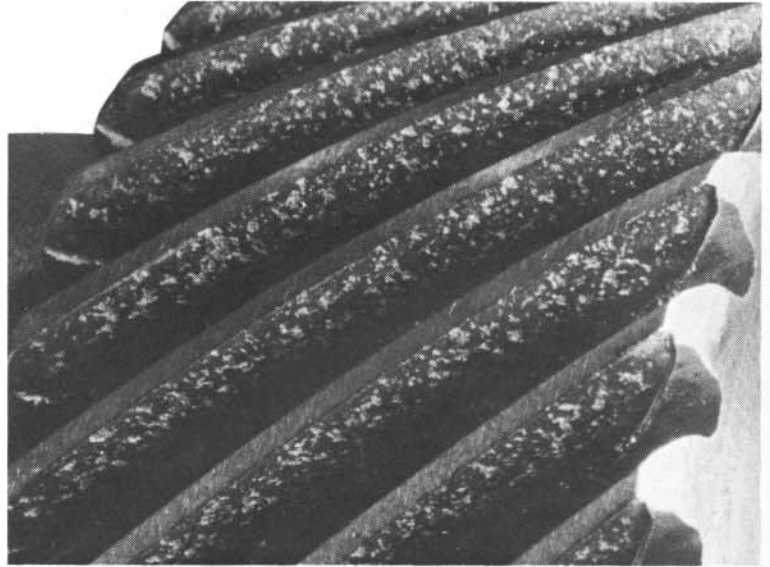
This is a deterioration of the surface due to chemical action. It is often caused by active ingredients in the lubricating oil, such as acid, moisture, and extreme-pressure additives.

Cause: The oil breaks down so that corrosive chemicals present in the oil attack contacting surfaces. Often this action affects the grain boundaries, causing fine pitting more or less uniformly over the tooth surfaces. At high temperatures, extreme-

Corrosive Wear: Although considerable wear has taken place, the surface still shows signs of having been attacked chemically. Wear of this nature will continue until the gear surface is beyond usefulness.

pressure additives sometimes form very active corrosive agents. Lubricants can also become contaminated from absorption of foreign material from external sources.

Remedy: Because they are chemically active, lubricants with high anti-scoring, anti-wear additive content must be kept under careful observation to ensure that they are not attacking working surfaces. By checking the lube oil for breakdown and by changing the lube oil at regular intervals, corrosive wear can be avoided.

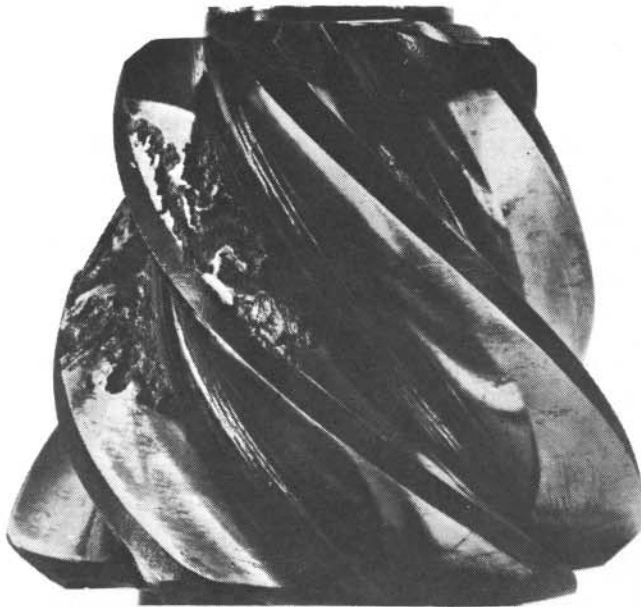
Spalling is similar to destructive pitting except that the pits are usually larger in diameter and quite shallow. Often the spalled area does not have a uniform diameter.

Cause: Spalling is usually caused by excessively high contact stresses. Usually, large pits are formed; because stress levels are high, the edges of the

Spalling: This hardened pinion shows an advanced stage of tooth spalling. Material has progressively fatigued away from the surface until a large irregular patch has been removed.

initial pits break away rapidly and large irregular voids are formed. Often these voids join together.

Remedy: Contact stress on the gear surface can be reduced below the endurance limit of the material. If the gear material is not hardened, hardening will give the material increased surface strength. Often a complete redesign of the gear elements is best since destructive pitting and spalling are evidence that the gears do not have sufficient surface capacity.

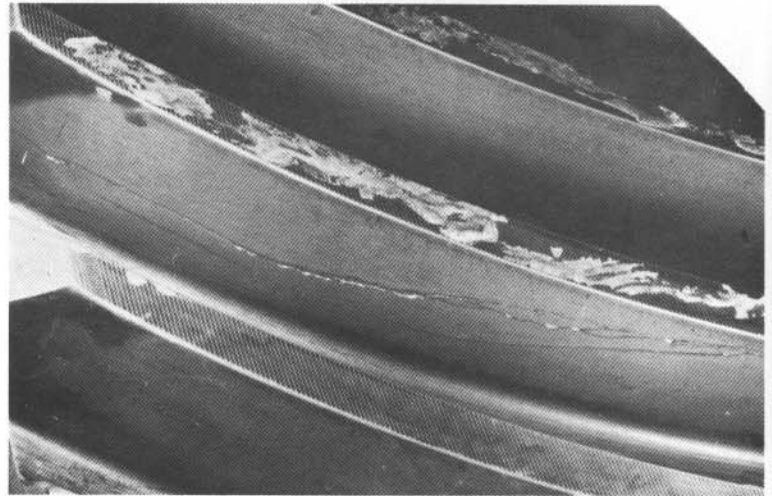
Although not considered a pitting failure, case crushing may appear similar in that damage has occurred on the contacting surface. It occurs in heavily loaded case-hardened gears, such as those which are case-carburized or nitrided.

Failure often occurs on only one or two teeth of a pinion or gear; the other teeth appear to be undamaged. Often, longitudinal cracks appear on

Cause: Cracks originate at the subsurface when stresses exceed the strength of the subsurface material. The cracks propagate along the case-to-core boundary and to the surface of the gear tooth. When several cracks reach the tooth surface, large chunks of material are removed. Failures are caused by insufficient case depth or by very high residual stresses in the gear.

Case Crushing: Several large longitudinal cracks, and several smaller ones, have appeared in the contact surface of this case-carburized bevel gear. The major cracks originated deep in the case-core structure and worked their way to the surface. Long chunks of material are about to break loose from the surface. The cracks should not be confused with normal fatigue cracks, which result from high root stresses and normally form below the contacting face.

Remedy: Failures most often can be overcome by increasing the effective depth of the case material. A change in basic material can be considered—for example, one that produces a hard core material for the same depth of case. Some carburizing materials will produce a 40-Rc core whereas others will only produce 30-32 Rc. This amounts to a considerable difference in strength.

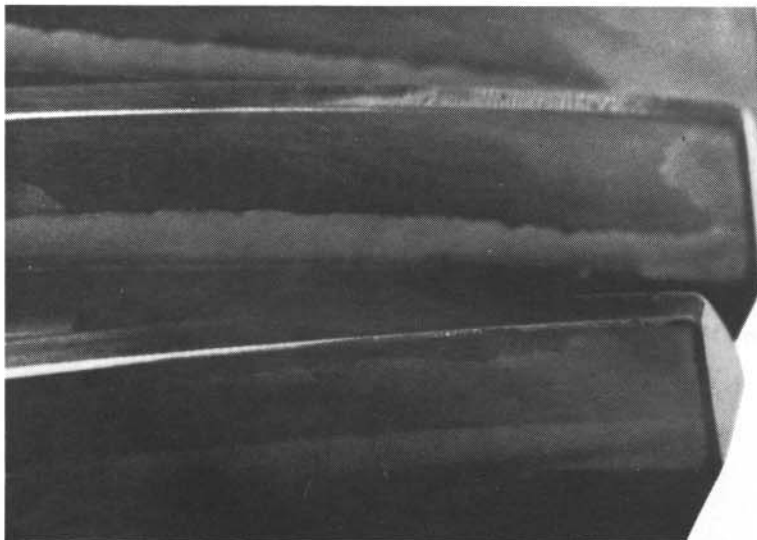
Frosting: This hardened helical gear shows a typical frosting pattern. Note that frosting is predominantly in the dedendum section, although patches do appear in the addendum section. This frosting pattern shows no radial welding and tear marks.

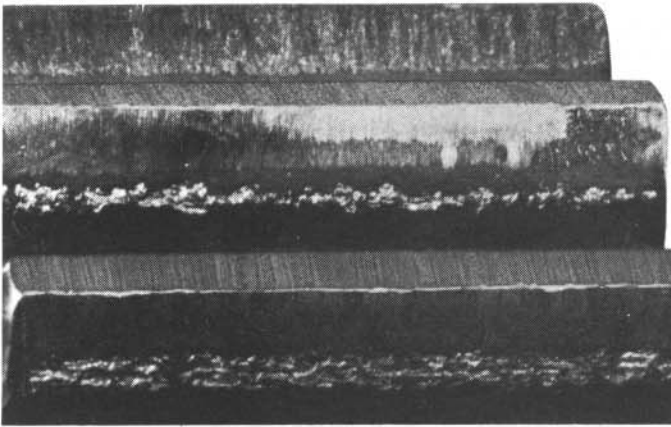
This type of failure shows definite indications of radial scratch and tear marks in the direction of sliding. Often material has been displaced radially over the tips of the gears. Also, there are indications that considerable material has been removed from above and below the pitch line, and the pitch line itself stands out prominently. The profile is completely destroyed and for all practical purposes the gear is not fit for service.

Cause: This failure is usually caused by inadequate lubrication or by excessive operating temperature, surface load, or surface speed, all of which generate excessive heat. When the lubricant breaks down, the welding and tearing destroys the profile in minutes.

Destructive Scoring: Heavy scoring has taken place above and below the pitch line, leaving the material at the pitch line. As a result, the pitch line pits away as it attempts to redistribute the load. Usually the gear cannot correct itself and ultimately fails.

Remedy: The lubricant must be able to stand up under the load, speed, and temperature con-

ditions of the mesh. Extreme-pressure additives are useful. Also, special high-viscosity compounded gear oil will often prevent scoring of this nature. Synthetic fluids with anti-scoring additives will prevent scoring at higher temperature.

In general, a careful analysis of the amount of heat being generated by the mesh is necessary, so that a fluid can be chosen that matches these conditions. If this is not possible, the gear set must be redesigned to reduce surface stresses, mesh losses, pitch-line velocity, and inlet-oil temperature.

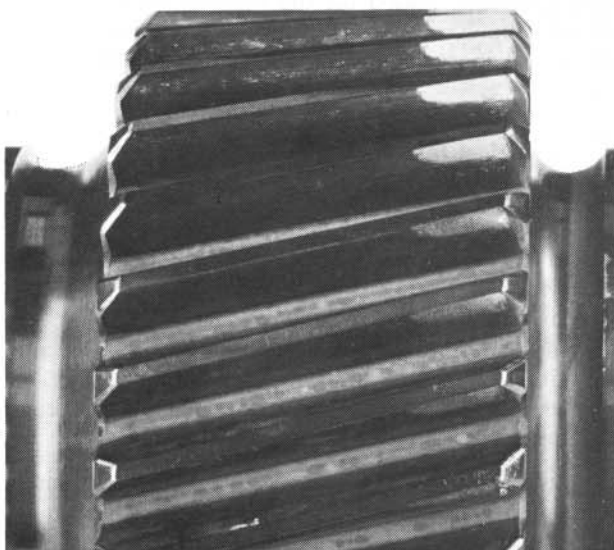
This scoring, similar to moderate scoring, takes place in localized areas along the contacting pattern of the gear teeth. Scoring is usually concentrated in these areas and does not spread across the full face width of the contacting gears.

Localized Scoring: This high-speed, high-load helical gear shows localized scoring on the ends of the teeth. This failure was caused by a design oversight: when the gear casing reached operating temperature, differential expansion caused a shift in alignment across the face of the gear. The resulting load distribution caused scoring.

Cause: Scoring of this nature is usually the result of local load concentrations caused either by design or by unintentional factors such as a misalignment resulting from poor manufacture, deflections under load, or temperature gradients across the face due to non-uniform cooling of the mesh. If the load concentration is near the ends of the teeth, the cause is misalignment, with more load being carried on this portion of the teeth than the lubrication film can support. Sometimes load is concentrated in the center of the gear teeth.

A crown is sometimes used at the center of the tooth to prevent the load from shifting if the design is prone to misalignment under operation. Because of this crown, the center of the tooth carries more load; often the higher load breaks down the lubrication film, permitting metal-to-metal contact and subsequent scoring. Sometimes an "effective crown" can be caused by unequal cooling of the mesh, which in effect causes the diameter of the gear in the center to grow with respect to the diameter of the two ends. Wide-face gears are particularly prone to this difficulty.

Remedy: Scoring failures of this nature can be avoided by eliminating localized loading. If misalignment is present, the gear casing may be deflecting non-uniformly, gear-shaft deflection may be excessive, bores of the casing may be out of parallel, or the gears themselves may be cut with a helix-angle error.

To eliminate localized scoring due to temperature gradients, particular attention must be paid to obtaining uniform heat removal across the mesh. Changes may be necessary in the amount of cooling oil and how it is applied to the mesh. If scor-

ing is the result of too much crown, this crown can be reduced to a safer level.

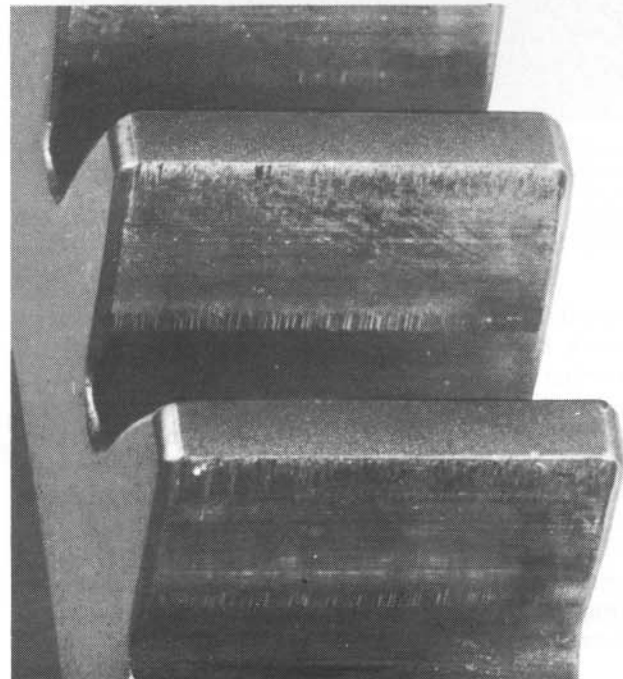
Tip and Root Interference: This gear shows clear evidence that the tip of its mating gear is fouling the root section. Localized scoring has taken place, causing rapid metal removal in the root section. Generally, interference of this nature can cause considerable damage.

In this type of scoring, the deep-dedendum portion of the gear shows definite signs of metal removal and may often show destructive radial scratch marks. Other portions of the contacting face look undamaged. Sometimes the tip of the gear or pinion shows unmistakable signs of metal removal, with the damaged tips having an abraded look and tear marks in the direction of rotation.

on the normal causes of scoring failure. The tip of the pinion may require tip modification, the root section of the gear may have a profile error, or the gear pair may be running on tight centers. The heavy loading at the tip or root of the mating pair or the interference caused by a tight mesh prematurely breaks down the lubricant film, causing rapid metal removal at the tips and roots and general abrasion of the teeth.

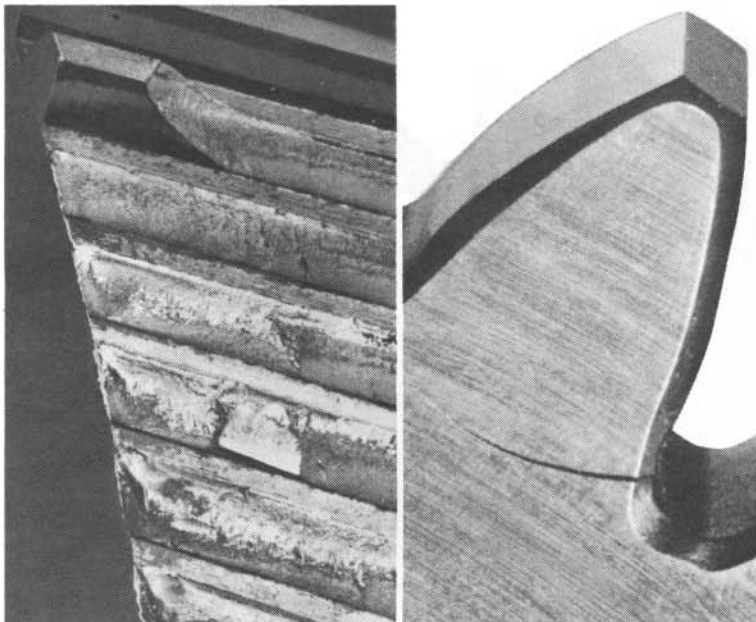
Gear-tooth failure from bending fatigue generally results from a crack originating in the root section of the gear tooth. The whole tooth, or a part of the tooth, breaks away. Most often there is evidence of a fatigue "eye" or focal point of the break. The break shows signs of fretting and conventional smooth beach marks in the break area. Generally there is a small area that shows a rough, jagged appearance, indicating this was the last portion of the tooth to break away.

Beam Bending Fatigue: (right) This aircraft power spur gear shows a fatigue crack caused by stresses at the root fillet.

Beam Bending Fatigue: (left) Each failed tooth started at a crack that had been in progress for some time. All the failed teeth show evidence of fretting corrosion and typical beach marks common to this kind of failure. Undoubtedly one tooth broke away first, causing an impact that then quickly broke the remainder of the teeth.

many. Most failures result from excessive tooth loads, which result in root stresses higher than the endurance limit of the material. When gears are loaded in this manner and subjected to enough repeated stress cycles, the gear tooth will fail.

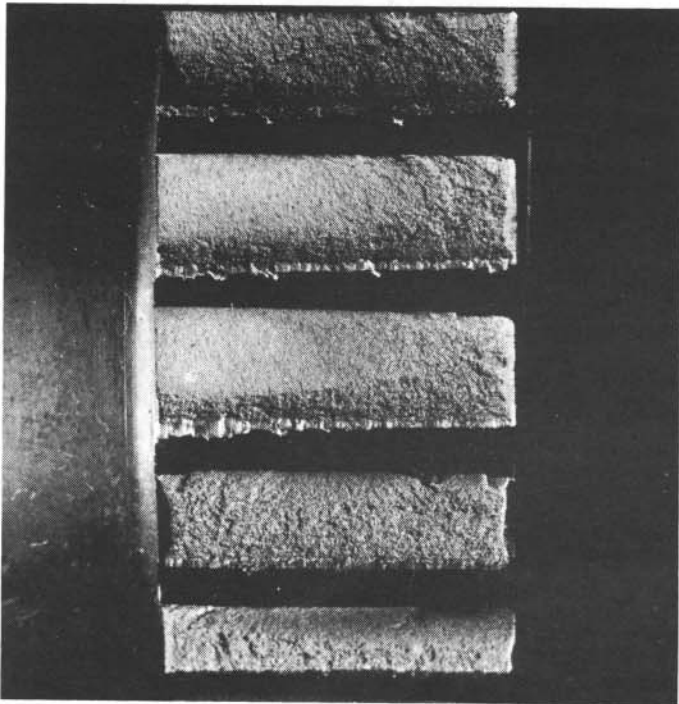
Overload Breakage: The break in this hardened and ground spur gear has a brittle fibrous appearance and the complete absence of any of the common beach marks associated with fatigue failure. In this case, one tooth failed from shock and the force was transmitted to successive teeth. As a result, several teeth were stripped from the rotating pinion.

Remedy: It is difficult to design against failures of this type, since often the failure is a direct result of some unpredictable occurrence. It may

be possible to incorporate overload-protection devices, such as torque-limiting couplings with shear sections.

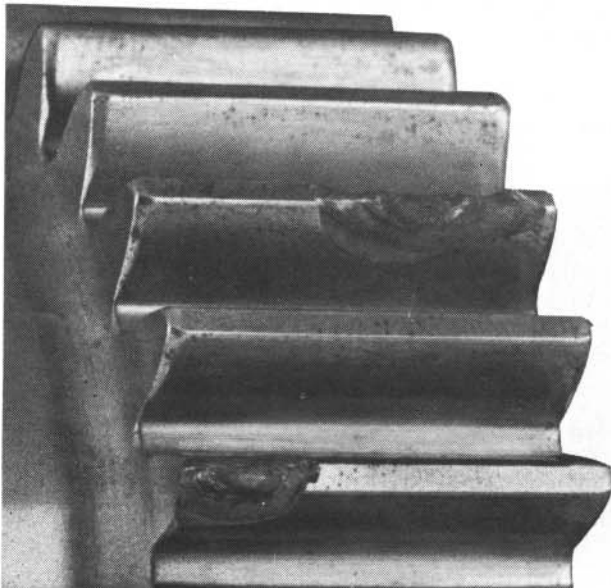
Gear-tooth breakage is usually associated with the root-fillet section of the gear tooth; however,

Random Fatigue Breaks: These breaks are not typical beam bending failures. They originate high on the tooth flank and are somewhat uniformly dispersed across the face of the gear. Failures of this nature originate from stress risers other than at the root fillet. In this installation, fatigue failure resulted from grinding cracks on the tooth flanks.

breakage failure can occur in other portions of the gear tooth. Sometimes, the top of a gear tooth will break away or large chips will fatigue away from the end of a tooth.

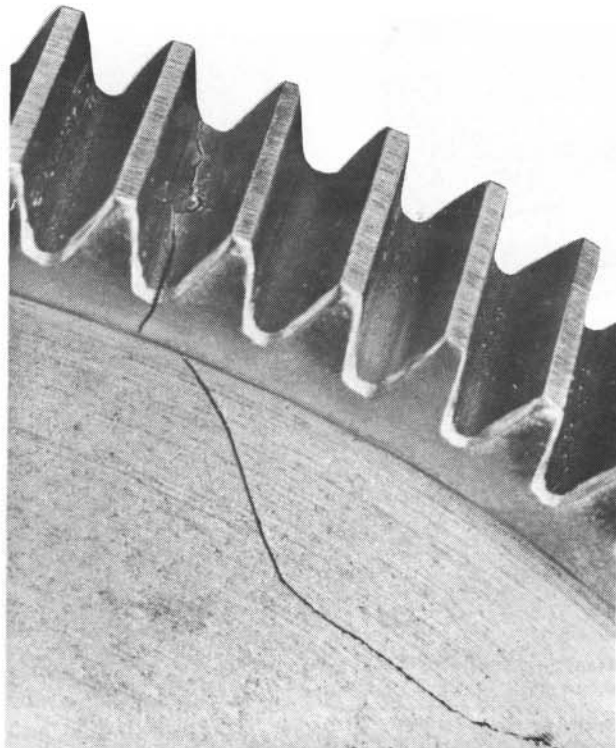
The rim of a gear usually fails between two adjacent teeth. Cracks propagate through the rim and into the web. Sometimes, cracks appear in the web near the rim and web junction without disturbing the rim itself.

Rim and Web Failure: This hardened and ground spur gear fractured through the root section. The crack propagated from the root section into the web of the gear. Such failures are not uncommon on highly loaded thin rims and webs.

Cause: Often, the failures are caused by flexure stresses in the gear teeth. If the crack starts from a high stress point, it may propagate through the rim instead of across the tooth at the root section. Web cracks may be caused by stress risers from holes in the web, or by web vibrations.

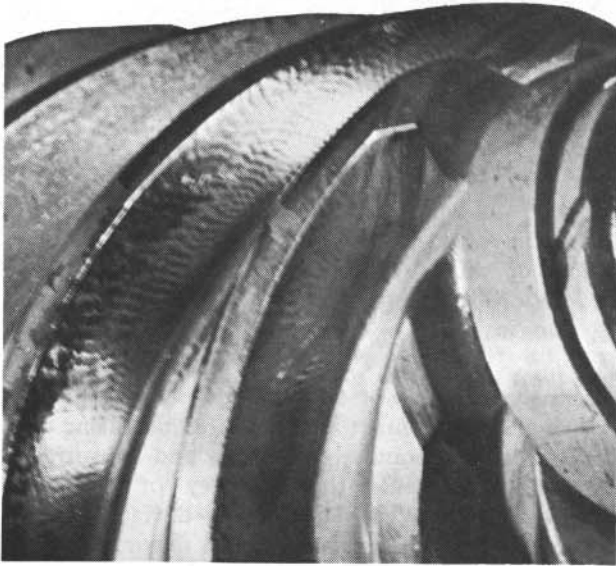
This is a periodic wave-like formation at right angles to the direction of sliding or motion. It has a fish-scale appearance and is usually observed on hardened gear surfaces, although it can occur on softer tooth surfaces under certain conditions. Rippling is not always considered a surface failure, unless it has progressed to an advanced stage.

Cause: High contact stresses under cyclic operation tend to roll and knead the surface causing the immediate subsurface material to flow. Slow-speed operation is usually associated with this type

Rippling: A typical case of rippling appears on this hardened hypoid pinion. Note the waviness or fish-scale pattern. Rippling often shows up on highly loaded hypoid gears but can be produced on highly loaded spur gears as well.

of failure, because it does not build up adequate elasto-hydrodynamic film thickness. This combination of high contact stress, repeated cycles, and an inadequate lubricating film will produce a rippled surface.
