AIRCRAFT ACCIDENT REPORT

LOS ANGELES AIRWAYS, INC.

S-61L HELICOPTER. N300Y

COMPTON, CALIFORNIA

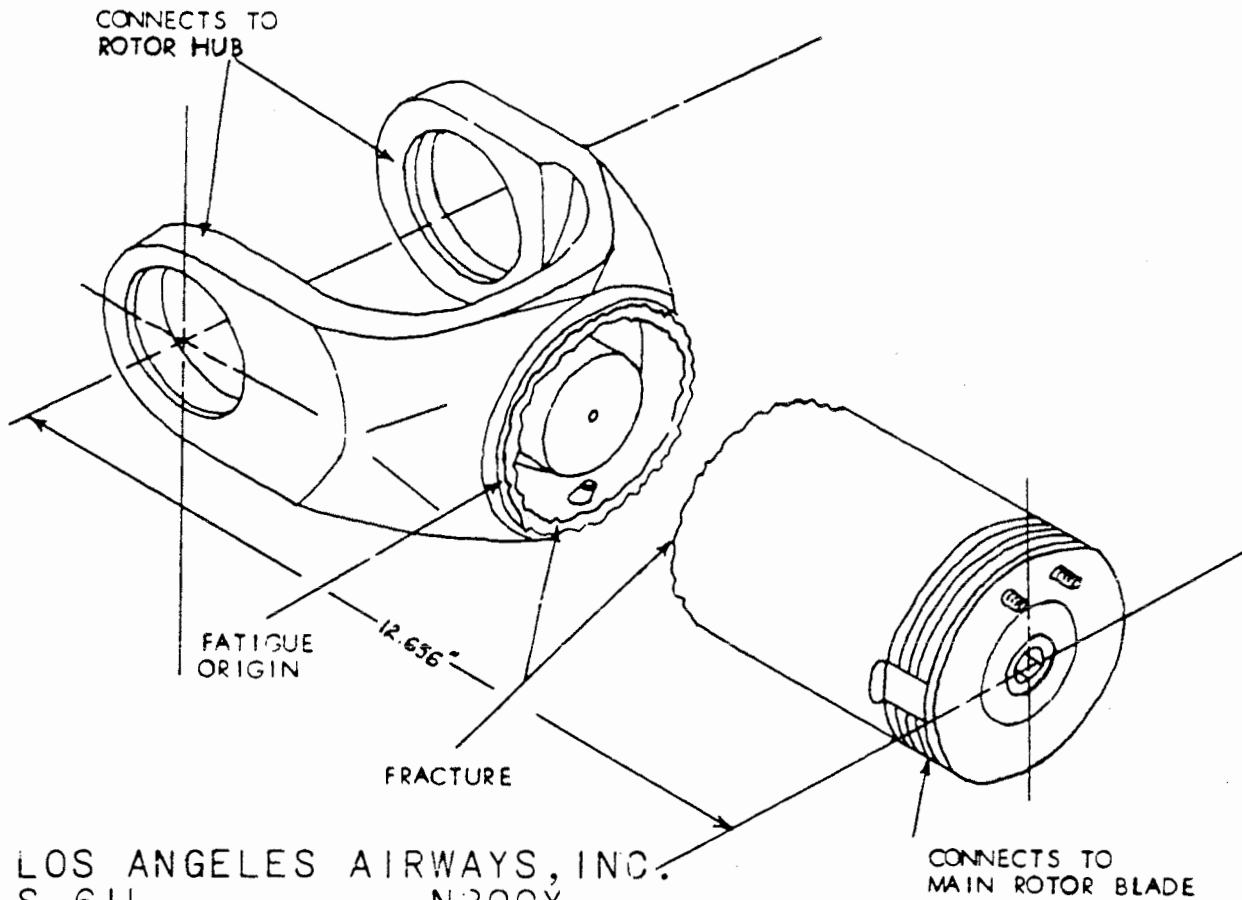
ATTACHMENT 1
MAIN ROTOR SPINDLE
PART NO. S6110-23325-2B

assembly were located in the main impact area. The fifth main rotor blade (yellow) including the sleeve and part of the spindle, was located approximately one quarter of a mile northwest of the main wreckage site. Minor parts associated with this rotor blade were scattered over a three-block area northwest of the park. Examination of the yellow blade spindle (S/N AJ19) revealed a fatigue fracture in the shank of the spindle adjacent to the shoulder at the inboard end of the shank. (See Attachment 1.)

A stereomicroscope examination of spindle AJ-19 revealed that the nucleus of the fatigue fracture was on the trailing side of the spindle, one-eighth of an inch below the centerline, approximately at the shank tangency point, with the 0.125 inch radius at the shank/fork junction. The crack had originated in the base metal surface at the interface with the nickel plating, and propagated through approximately 72 percent of the shank cross-section prior to the failure. Additional laboratory studies revealed the following factors associated with the development of the fatigue crack:
