Failure Analysis of a Shot-Peened Component

Om Johari
ITT Research Institute

William A. Sipes
Naval Air Development Center

A comprehensive scanning electron microscope (SEM) survey of the fracture surfaces of an aircraft main landing gear shock strut piston showed that improper shot peening contributed to the initiation of the anomalous fatigue failure.

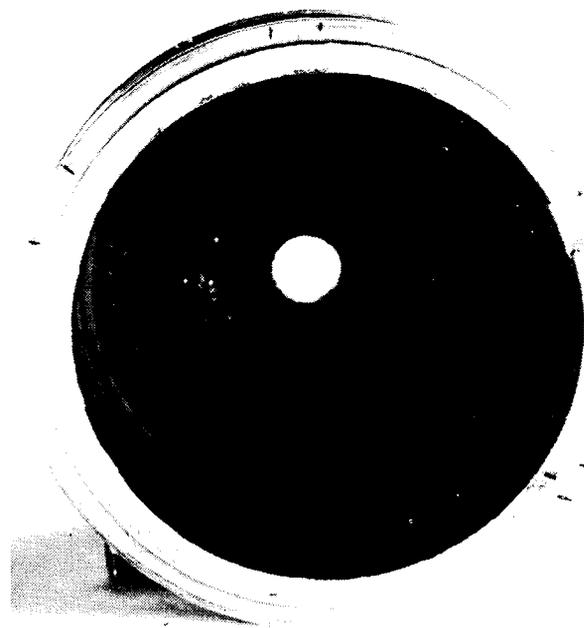
Before receipt of the sample at IIT Research Institute (IITRI), it had been analyzed by the NADC using optical and replica transmission electron fractography (1)**. Fig. 1 shows the overall fracture surface, Fig. 2 the elevation view of the failed piston (1), and Fig. 3 an overall view of the part as received by IITRI. We did not have access to the other half of the fracture. Close-ups of areas 1 and 3, as shown in Figs. 4 and 5, were examined in detail. A cursory examination of areas 2 and 4 indicated them to be identical to 1 and 3. The identification of fracture mode was not possible from optical macrofractographs alone. The information provided by NADC indicated it to be a fatigue failure (1).

Fig. 1 - Plan view of failed piston in as-received condition by Naval Air Development Center

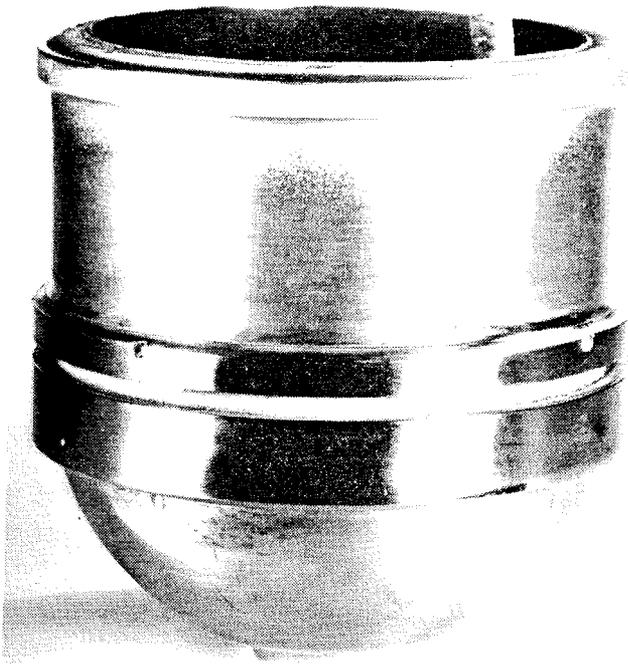
Fig. 2 - Elevation view of failed piston in as-received condition by Naval Air Development Center

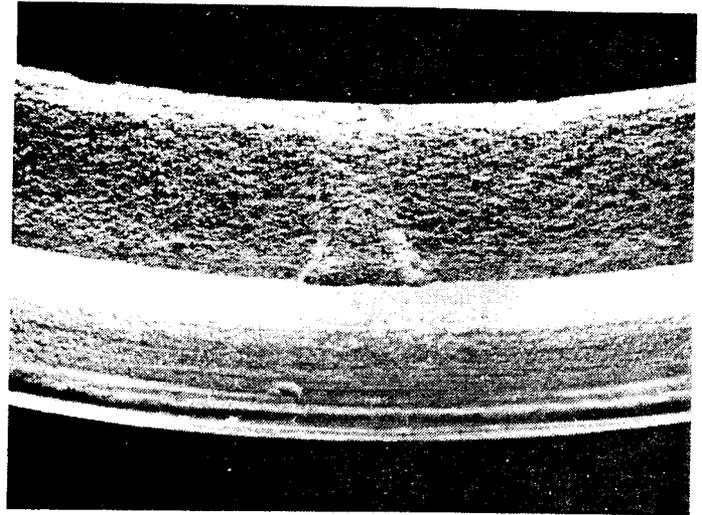
Fig. 4 - Close-up of area 1 in Fig. 3. Magnification 5X

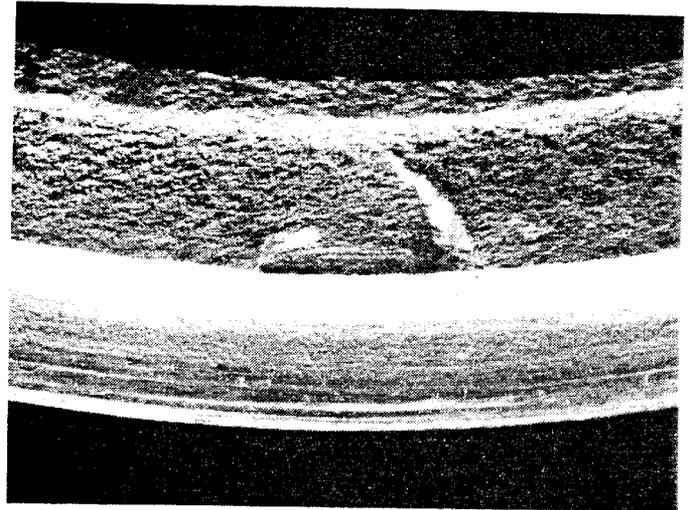
Fig. 5 - Close-up of area 3 in Fig. 3. Magnification 5X

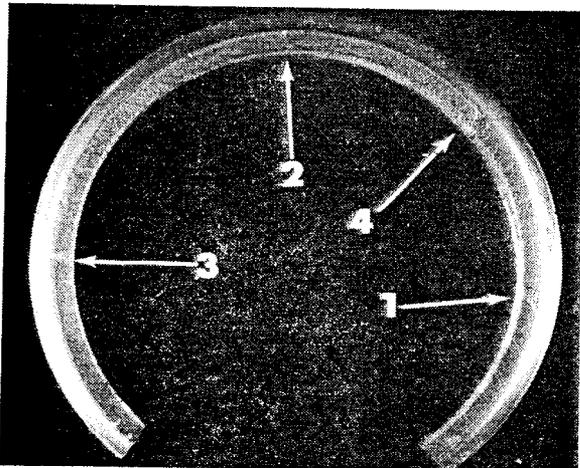
Fig. 3 - Failed part in as-received condition by IITRI indicating areas examined

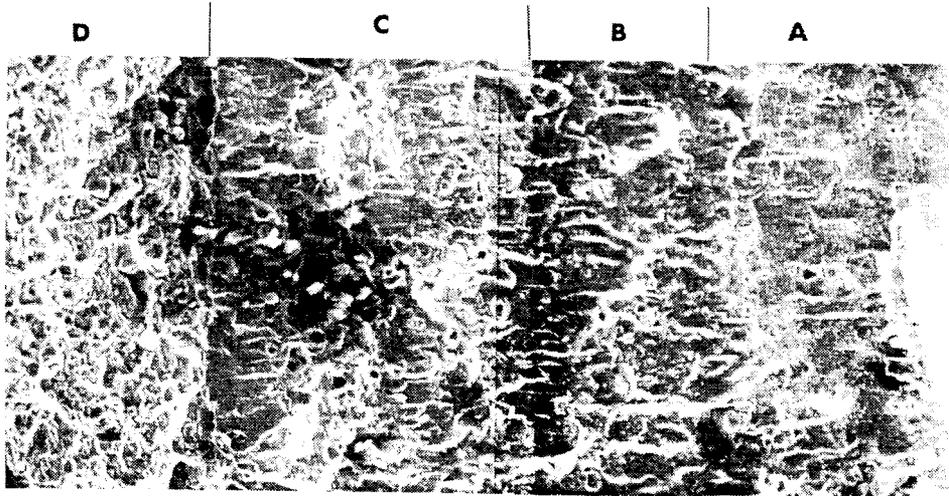
Fig. 7 - Region at center of SS in Fig. 6. showing four distinct regions A, B, C, and D. Magnification 140X reduced 77% for reproduction

view of the center of region SS of Fig. 6. Four distinct regions are identified, A, B, C, and D. A being closest to the outside shot-peened surface, D being the final fracture overload region. Typical features of region D are illustrated in Figs. 8A and 8B. Regions B and C were clearly separated because, both in high-magnification optical macrofractographs (Fig. 9) and in SEM photographs, region B was much darker than region C. Typical fatigue striations could be readily observed in region C. The direction of striations pointed toward the center of area SS as the origin, though local effects of grain orientations were also observed (Figs. 10A-10C). Except toward the edges of crescent SS (as shown in Fig. 10), the striations, for the most part, were parallel to the circumference of the ring-shaped sample.

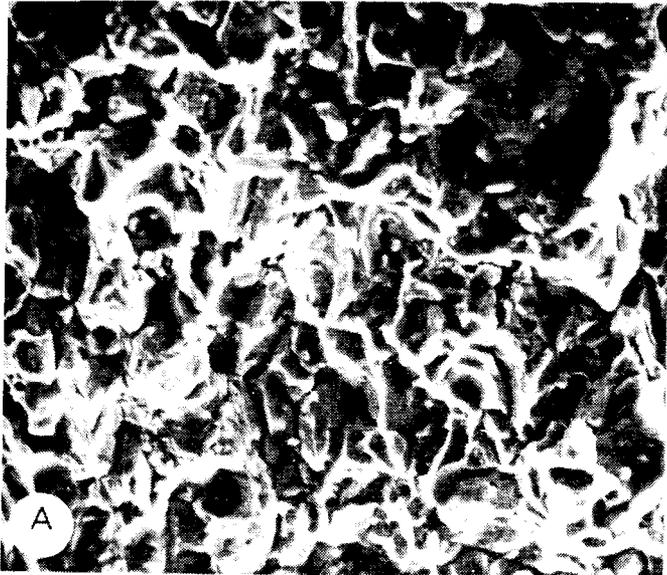
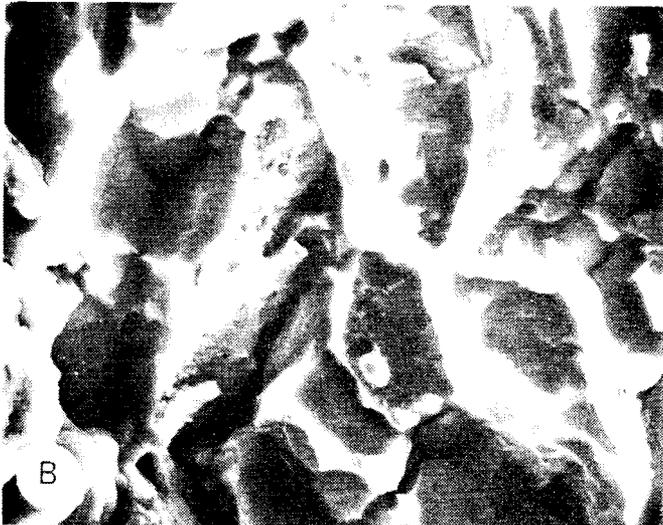
Fig. 8 - Typical features of region D in Fig. 7 showing overload failure. Magnification: A - 300X, B - 1000X

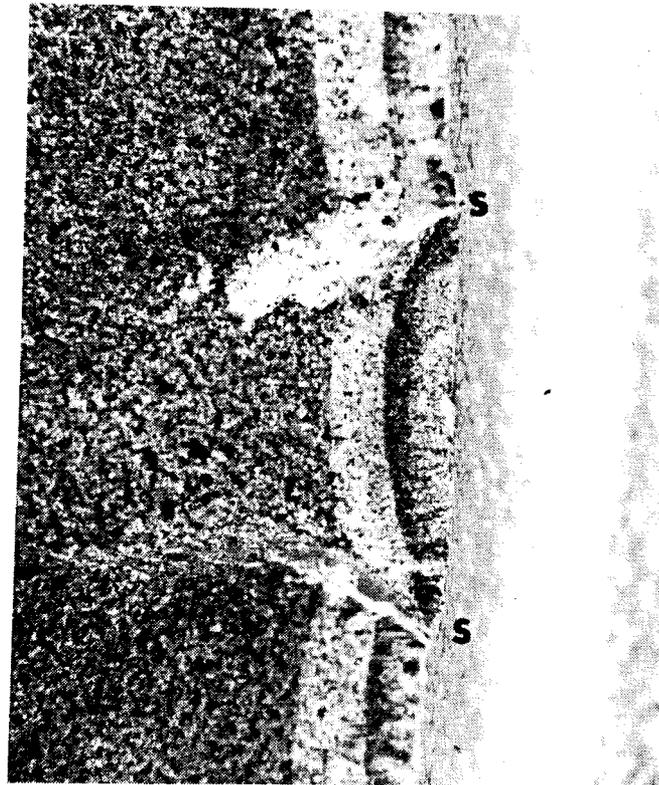
Fig. 9 - Optical macrophotograph of suspect origin in specimen 3. Magnification 18X

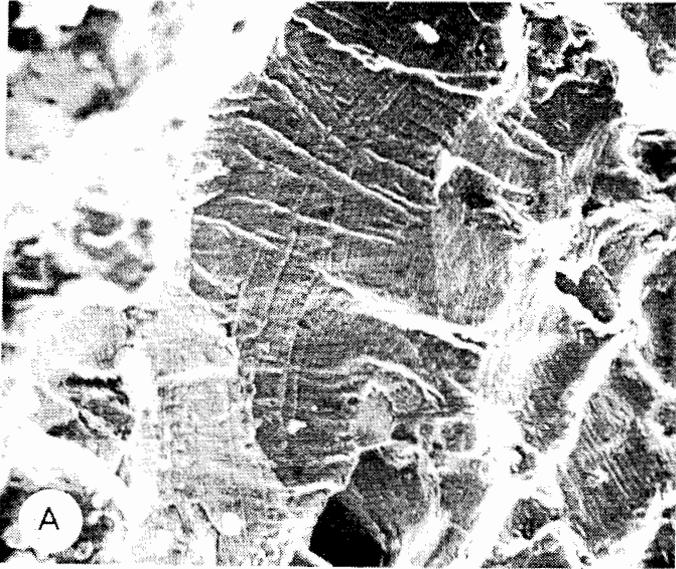
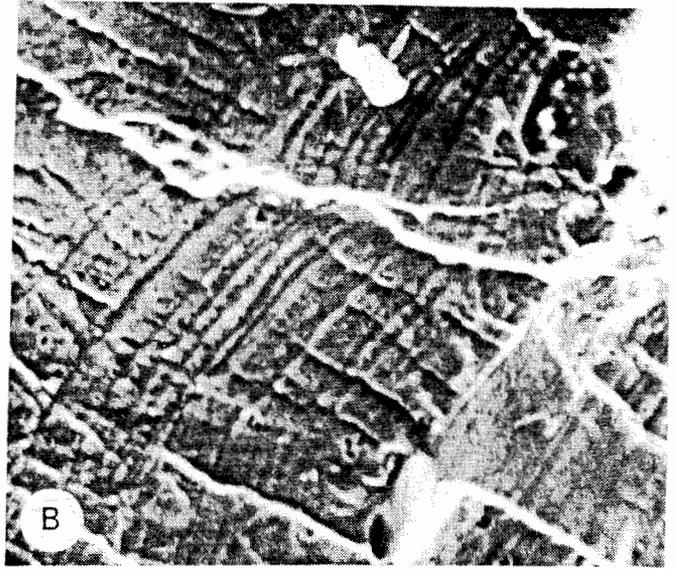
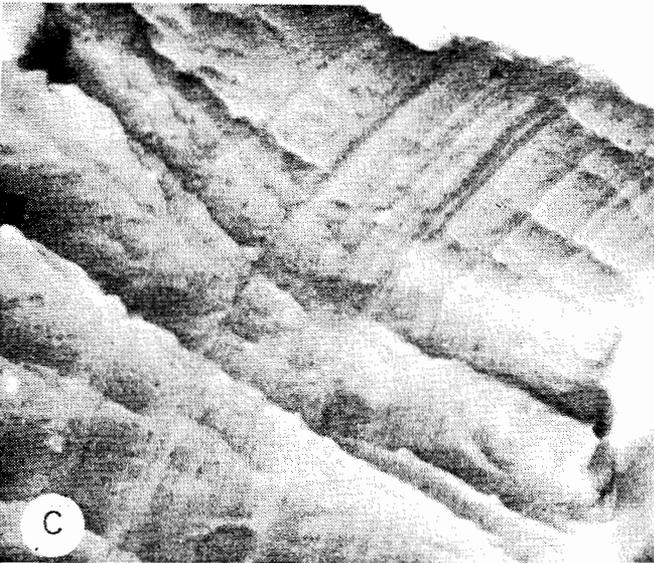
Fig. 10 - Fatigue striations in region C. A—low magnification, 810X. While most striations point to center of SS as origin, local differences in striation directions, attributed to individual grain orientation, are also seen. B—higher magnification (2700X) of top central region in Fig. 10A. C—another region showing striations in regions C. SEM was operated at 25 kV for this photograph, and at 5 kV for photographs in Figs. 10A and B, thus accounting for different appearance. Magnification 3000X

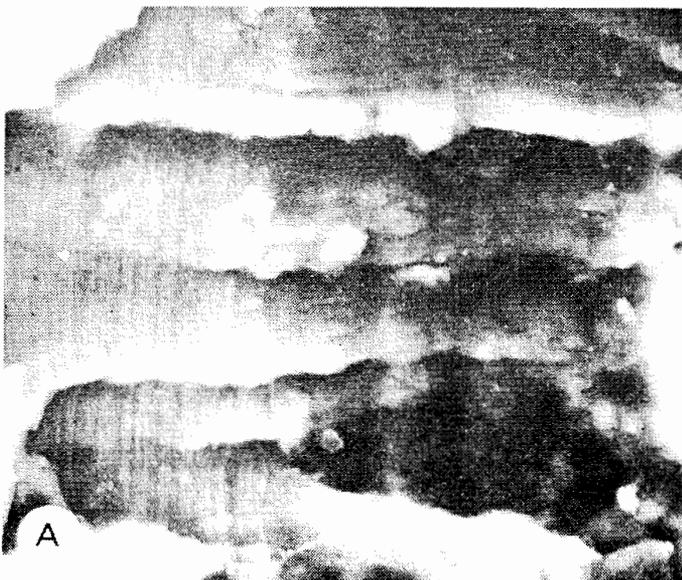
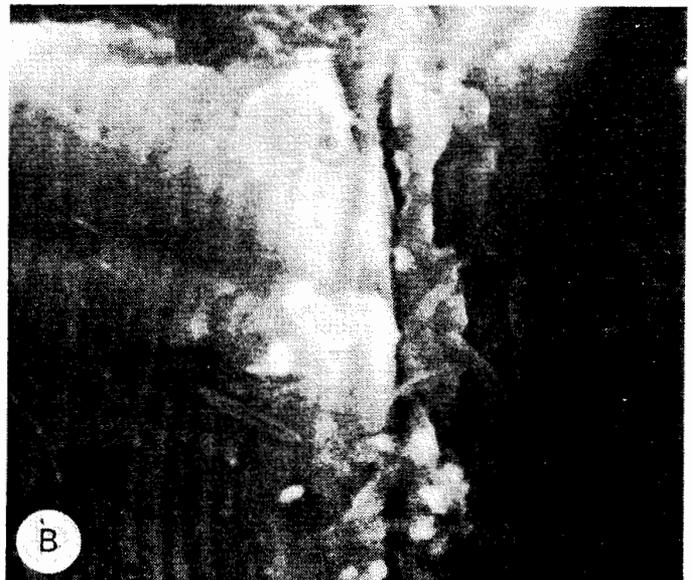
Fig. 11 - Region C on left and region B on right. Demarcation between two regions is clearly observed. Magnification: A—500X, B—6000X

Figs. 11A and 11B show that the boundary between regions B and C is clearly separated. In general, region B was heavily contaminated; the film which was present could not be removed by repeated ultrasonic cleaning. The structure of

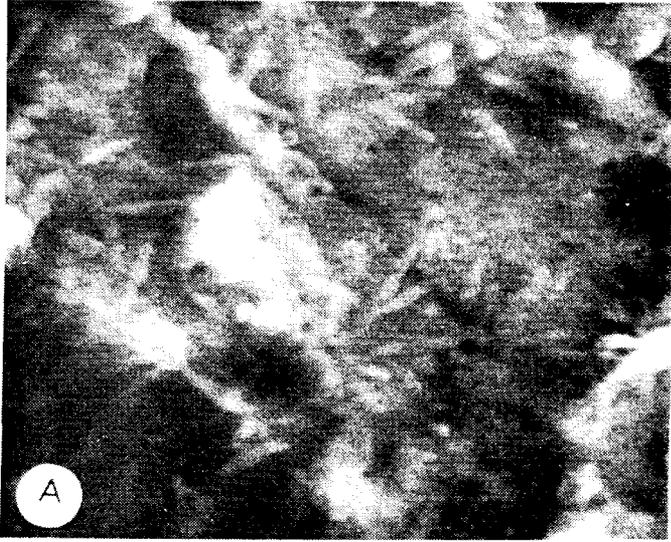
Fig. 12 - Details of contaminants covering most of region B. Magnification 7700X

the contaminants is clearly brought out at high magnification in Fig. 12. Fig. 13 presents a comparison between regions B and C. The fatigue features can be seen at some locations in region B, but at most locations the features are totally obscured due to being covered by the contaminants.

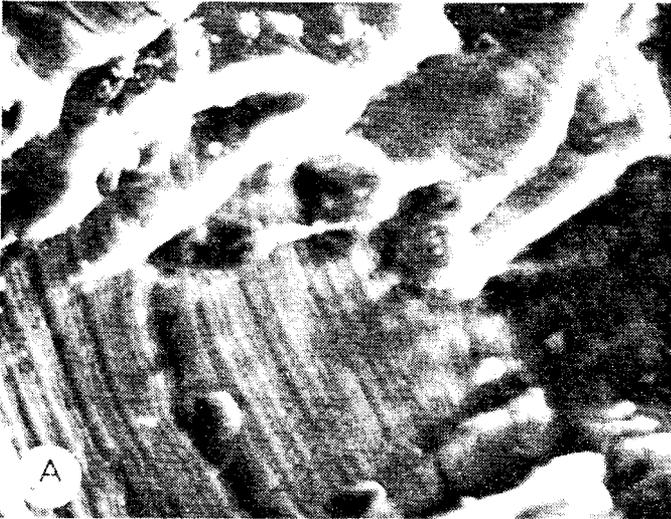
Fig. 13 - Fatigue striations in (A) region C (magnification 2300X) and (B) region B (magnification 2300X). Striations are clearer and sharper in region C than in region B, where they are obscured by contaminants

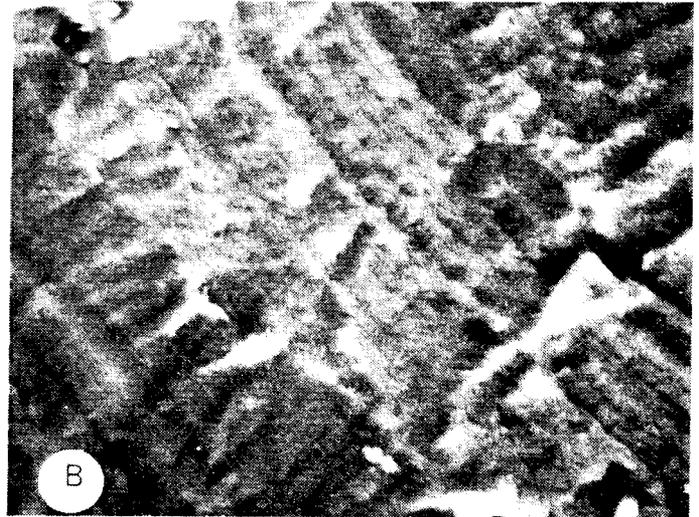
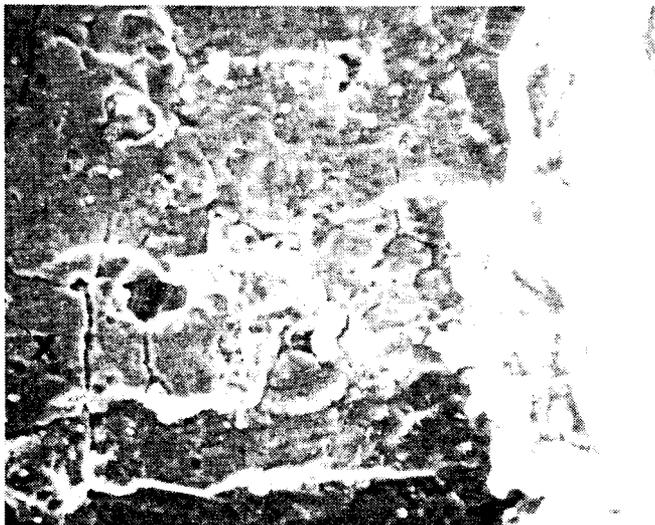
Fig. 14 - High magnification view of region A at center of fracture edge in Fig. 7 magnification: 460X

In region A, no specific initiation point could be found; Fig. 14 is a high-magnification photograph of this region. Grain boundaries were separated and were clearly identified in most areas of region A. The structure here appears to have been induced by chemical attack (Fig. 15).

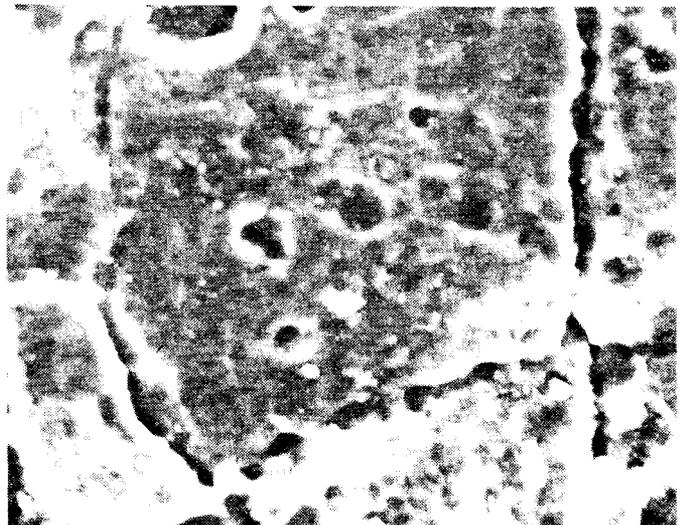
Fig. 15 - Details of grain X in Fig. 14, showing pitting and grain boundary attack. Magnification: 1380X

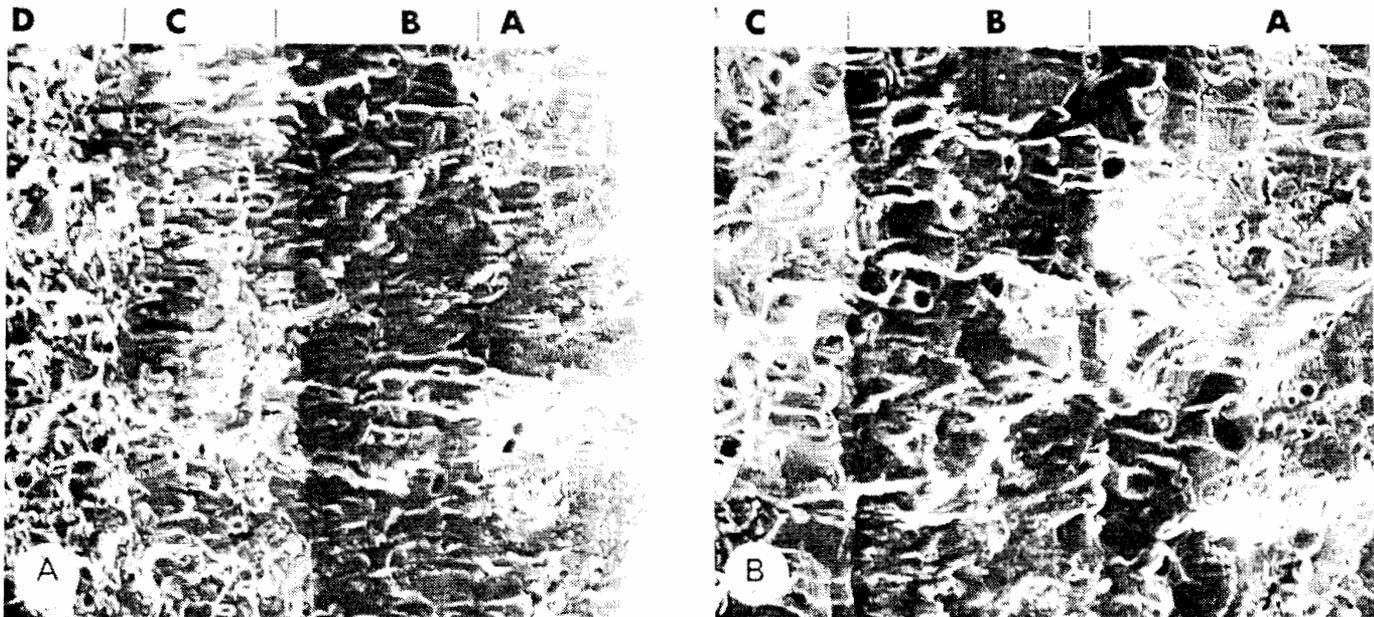
area outside the suspect-origin region described (that is, outside region SS of Fig. 6), four similar regions were observed (Figs. 16A and 16B). The features of regions C and D were identical. In all areas of regions B and C the striations were parallel to the circumference of the sample (Figs. 17 and 18). The darker region B (Figs. 17A and 17B) was again more contaminated than region C, and though fatigue features are suspected, they could not be clearly resolved. In Figs. 18A-18C the boundary between B and C is, again, very distinct. Area A (Figs. 19A and 19B) is also very similar in the regions inside and outside SS of Fig. 6.

Fig. 16 - Two areas outside crescent-shaped suspect-origin SS. Four regions (A, B, C, and D), identical to Fig. 7 are observed. Magnification: A-100X, B-230X

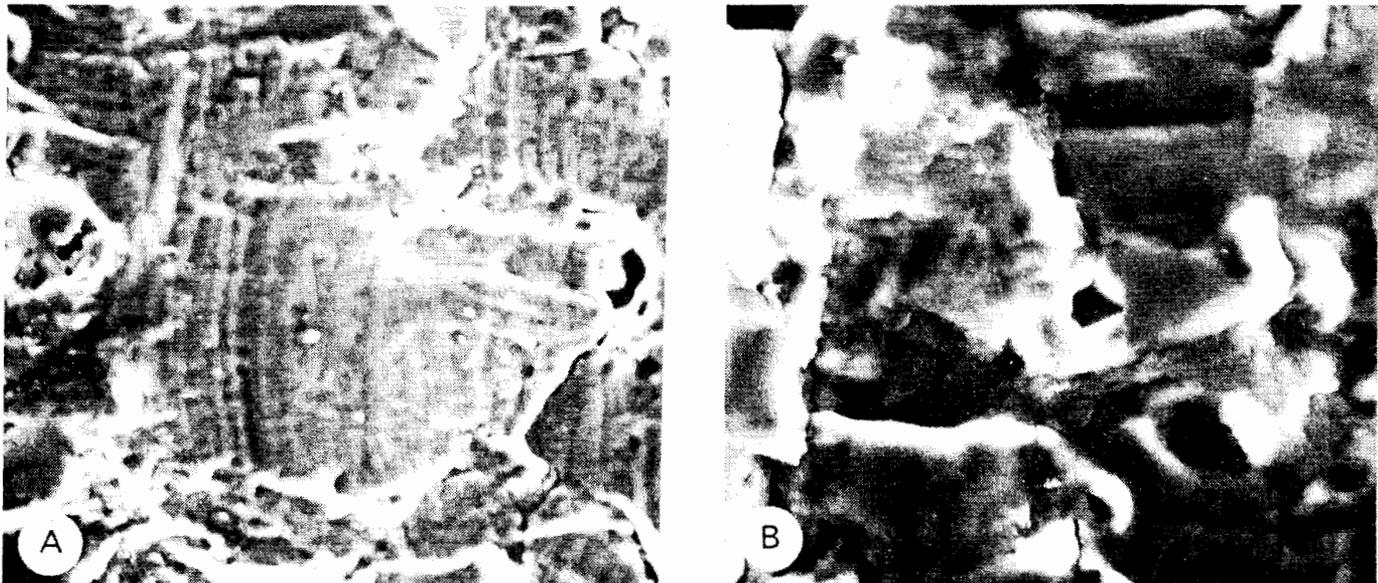
Fig. 17 - Two views of region B. In (A) presence of fatigue striations is not as clear as in left sides of Fig. 18, and in (B) fatigue features are not resolved due to surface contaminants. Magnification: A-770X, B-1000X

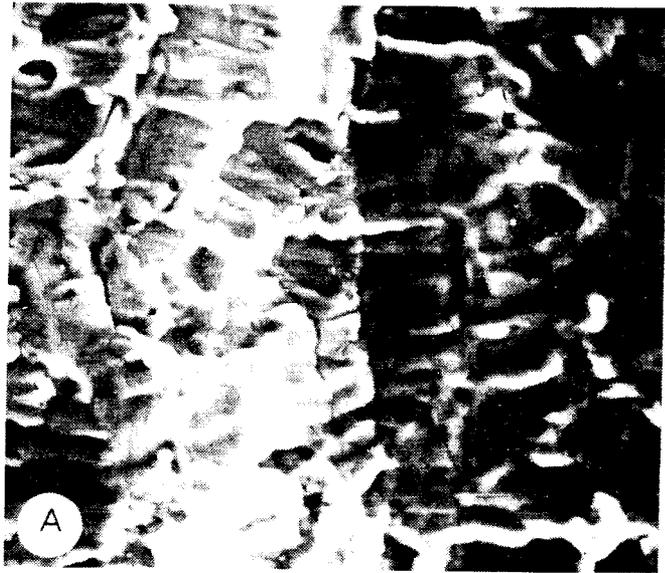
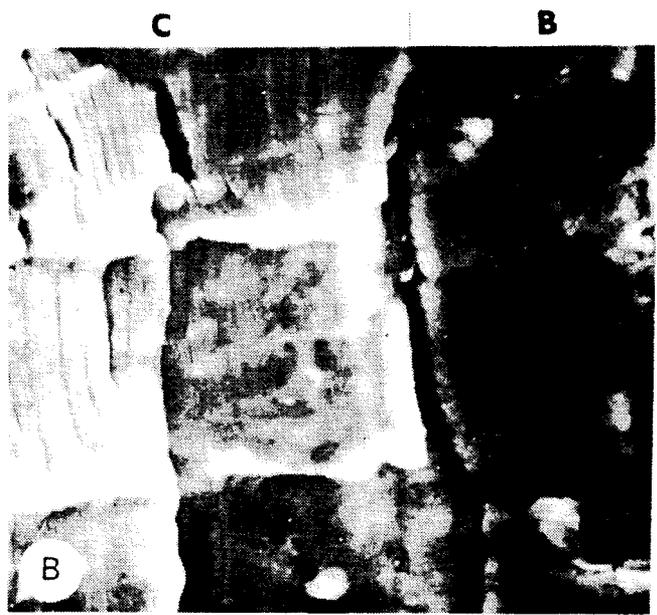
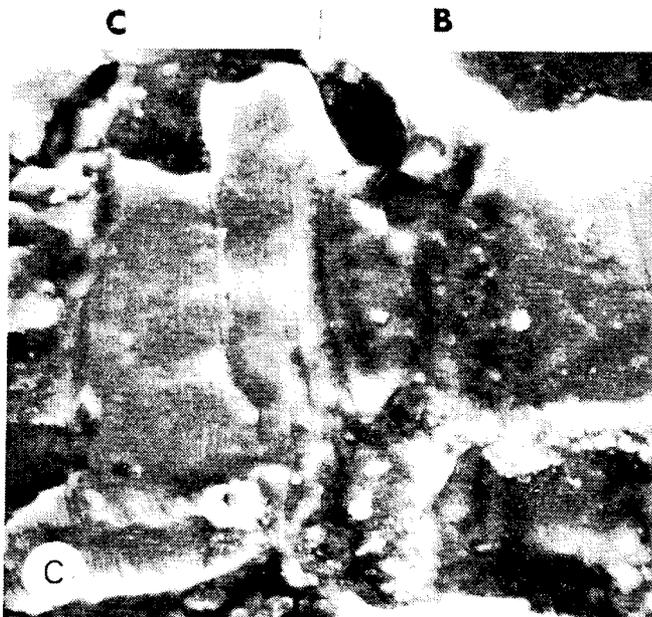
Fig. 18 - Views of regions B and C. A--region B on right and region C on left (500X). B--high magnification (2300X) view of center of Fig. 18A, showing striations in region C and contaminants in region B. C--another area (1000X) showing identical features in regions B and C as in Fig. 18B

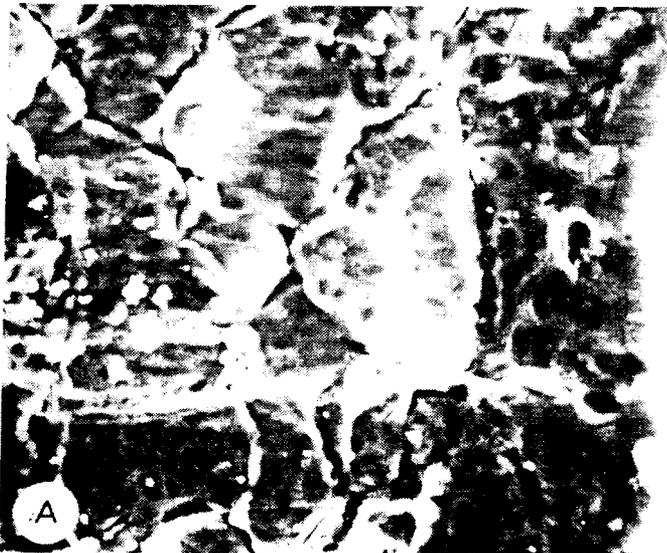
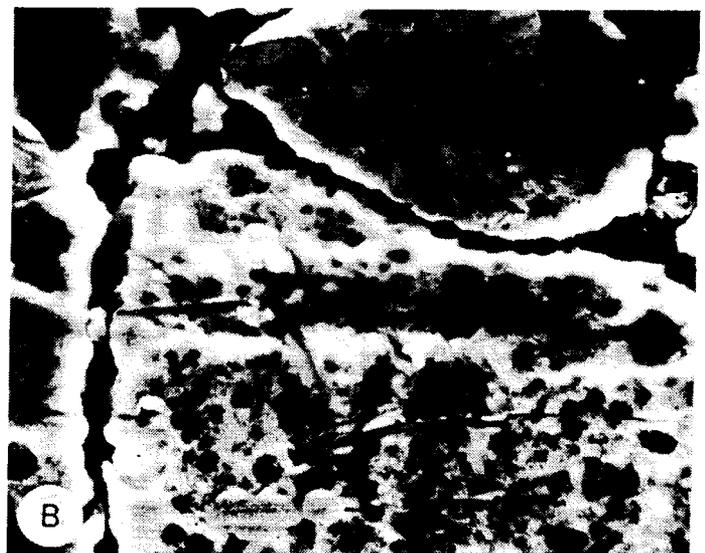
Fig. 19 - Appearance of region A outside crescent region SS. Features are similar to those of region A in Figs. 14 and 15. Magnification: A--770X, B- 2300X

The identical nature of A areas (Figs. 14 and 19) in SS regions (there were at least five such regions at various points on the circumference of the section received) and outside SS is attributed to continuous rubbing and smearing in this area which fractured first, and chemical attack resulting from exposure to corrosive environments during the life of the part since this area, being closest to the specimen surface, suffers maximum exposure. Also, alkaline solutions are used to clean aluminum alloy components, and the structure in Figs. 14 and 19 could arise from the use of such solutions before the crack opened beyond the initial stages of region B.

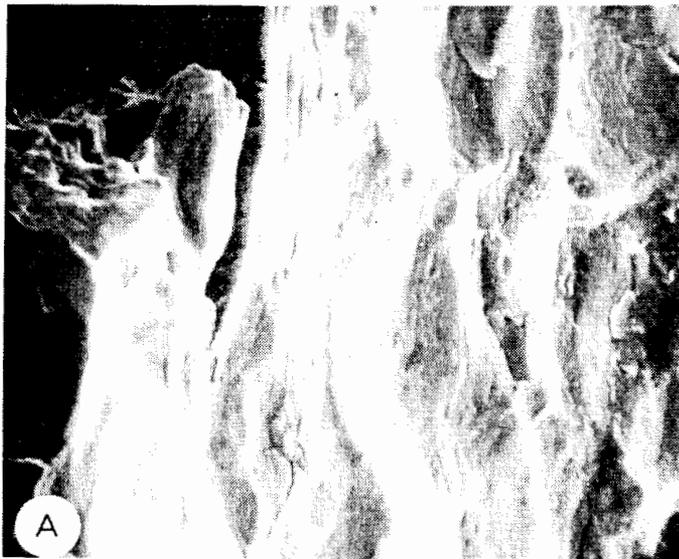
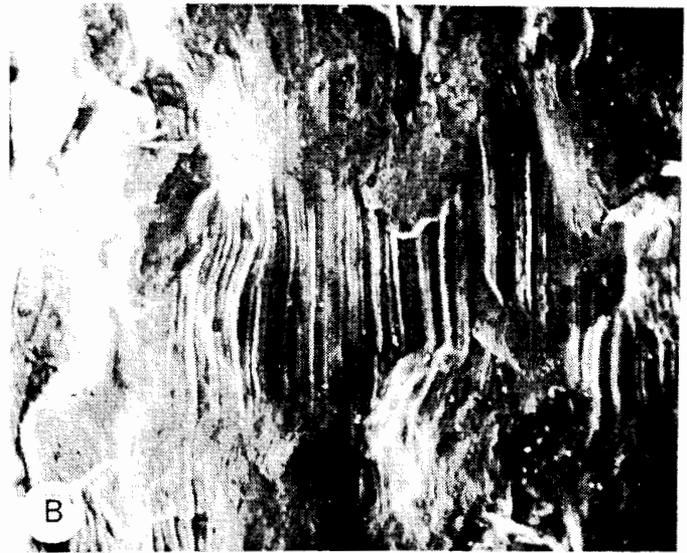
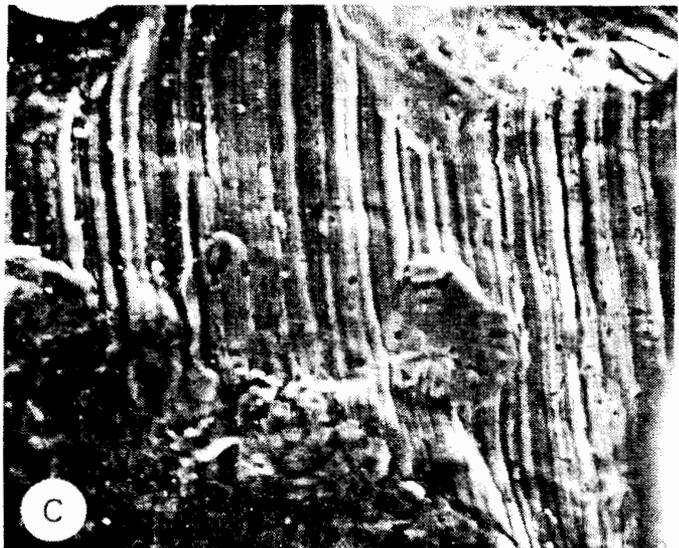
Fig. 20 - Study of shot-peened surface. A—crack on shot-peened surface at lower end of crescent region SS. B and C—many areas on shot-peened surface showed presence of original machine markings. Some areas were either unexposed or lightly exposed to shots, due to poor shot-peening control, and hence resulted in local regions of high tensile stresses. Magnification: A—180X, B—180X, C—500X

always occurred in a plane below the minimum cross-section plane containing most of the fracture. The specimen had been shot peened, and a study of the shot-peened surface revealed many defects; some areas showed surface cracks and many areas showed original machine markings suggesting improper control of shot-peening parameters (Fig. 20).

Region A in the areas observed (for example, Figs. 7 and 16) extends to approximately 0.025 cm below the shot-peened surface. Since shot peening is employed to prevent fatigue failures by providing compressive stresses at the immediate surface (usually the first 0.013 cm or less), observations such as in Fig. 20 indicate that many areas were either not hit or very lightly hit by the shots and derived no benefit from the shot-peening operations. Large isolated areas of unfavorable stress states caused by poorly controlled shot peening and located at or near the minimum section of the strut could thus act as initiation sites. The observations of many suspect initiation sites support this explanation, although precise correlation between any surface defects and fatigue initiation sites was not found.

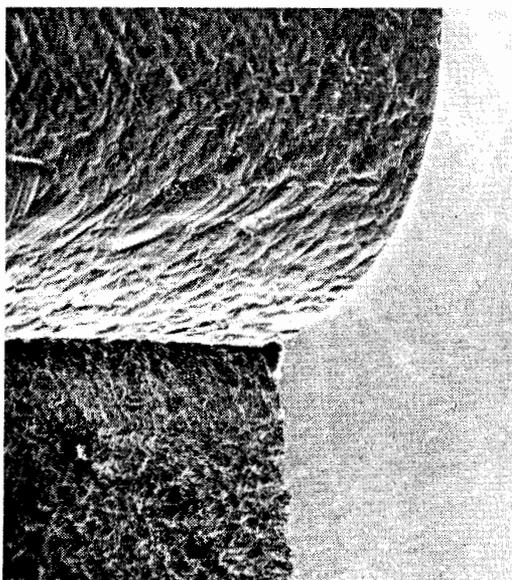
Fig. 21 - SEM enables examination of all three surfaces at one time. Polished surface is on right, shot-peened surface on top left, and fracture surface on bottom left. Magnification: 24X

To verify the shot peening damage further, a metallographic section was prepared (Figs. 21 and 22). Detailed SEM examination of this section (Fig. 23) revealed presence of many flaws and confirmed the uneven nature of shot-peening load distributions.

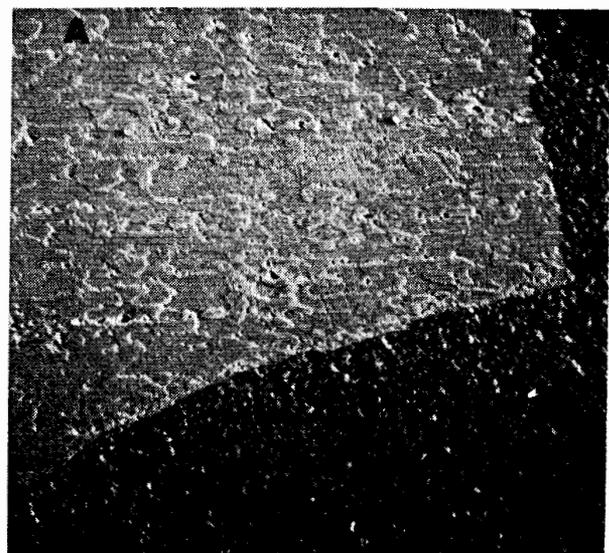
Fig. 22 - Backscattered SEM photograph. Section through shot-peened surface (curved edge) and fracture surface (straight edge) showing microstructure of alloy as revealed by SEM. Sample is mounted in bakelite. Magnification: 100X

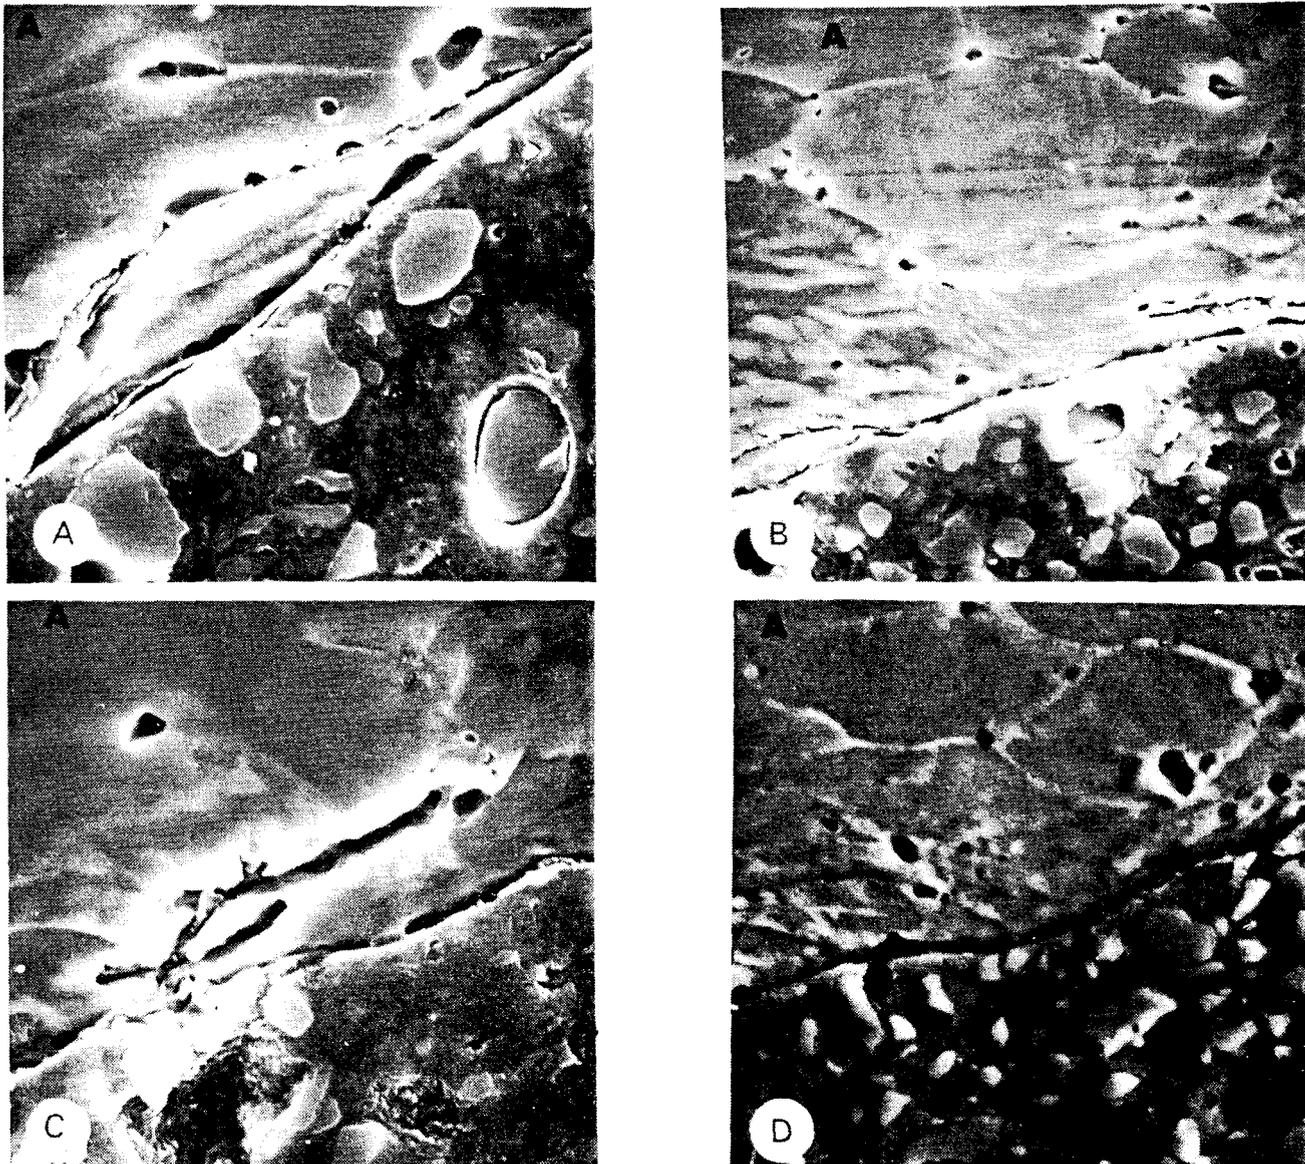
Fig. 23 - Four views showing details of shot-peened edge in Fig. 2. Notice extent of deformation induced and nature of defects which are present. (All micrographs are secondary electron images in SEM.) A—alloy, B—bakelite. Magnification: A—2000X, B—1000X, C—2000X, D—1000X
