TECHNICAL REPORT NO. 420

M9 ACE TRANSMISSION OUTPUT
SHAFT FAILURES

R. DAVIS MENTZER, JR.

APRIL 1986

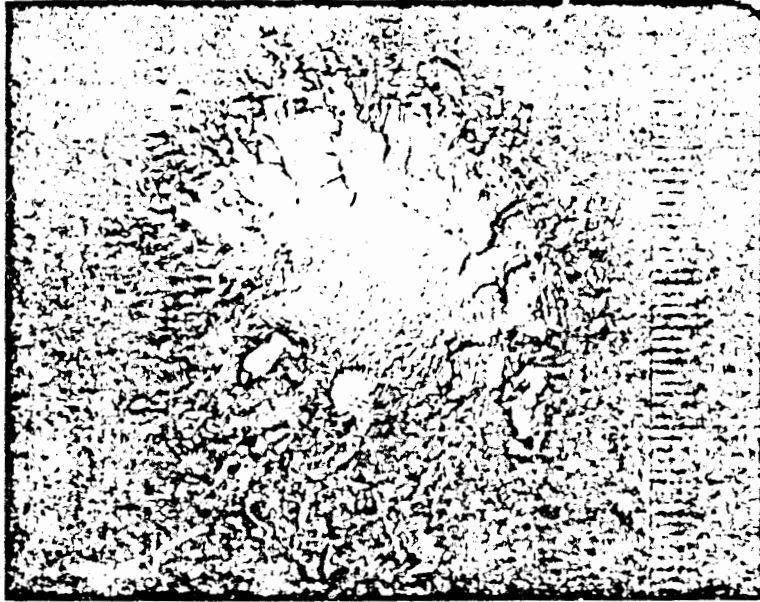
Cracks initiated and propagated near the root fillet of each spline tooth with fracture occurring in the transverse plane of the shafts at spline runout. No other cracking or deformation was found away from the highly stressed end of the shafts.

Figure 1. Fracture surface of shaft 9.

Recommendations offered by the Materials Branch to increase shaft life highlighted reducing the stress at the spline fillet. This could be accomplished by increasing the fillet radius of the splines and requiring the operators to bring the vehicle to a complete stop when shifting from reverse to forward to reduce loading.

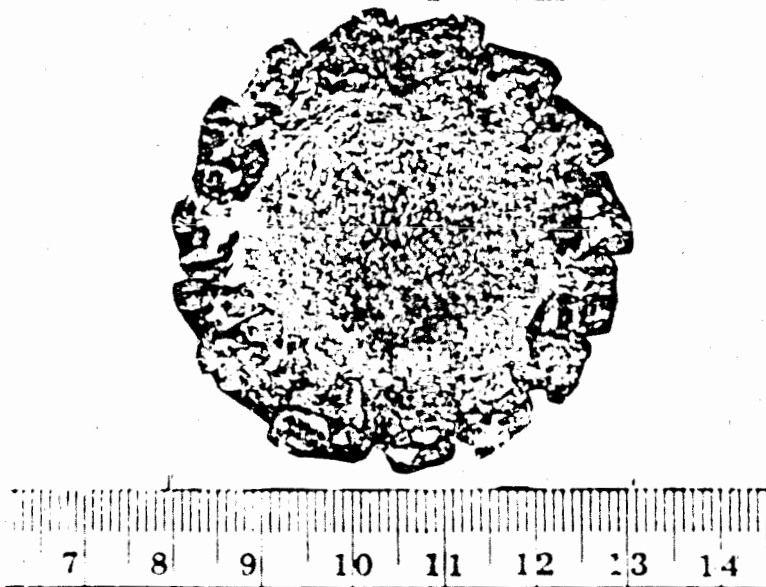
Figure 2. Fracture surface of shaft 11.

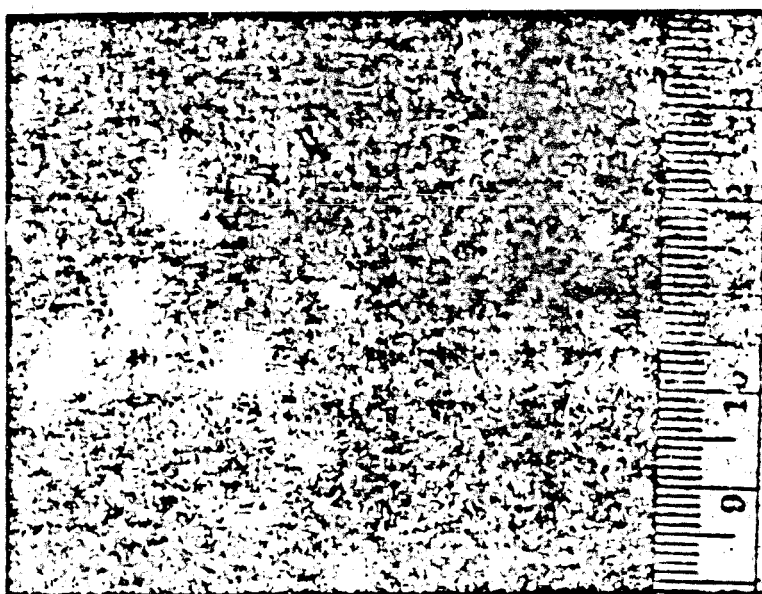
Figure 4. Cross section of shaft 3 near spline runout. Note that all cracks extend through the case. A similar situation was found in shaft 4.

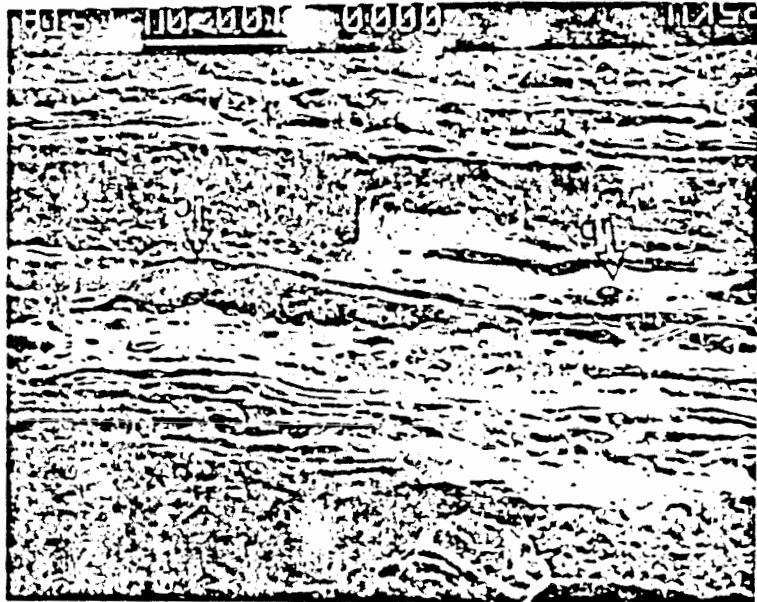
Figure 5. Laboratory fracture of shaft 9. In the case, the fracture was dominated by transgranular cleavage (A) and had interspersed microvoid coalescence (B). Secondary electron image.

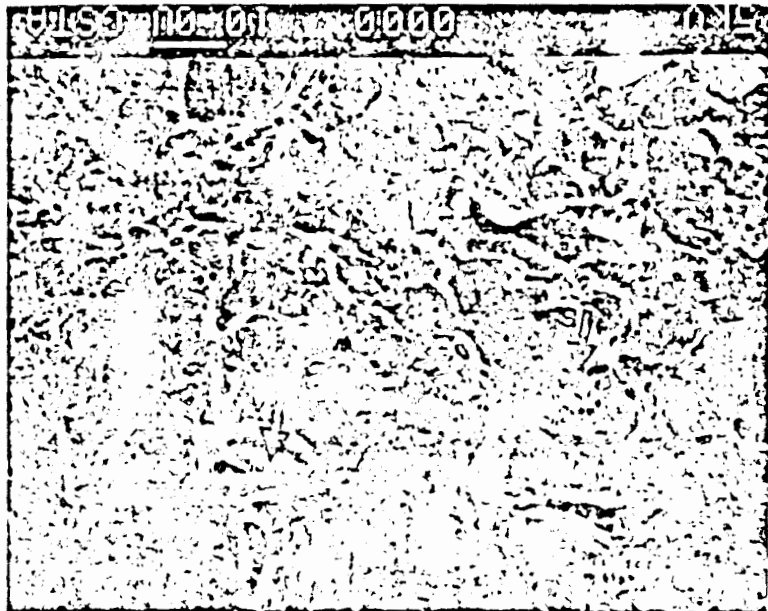
Figure 6. Laboratory fracture of shaft 9. In the core, the fracture was entirely microvoid coalescence. Void origins were predominantly KHS as at C with some origins at calcite modified at D.

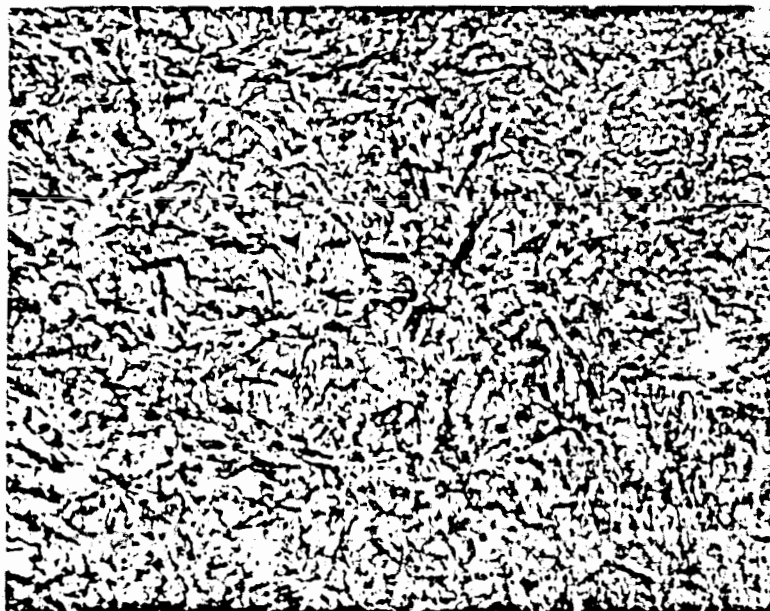
Figure 10. Microstructure of hardened case. Gray and dark constituents are plate martensite; white constituents are retained austenite

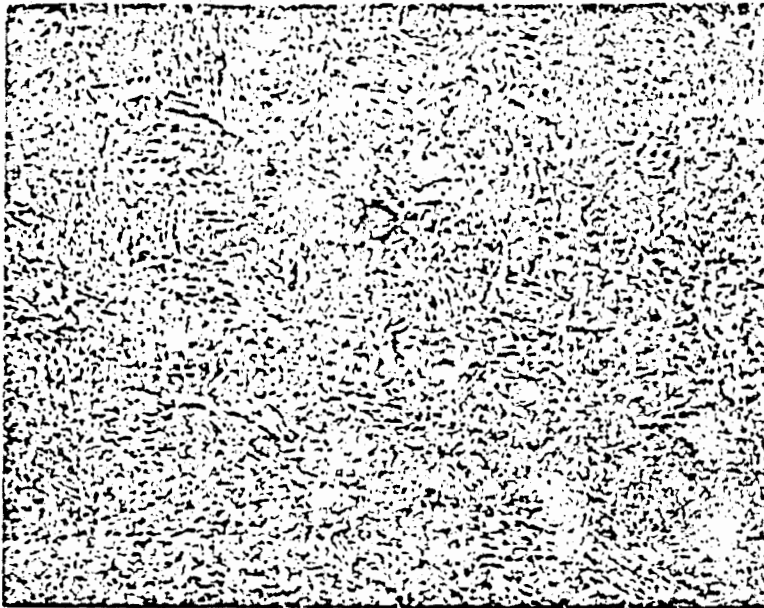
Figure 11. Bainitic Structure of shaft core.

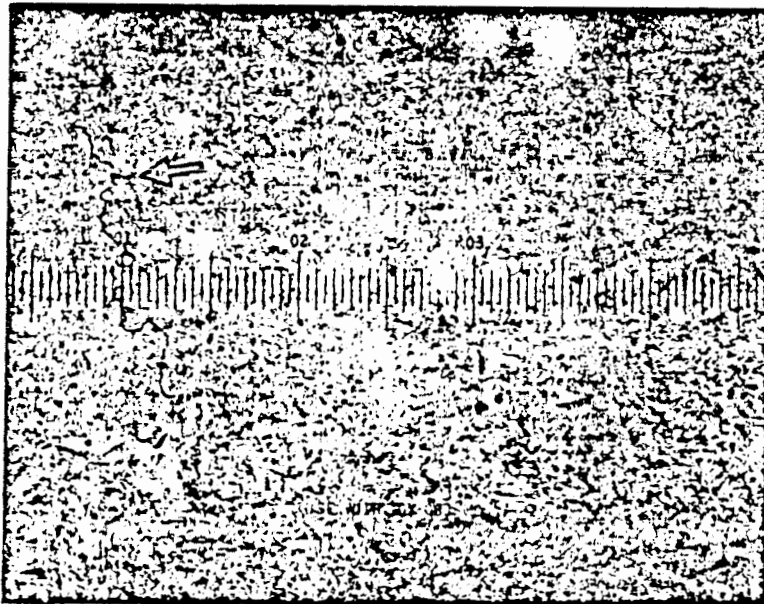
Figure 12. Transverse microsection taken 20 mm from threaded end.
Note intergranular fracture in center of root. Scale is in inches.

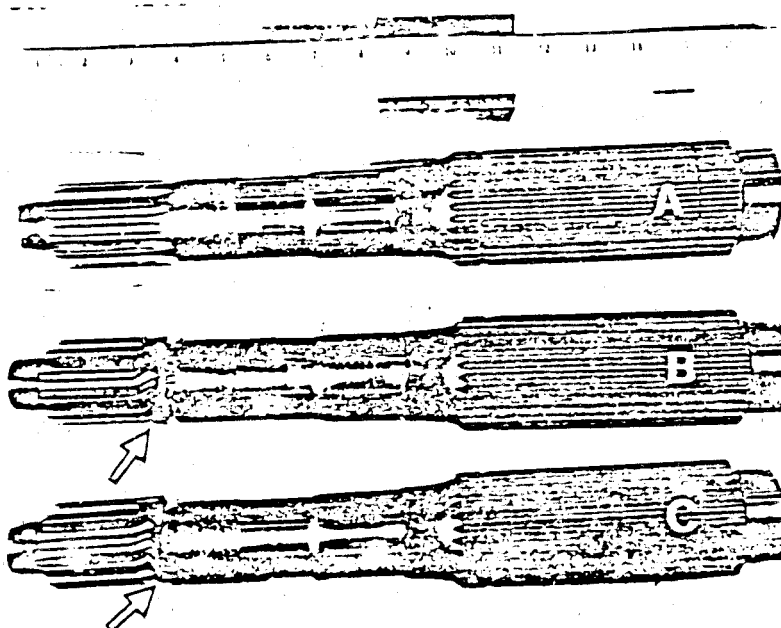
Figure 1. Shaft A was undamaged. Fracture path of shafts B and C in the splines indicated by arrows.

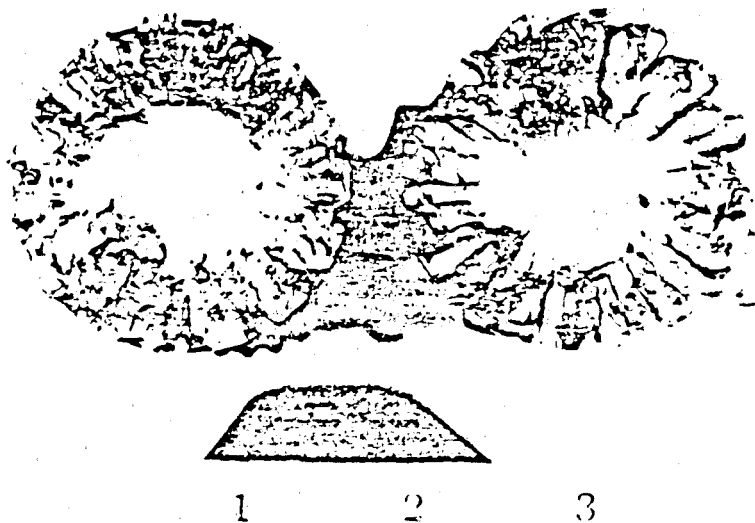
Figure 2. Mating fracture surfaces of shaft 3.

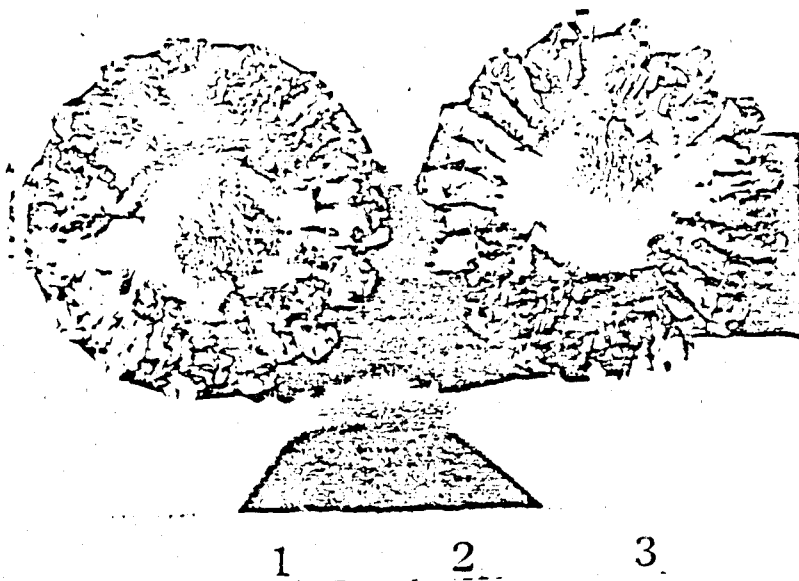
Figure 3. Matching fracture surfaces of shaft C.

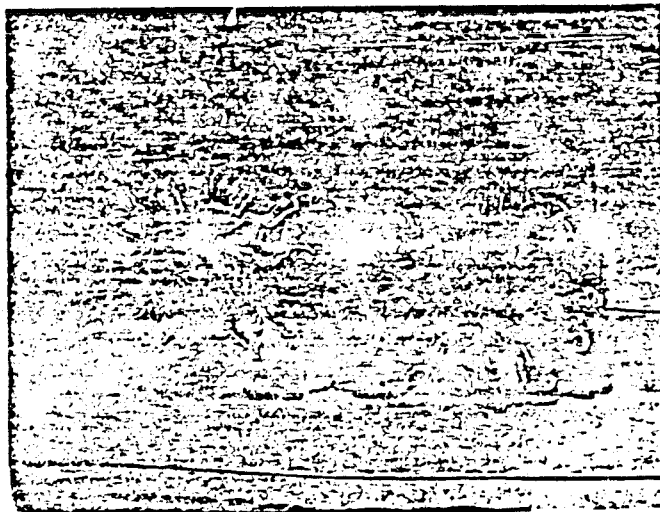
Figure 6. Magnetic particle testing reveals extent of cracking in shaft B.

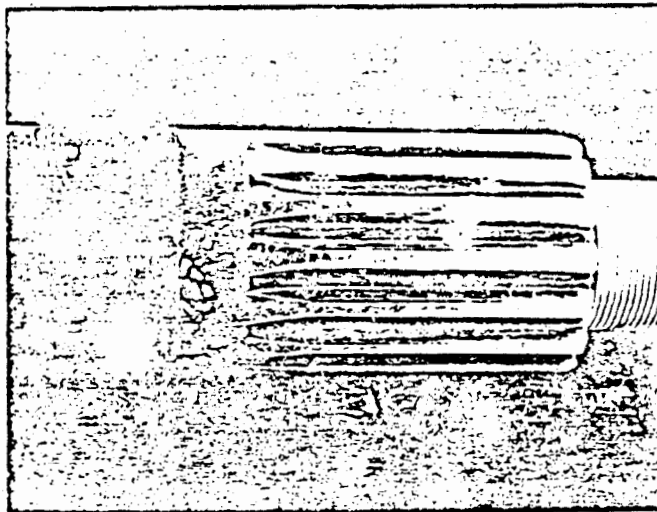
Figure 7. Magnetic particle testing revealed no discontinuities indicative of cracks or other defects.

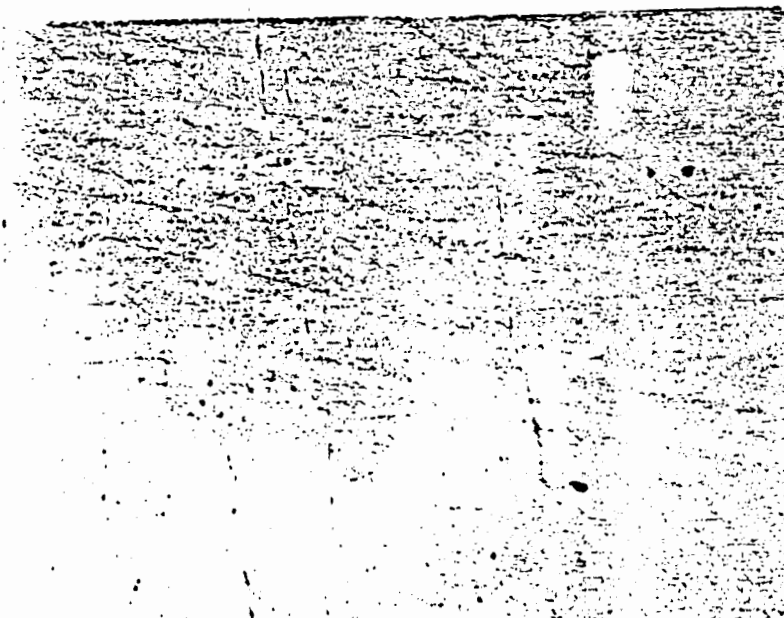
Figure 8. Longitudinal micrograph of shaft B.
No Etchant. Magn: 100 X

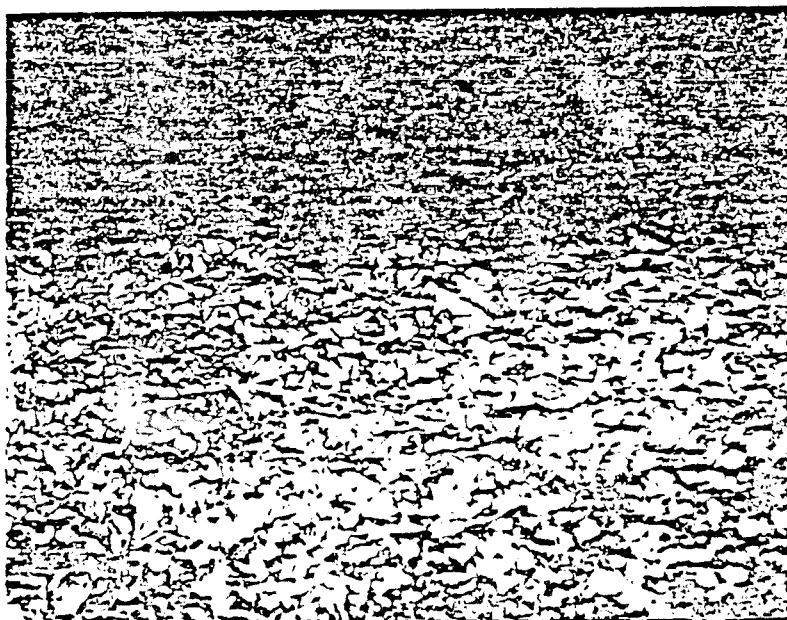
Figure 10. The carburized case of shaft A consisted of a layer of martensitic lathes in a matrix of retained austenite (white). Etchant: 2% Nital Magn: 400 X

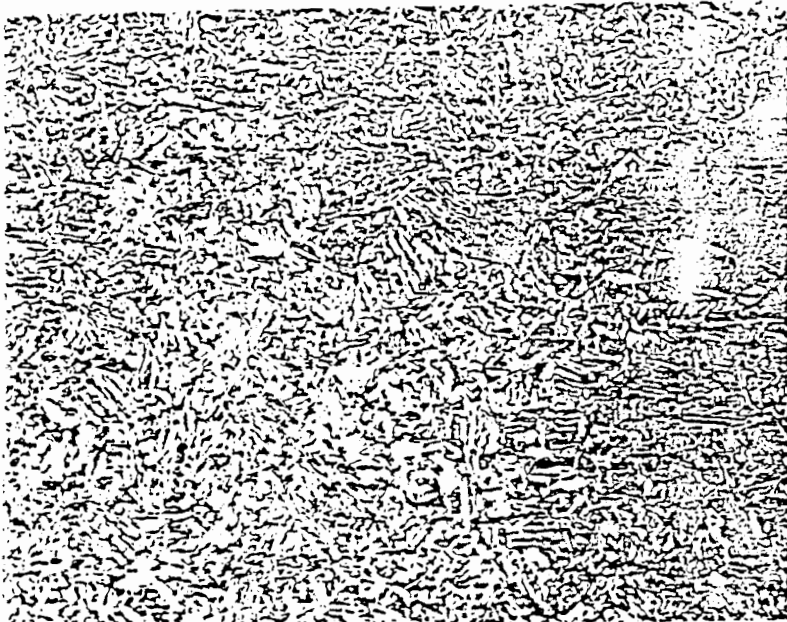
Figure 11. Microstructure of a transverse section of the core of shaft C consisted of bainite (dark regions) and ferrite (white, equiaxed regions).
Etchant: 2% Nital Magn: 400 X

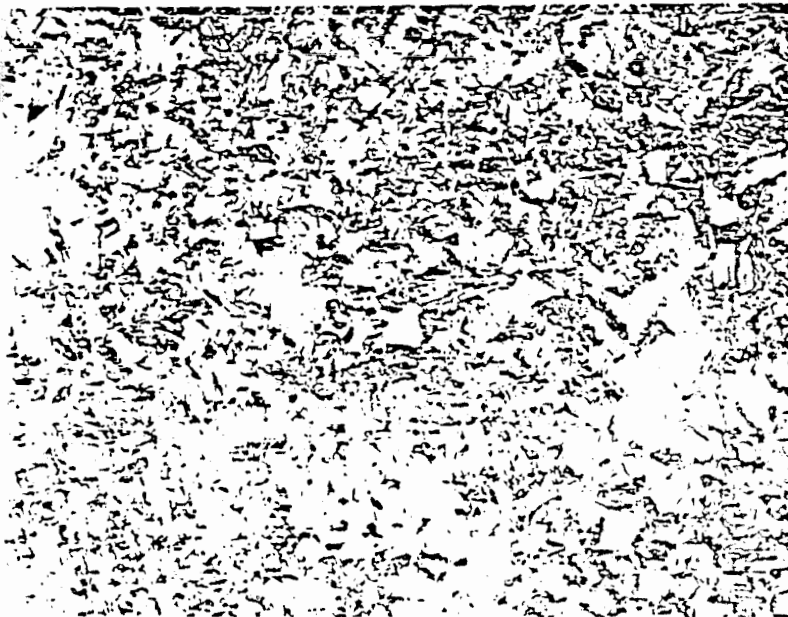
Figure 12. Microstructure of a transverse section of the core of shaft A consisted of tempered martensite (gray) and bainite (dark areas). Etchant: 2% Nital Magn: 400 X
