FLIGHT SAFETY FOUNDATION  
**Aviation Mechanics Bulletin**

SEPTEMBER–OCTOBER 2001

# **Inadequate Shot Peening Cited in Two Failures of Left-main Landing Gear on Fokker 100**

# Inadequate Shot Peening Cited in Two Failures of Left-main Landing Gear On Fokker 100

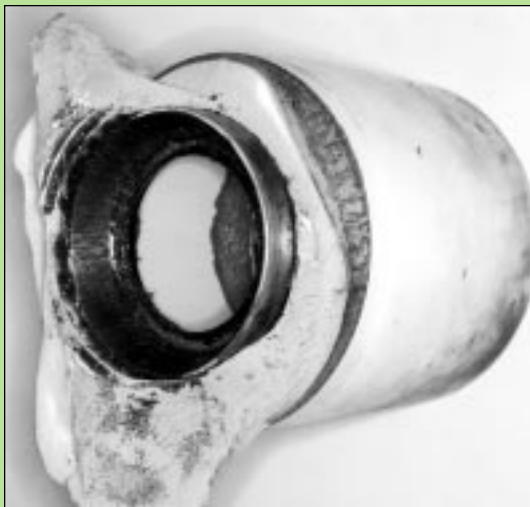
**On the cover:** A close-up of the fractured left-main landing-gear outer wheel on a Fokker 100. Left-main landing-gear components on the airplane failed during two landing incidents in Australia. (Source: Australian Transport Safety Bureau)

The technical report said that a comparison of the surface of the repaired area and the original surface of the wheel hub revealed a “markedly different” intensity in the shot peening of each area. The intensity of shot peening was lower on the repaired surface, the report said.

“This variation would be expected to lower the resistance of the wheel to fatigue cracking,” the air safety occurrence report said. “The lower level of compressive residual stress associated with the less intense shot-peening process applied to the repaired [area] would also increase the likelihood of fatigue failure under normal loading conditions.”

The ATSB air safety occurrence report on the July 4 landing incident said that the wheel failed because of fatigue cracking that began at the surface of the metal in the repaired area of the wheel hub.

Both air safety occurrence reports included a recommendation to the U.K. Civil Aviation Authority (U.K. CAA) to review the repair process and the overhaul process for the failed wheel and for the failed torque links that were identified during the ATSB investigation of the second landing incident to ensure that the processes conform to airworthiness requirements.

The technical report also included a recommendation for an audit of the company responsible for the repair and overhaul of the left-main landing gear
