1. Report No. FHWA/TX-06/5-4178-01-2		2. Government Accession No.	3. Recipient's Catalog No.	
4. Title and Subtitle Application of Ultrasonic Impact Treatment to In-Service Signal Mast Arms		5. Report Date June 2005, Rev. November 2005

## **Application of Ultrasonic Impact Treatment to In-Service Signal Mast Arms**

CTR Research Report:	5-4178-01-2
Report Date:	June 2005
Research Project:	5-4178-01
Research Project Title:	Ultrasonic Impact Treatment (UIT) for Traffic Signal Structure Fatigue Details
Sponsoring Agency:	Texas Department of Transportation
Performing Agency:	Center for Transportation Research at The University of Texas at Austin

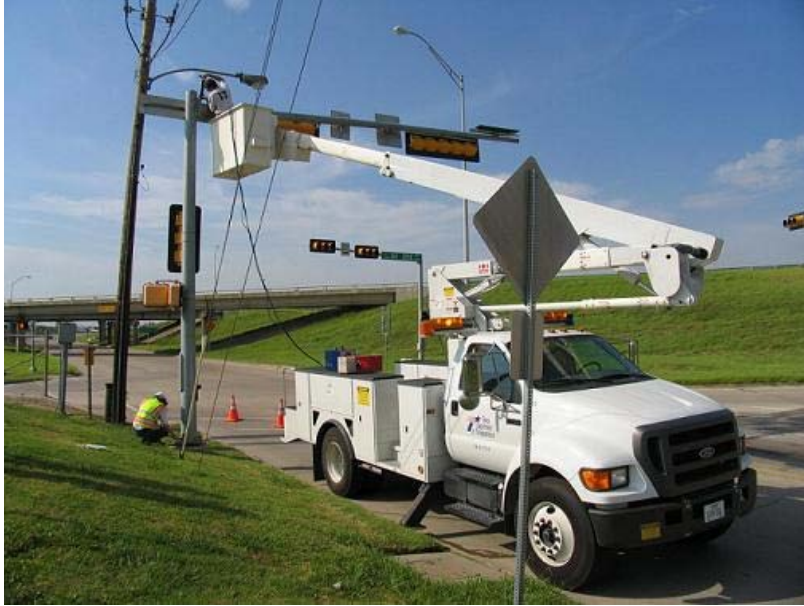
*Figure 2.2 Mast Arm 1 on the Northeast Corner of the North Intersection of I-35E and Bonnie Brae Street in Denton, TX*

The location of the structures for UIT retrofit was chosen due to a recent fatigue failure of the mast arm on Structure 1. Many of the treated arms were similar in geometry and subjected to similar wind conditions as the failed arm. The UIT treatment was applied to increase the fatigue resistance of these arms and prevent future service failures.

Mast arm 1, shown in Figure 2.2, is 24 feet long 7.5 inch diameter with an end plate bolt spacing of 6" x 10". Mast arm 2, shown in Figure 2.3, is 8 inch diameter 28 feet in length with an end plate bolt spacing of 7" x 11". Mast arm 2 has been in service for approximately 10 years. Mast arm 1 was replaced after a recent fatigue failure, and had been in service approximately one year at the time of treatment.

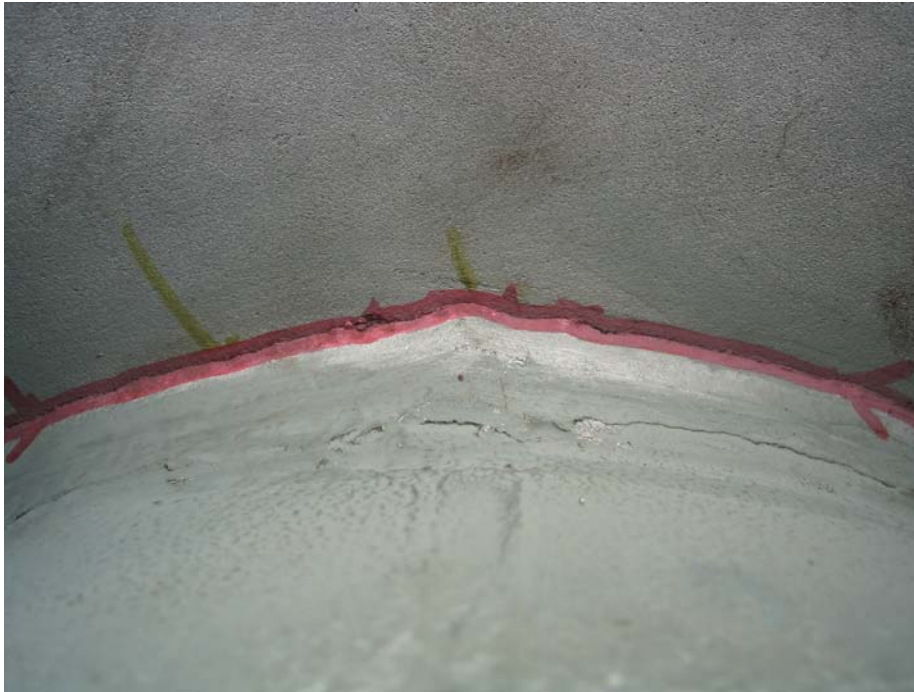
*Figure 2.5 Fatigue Crack at End Plate Weld Toe in Laboratory Specimen*

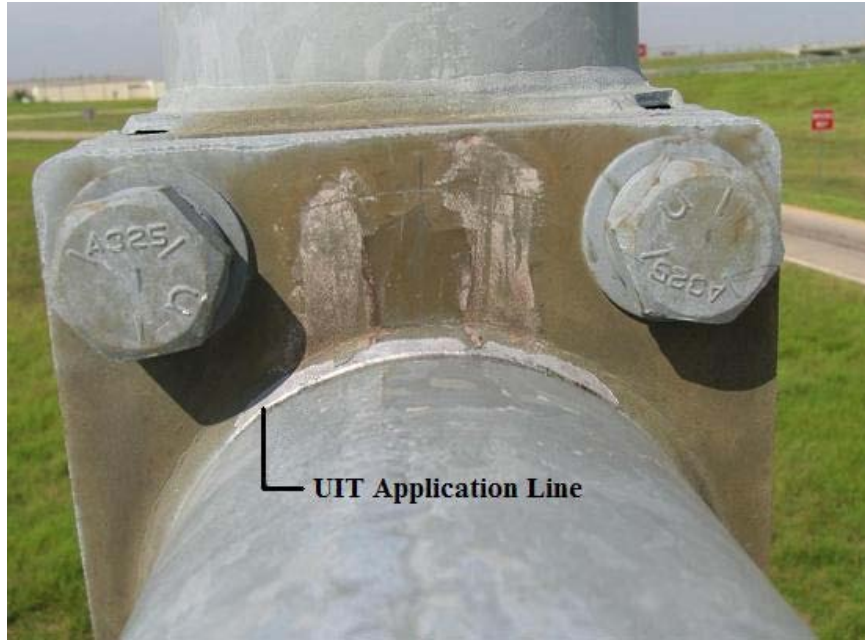
Figure 2.6 and Figure 2.7 show the weld on Mast arm 2 after treatment and after spraying with the zinc rich paint to restore the galvanic corrosion protection to the treated region. Figure 2.8 shows the weld at the base of Mast 2 after treatment. The treated region of the weld is visible as the shinier area in Figures 2.6 and 2.8. The treatment was applied only to the top tension portion of the mast arm joint. The weld of the mast to the base plate was treated all around the joint. The bolts attaching the end plate to the mast interfered with the UIT tool which prevented treatment to the weld adjacent to the bolts. The treatment should be applied to as much of the weld on the top of the mast arm as is possible, but not less than a 90° arc of the mast arm.

*Figure 2.6 Mast Arm 2 After UIT Application.*

The bolts used on Mast arm 2 interfered with UIT application, so the technician applied UIT as best as possible, and the TxDOT inspector found the application to be adequate. The UIT should be applied at a 45° angle each side of vertical, however this was not always possible and the UIT was applied as closely to a 45° angle as possible. The TxDOT inspector suggested using the UIT tool with a 15° angle that is available, but it was decided that technicians in the field would be unlikely to switch to a 15° angle UIT tool; therefore, the straight UIT machine was used in an effort to simulate typical field applications as accurately as possible.

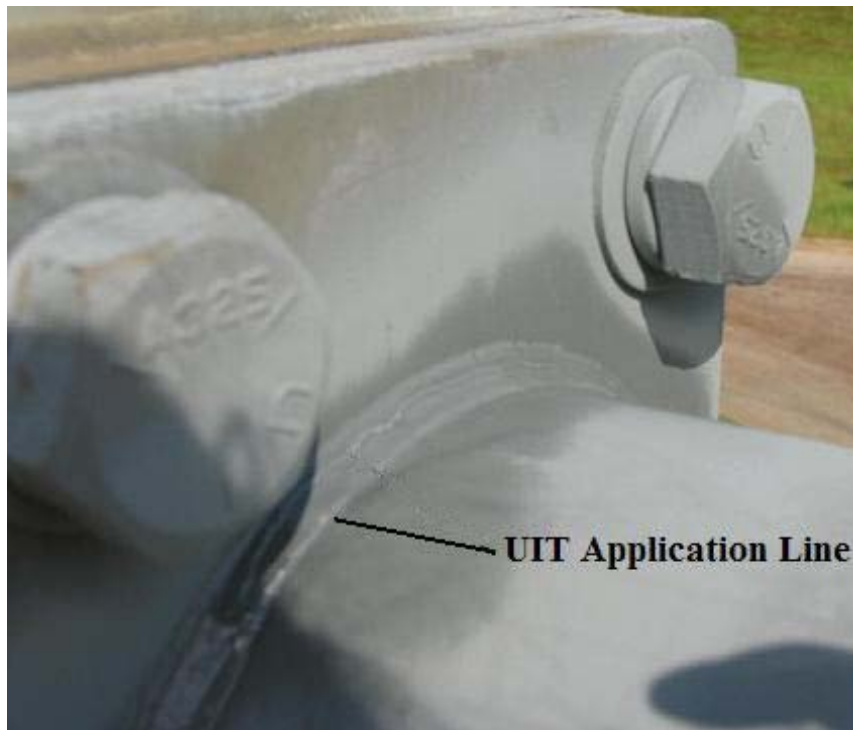
*Figure 2.7 Mast Arm 2 After UIT and Application of Zinc Rich Spray Paint*

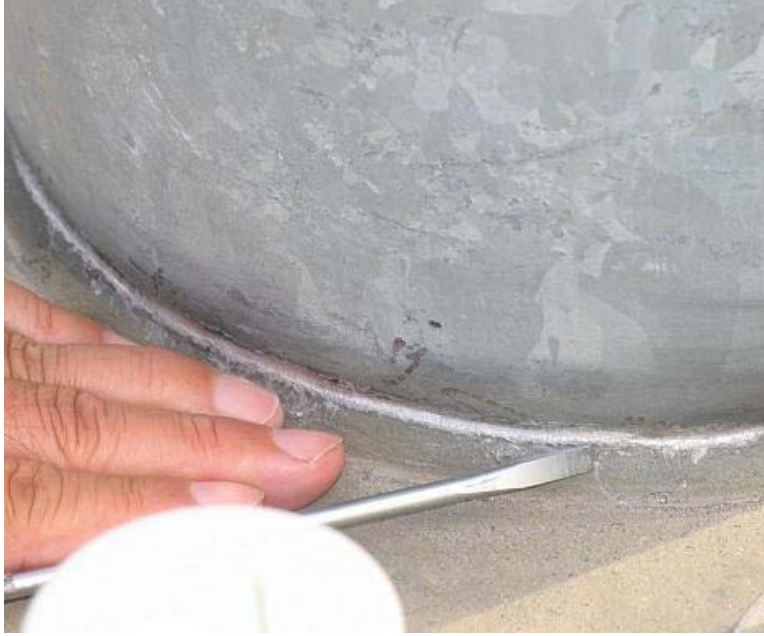
*Figure 2.8 UIT Application at the bottom of Mast 2*

The end plate-mast arm weld toe was treated first via bucket truck. Next, the technician descended and applied the UIT at the base plate-mast weld toe. To save time, the TxDOT inspector used the bucket truck to inspect the UIT application at the end plate-mast arm weld toe while the base plate-mast UIT application was performed. After satisfactory inspection by the TxDOT inspector, the TxDOT inspector applied two coats of a zinc-rich paint. A flat-head screwdriver was used to scrape away galvanizing loosened by the UIT application as shown in Figure 2.8. Once the UIT application area was scraped clean 2 coats of zinc-rich paint were applied. The paint was Rust-oleum Cold Galvanizing compound, 93% pure zinc.

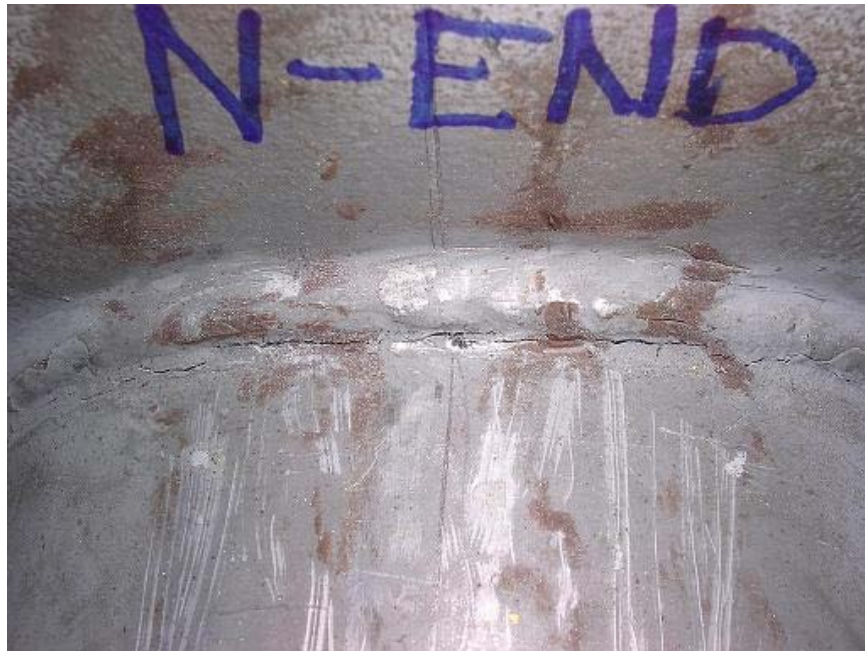
The testing conditions of Phase 1 lasted until mast arm DU developed fatigue cracking that lowered applied loads below the limits at 90,680 cycles. A close-up of the fatigue cracks in the DU mast arm weld toe along the UIT application line is shown in Figure 3.9. Figure 3.10 shows the entire fatigue crack on mast arm DU after highlighting with a red marker.

*Figure 3.9 Close-up of Fatigue Crack on Specimen DU Mast Arm Weld Toe Along the UIT Application Line (90,680 cycles)*

The fatigue crack in specimen DU was repaired by grinding away the galvanizing and re-welding the fatigue crack. The mast arms were then cycled between maximum and minimum load at 0.08 Hz to determine the displacements for Phase 2 of the dynamic test.

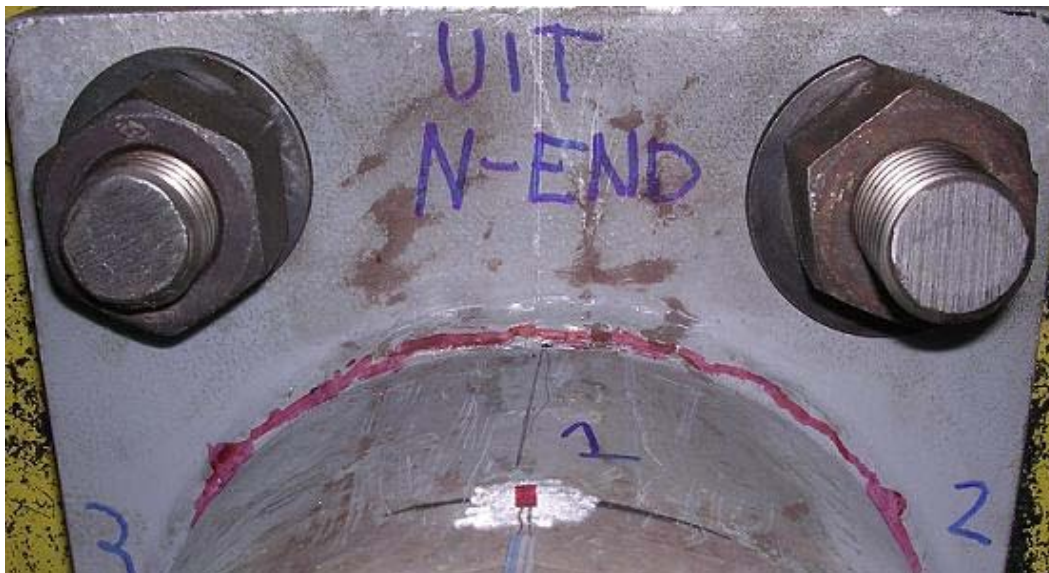
*Figure 3.10 Highlighted Fatigue Crack on Specimen DU Mast Arm Weld Toe Along the UIT Application Line (90,680 cycles)*

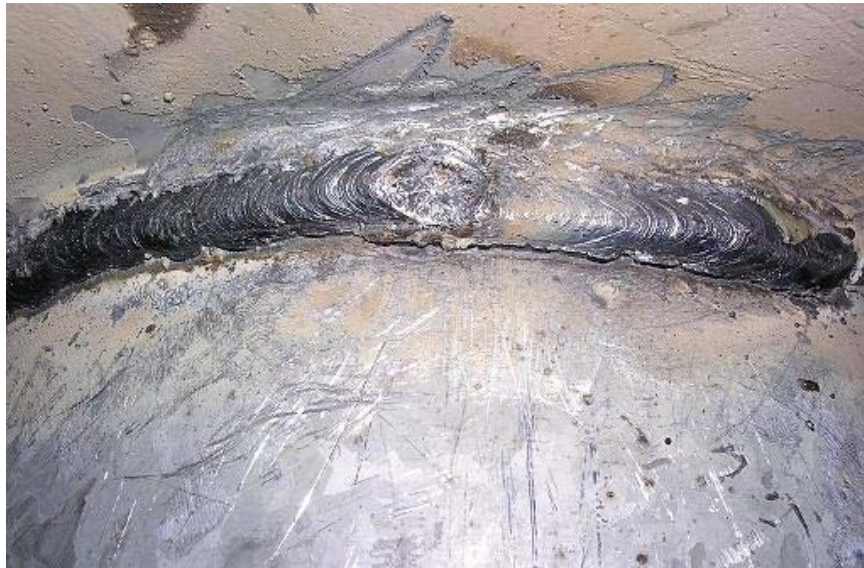
The testing conditions of Phase 2 lasted until a new fatigue crack on mast arm DU occurred through the weld repair at 116,876 cycles. A close-up of the second fatigue crack in the DU mast arm weld toe through the weld repair is shown in Figure 3.11.

*Figure 3.11 Close-up of Fatigue Crack on Specimen DU Mast Arm Weld Toe Along the Weld Repair (116,876 cycles)*

After the failure of the weld repair on mast arm DU, it was decided to add a stiffener to mast arm DU, to reinforce the weld and prevent further fatigue cracking. Figure 3.12 shows the stiffener added to mast arm DU before Phase 3 dynamic testing.

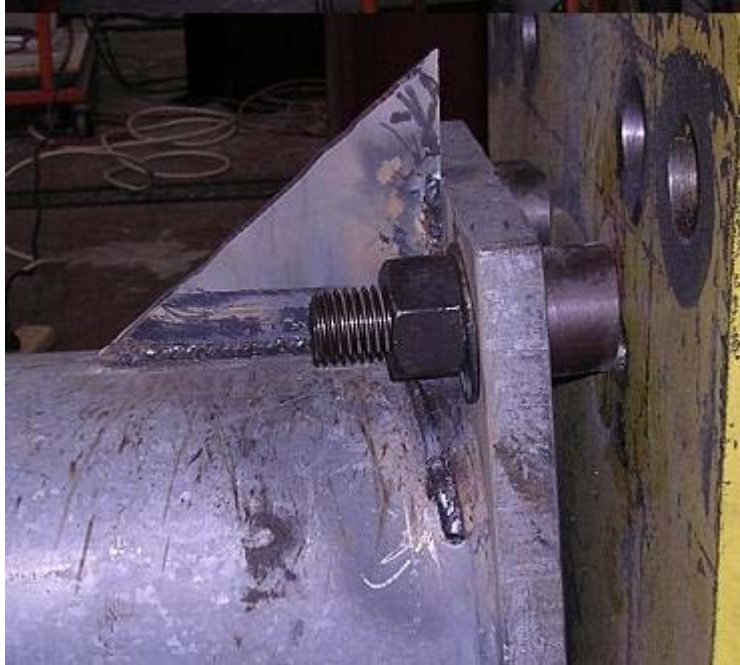
*Figure 3.12 Stiffener Added to Mast Arm DU After 116,876 Cycles*

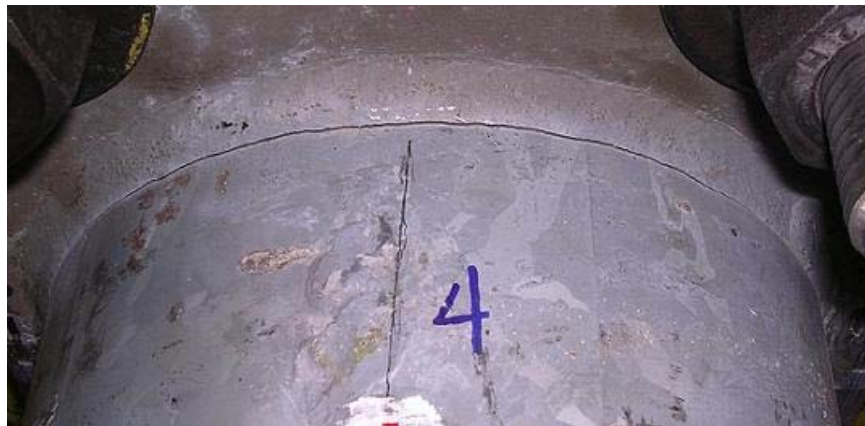
The testing conditions of Phase 3 lasted until mast arm DN developed a fatigue crack at 224,905 cycles. A close-up of the fatigue crack in the DN mast arm weld toe is shown in Figure 3.13. Figure 3.14 shows the entire fatigue crack on mast arm DN after highlighting with a red marker.

*Figure 3.13 Close-up of Fatigue Crack Along Mast Arm Weld Toe of Specimen DN (224,905 cycles)*

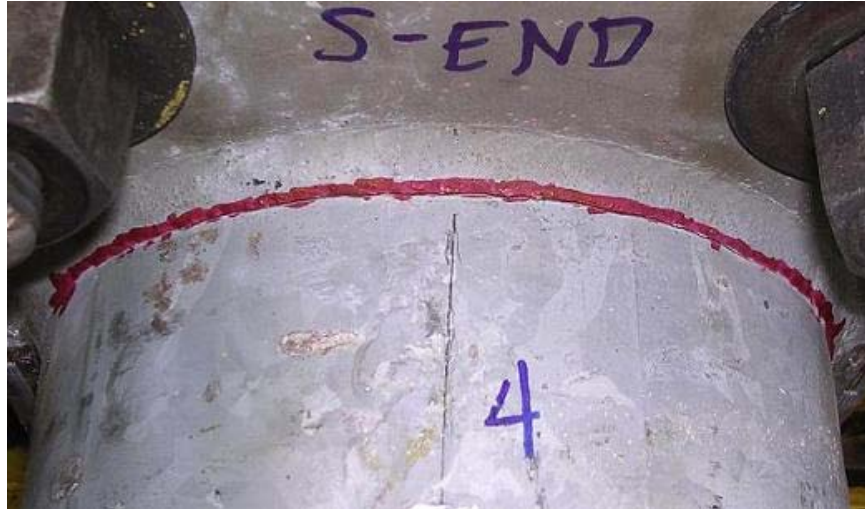
*Figure 3.14 Highlighted Fatigue Crack Along Mast Arm Weld Toe of Specimen DN (224,905 cycles)*

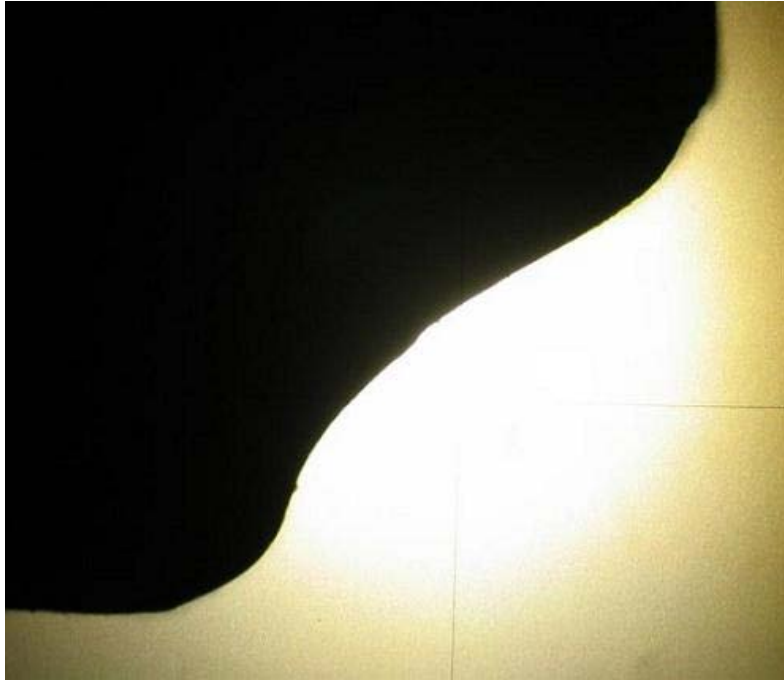
*Figure 3.20 10x Magnification of Mast Arm DU Weld After UIT*

Figure 3.20 shows the weld profile of mast arm DU after UIT Application at 10x magnification. Comparison of weld toe regions in the two figures clearly shows the effect of UIT on weld toe profile. Previous research determined that UIT produces an increased radius at the weld toe [1,4].
