SHOT PEENING IN STEAM TURBINES

**Ralph J. Ortolano, P.E., Consulting Engineer, Turbine RESCUE
Robert L. Kleppe, Manager, Technical Services, Metal Improvement Company
Russell W. Chetwynd, Turbine Engineer, Southern California Edison Company**

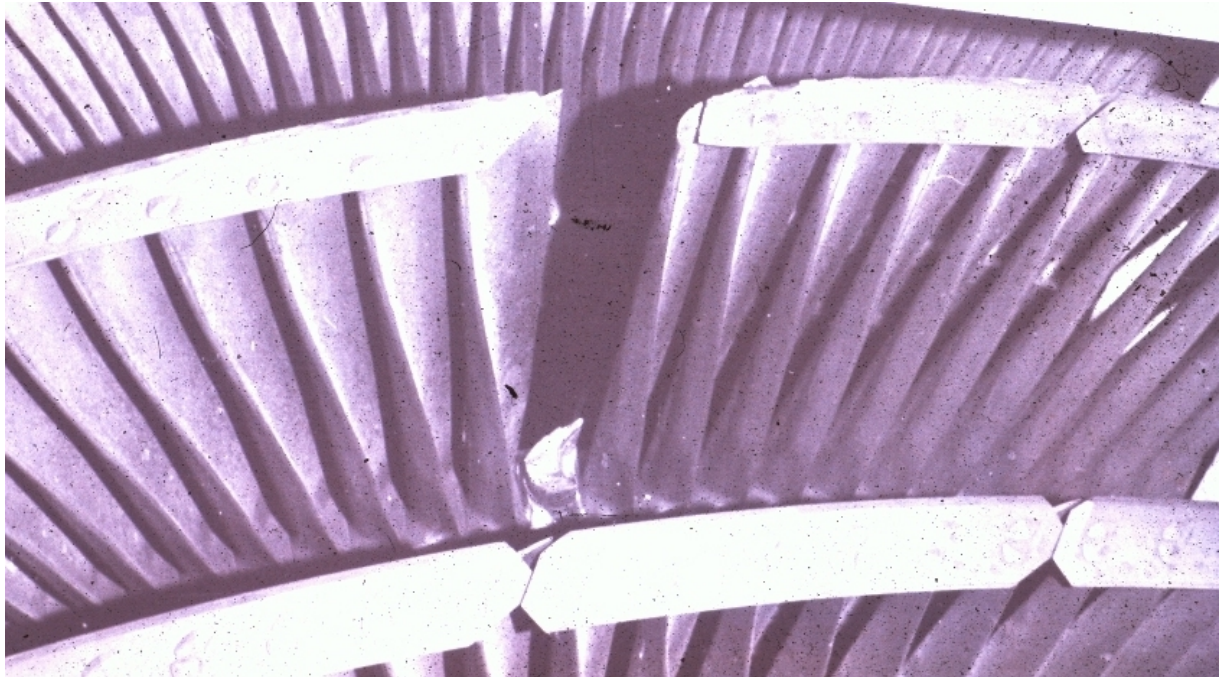
In 1973, and again in 1975, an electric power company suffered a forced outage on a large 790 mw coal fired plant low pressure steam turbine when rotor blades in the same L-2 stage broke off near the base of the blade ^{2, 3}.

In the 1973 failure, one blade broke off. Subsequent examination also revealed cracks in the covers and tenons on numerous blades. In the initial repair, it was decided to dress out the tenon cracks because they turned out to be shallow. New covers were made and foxholed to accept the shorter tenons resulting from the cover removal work. Both the tenon holes in the covers and the base of the tenons were shot peened to increase their resistance to fatigue. (Improvement summarized- with the exception of the increased local fatigue strength due to shotpeening, there was none. In fact, the tenons had been weakened by loss of section modulus when the cracks were ground out, and the covers were weakened by a reduced section-modulus due to the foxholing required.)

Unfortunately, after a little more than a year of operation, the repaired row failed again, this time breaking off two blades near the base of the foil. Again, cracks were found in the covers and when the covers were removed, tenon cracks were also found. Inasmuch as there were no spare blades available, the OEM (Original Equipment Manufacturer) recommended that the row be removed and a pressure plate installed. But because the manufacture and installation of the pressure plate required the 790 MW unit to be out of service for 12 weeks, this recommendation was unacceptable. Instead the owner/operator of the unit decided to repair the row by trimming off the original tenons and rebuilding the tenons with weld metal, stress relieving and reforming the tenons, installing new, full thickness covers, and shot peening the tenons and cover holes. It was also proposed to strengthen the design by underbrazing i.e. brazing under the cover at the interface between the blade tip and the cover), if this could be done without adversely affecting the tuning of the blades. Frequency checks were made on the assembled blading after tenon riveting, and verified after underbrazing that the tuning of each group of blading had not been adversely affected.

This repair was implemented in April 1975 and has been successful so far. The replacement row of blades which had already been purchased was retained as a spare row, and the repaired row left undisturbed. It has been examined several times since the repair and no defects have been found. (Improvement summarized- stronger, stiffer blade tips, lower stress on tenon, cover and blade, compressive surface stresses at base of tenons and in tenon holes due to shot peening, tuning verified and possession of spare blading.)

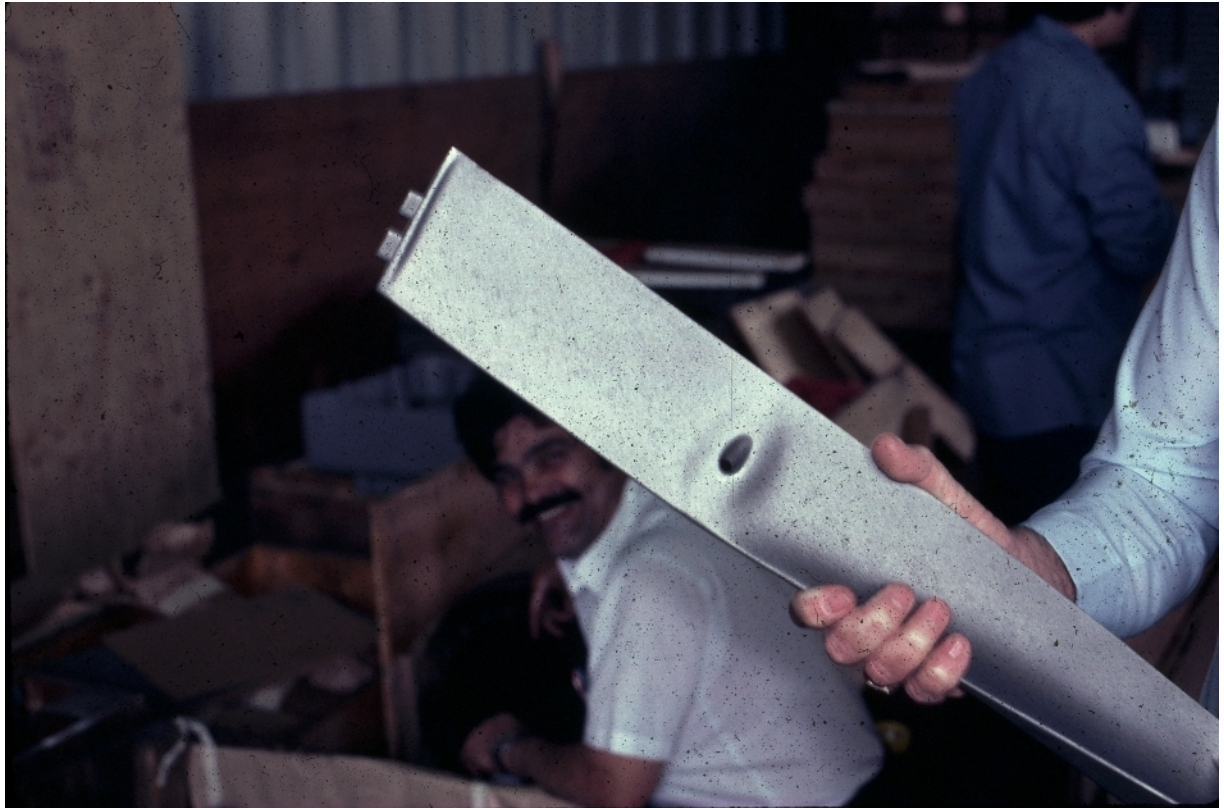
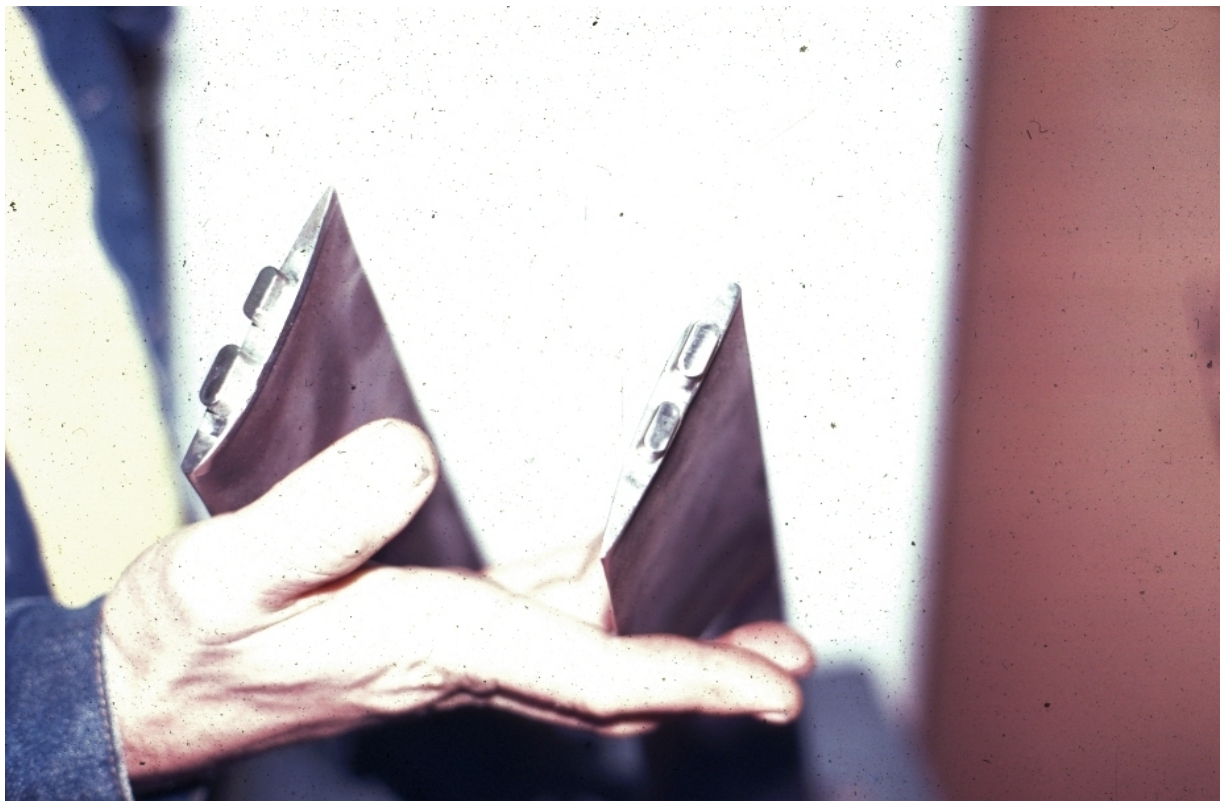
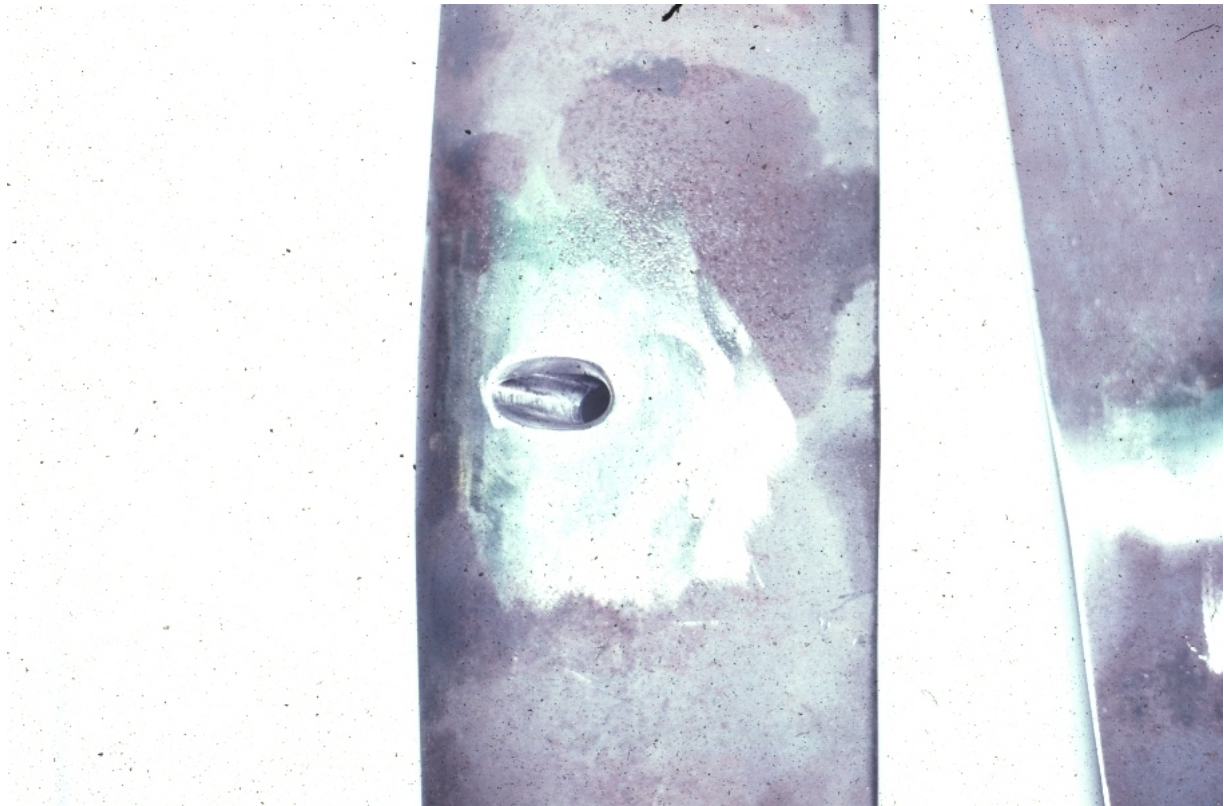
Other blading was found to be refurbishable (20.9" L-1 stage of 33.5 " end.), even though there was tie wire hole cracking and some pitting. The blade trailing edges were polished to remove pits, the tie wire holes with cracks were ground out and weld repaired. The tenons were rebuilt by welding, the tie wire holes were repaired by enlarging the hole edge radii, the pits were cleaned by chemical solution, and the tenons and tie wire holes were shot peened as indicated in the photographs that follow.
