# Controlled Shot Peening Reduces or Eliminates Stress Corrosion Cracking

**ABSTRACT** Controlled Shot Peening (CSP) is a cost effective technique to reduce and/or eliminate stress corrosion cracking (SCC) failures which cost industry millions of dollars. Cases are shown.

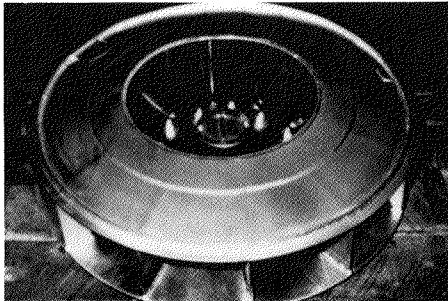
Fig. 1. Hastelloy Blower Wheel

**Problem:** A Hastelloy Blower Wheel used in hot nitrogen (300°F) failed in less than six months.

**Result:** No Failure after three years.

**Treatment:** Automatic Controlled Shot Peening with 170 shot to an intensity of 10A-14A followed by glass bead peening for decontamination. Coverage 200%.

**Control:** Almen strip for intensity, PEENSCAN\* for coverage.

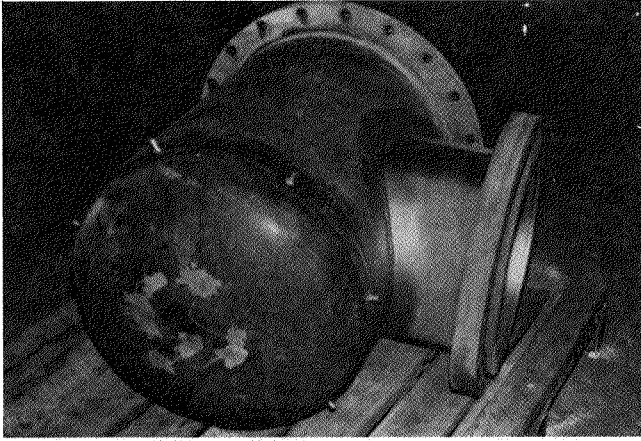
Fig. 2. Reboiler Head

**Problem:** Hastelloy B-2 reboiler heads used in water containing chlorides failed after eight months in the formed dome and the heat affected zones (welded).

**Result:** No failure after two years.

**Treatment:** Peened with 230 shot to an intensity of 12A-14A followed by glass peening for decontamination. Coverage 200%.

**Control:** Manually peened with PEENSCAN \* control.

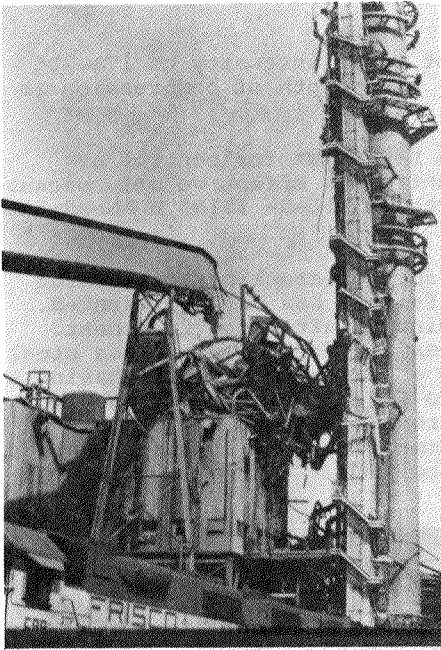
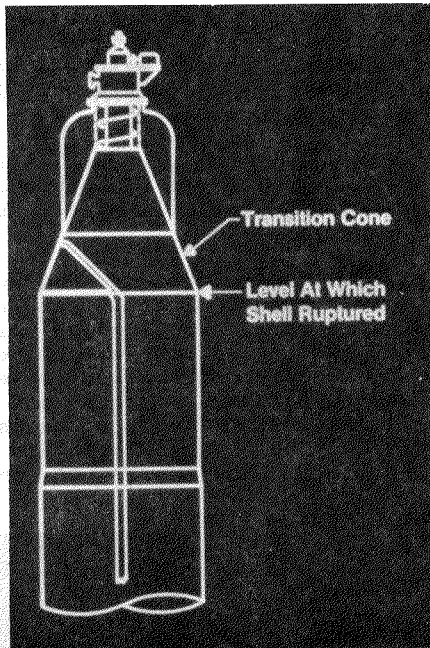
Mill Continuous Digester

Problem: Catastrophic failure due to SCC in a continuous digester over 200' high and thirty plus feet in diameter made of A-212B-1 3/4" thick steel led to the discovery of SCC in over forty percent of the units in use of its type and manufacture. Welds with and without stress relief showed cracks when inspected with Wet Fluorescent Magnetic Particle method. Strong caustic solutions containing many aggressive compounds especially sulfides and sulfites are felt to be especially detrimental in the environment of temperatures exceeding 200°F and pressures of 150 psi. A permanent one time fix is sought by the industry but in the meantime shot peening is controlling SCC in twenty digesters.

The need for very careful preparation was learned when less than perfect results were obtained because of short cuts taken such as failure to grind welds smooth after repair and proper care not taken with the WFMP inspection. These errors coupled with poor grinding technique causes flaws to go undetected and unrepaired. The environment to perform all operations is poor at best, and all work is done under severe time constraints because digester down-time cost can be \$25,000 per hour. It is therefore necessary to accept that we must often repeat the

procedure one or two more times at yearly intervals before getting a "clean digester", i.e. free of indications of any cracking upon WFMP inspection.

Result: Some digesters show no further cracking after three years. Danger of catastrophic failure has been eliminated. In some cases cracking was eliminated after one treatment. Shot peening is cost effective as compared to stainless steel weld overlay which still leaves a heat affected zone having a tensile stressed area subject to SCC. Because shot peening eliminates the danger of catastrophic failure savings of \$50,000 per year per unit are immediately available by using Controlled Shot Peening to control SCC.

Treatment: Peened with 230 shot to an intensity of 17A-20A using 230 shot. Coverage 100%. The depth of compression is estimated to be .020".

Control: Manually peened using PEENSCAN\* for control of coverage. The use of manual control is effective only because of coverage controls as set forth in MIL-S- 13165 B Amendment 2.

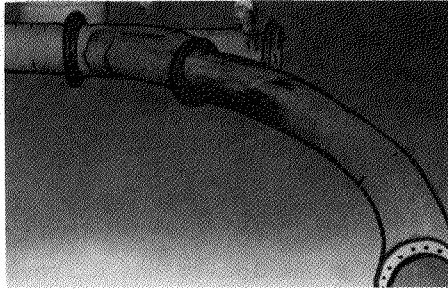
Fig. 4 Stainless Steel Spool

Problem: 304 stainless steel flanged pipe sections failed to SCC after exposure to sour water containing heavy sulfur and chloride contamination. Carbon steel failed in 1-1½ years. Unpeened stainless steel spools failed in less than one year.

Results: No failure after four years.

Treatment: Entire inside of spools and exterior welds peened using automatic control; shot size 230, intensity 010A-014A. Coverage 100%. Spools glass peened with glass shot for decontamination.

Control: Almen strip for intensity, PEENSCAN\* for coverage.

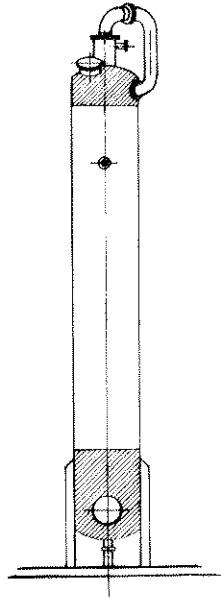
Fig. 5. Stripping Column

**Problem:** A stainless steel slurry stripping column failed to SCC in top and bottom sections due to chlorides and tensile stresses resulting from welding and forming during manufacture.

**Results:** No failure after two years of service.

**Treatment:** Tank interior bottom and top ends shot peened with 170 shot to intensity .012A-014A, followed by glass peening for decontamination. Coverage 200%.
