90027
P21.06

EFFECT OF SHOT PEENING ON THE PITTING FATIGUE STRENGTH OF CARBURIZED GEARS

Motokazu Kobayashi and Katsutoshi Hasegawa,
Mitsubishi Motors Corporation, Japan

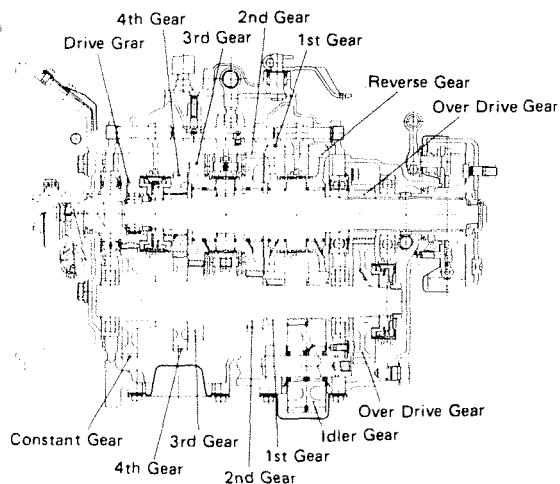
Fig.1 Cross Section Showing Transmission Components

Generally, the 2nd and 3rd gears shown in Figure 1 suffer bending fatigue fracture of the gear teeth most often, while the overdrive gear and constant-speed gear suffer pitting fatigue most often.

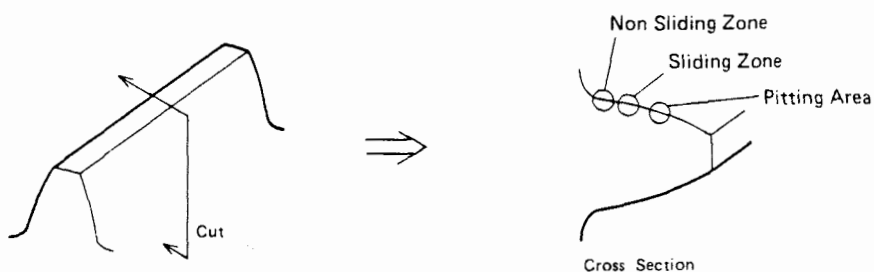
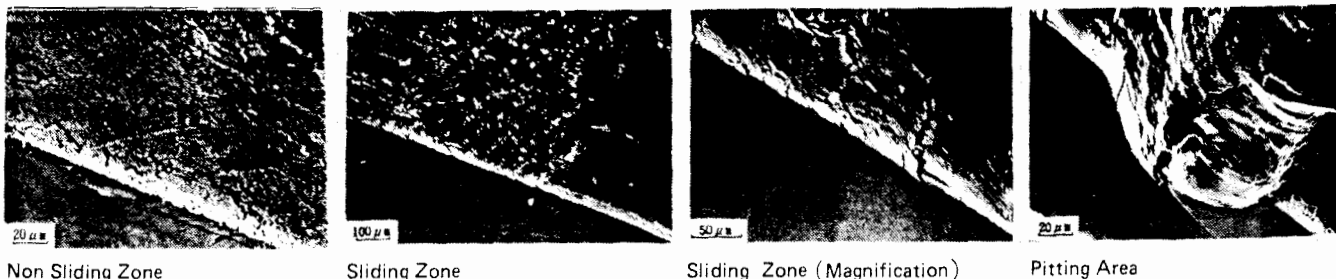
Photo.3 Observation by SEM of Tooth Surface after Durability Test

The result of observation by electron microscope of these pitted areas on the surface and cross section is shown in Photo 3. It can be seen that plastic flow developed under the surface from around the pitch circle to the tooth roots and that the pitting originated from intergranular oxidation, as discussed earlier.

Some theorize that pitting originates from immediately below the surface where maximum Hertz's stress occurs, but from the results presented above, it is believed that in the case of carburized gears, the intergranular oxidation on the surface is the origin of crack, which then propagates to cause pitting.

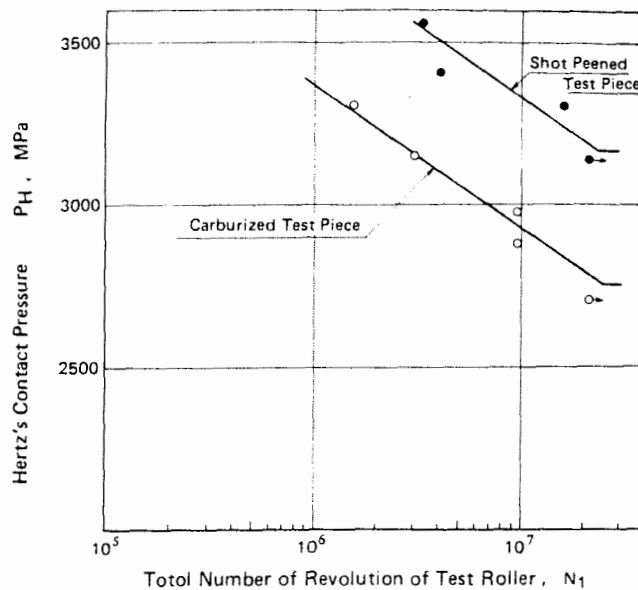
Fig.7 Results of Roller Pitting Fatigue Test

Fatigue Diagram. The results of the roller pitting fatigue tests of the carburized pieces and the shot-peened pieces, conducted under the above test conditions, are plotted with the tooth strength P_H on the ordinate and the life N to generation of pitting on the abscissa (semi-logarithmic scale) (Figure 7). It can be seen from the diagram that the shot-peened pieces have about 1.15-times higher fatigue limit at 2×10^7 cycles and about 10-times longer life under 3200 MPa Hertz's contact pressure.

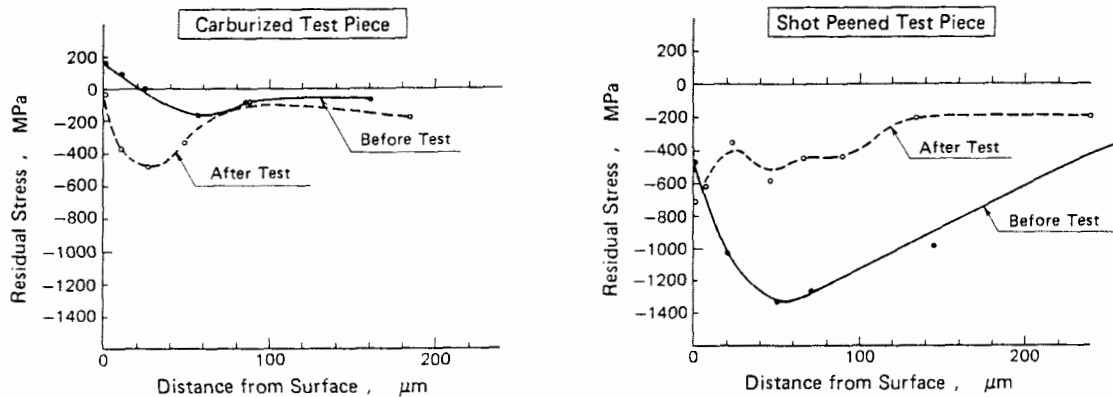
Fig.8 Residual Stress Distribution of Roller Pitting Fatigue Test Piece

The comparison of the carburized pieces and the shot-peened pieces before testing indicates that the former had a tensile residual stress of about 200 MPa on the surface and that the shot-peened pieces had about 500 MPa compressive residual stress on the surface. It can also be seen that under that shot peening conditions employed, the maximum residual compressive stress of about 1300 MPa occurs at a depth of 50 μm below the surface.

The degree of improvement in the residual compressive stress and that of the pitting fatigue strength do not necessarily correspond, but it is believed that this improvement in the residual compressive stress contributes to that of the pitting fatigue strength.

The measurement of the residual stress on the sliding surface after testing indicated a decrease in the internal residual compressive stress of the carburized pieces. In the vicinity of the sliding surface, however, a residual compressive stress probably due to the pressure of the mating roller was observed. In the case of the shot-peened pieces, the residual compressive stress on the surface was not changed significantly by the test.

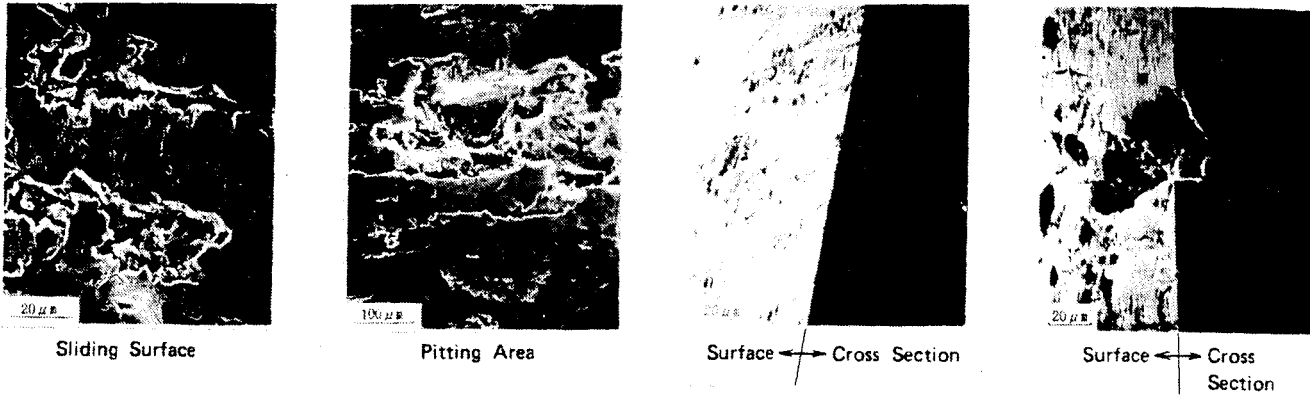
Photo.5 Observation by SEM of Carburized Test Piece Surface after Test

From these photos, plastic flow is observed on the topmost sliding surfaces of the carburized pieces as in the case of the field test gears. It can also be seen that the pitting originated from the intergranular oxidation. On the sliding surfaces, many open cracks were observed.

On the low surface pressure portions of the contact surface side sections, many such shallow cracks were also observed, but separation originating from them was not observed. On the contact surface center (increasing contact pressure) side, the cracks were smaller in number and pitting occurred in the center of the contact surface where the contact surface pressure was the highest.

From these observations, it is believed that cracking originating from the intergranular oxidation starts in the early stages of cycling, stops for some time due to the internal residual compressive stress and then propagates to final destruction in subsequent cycling.

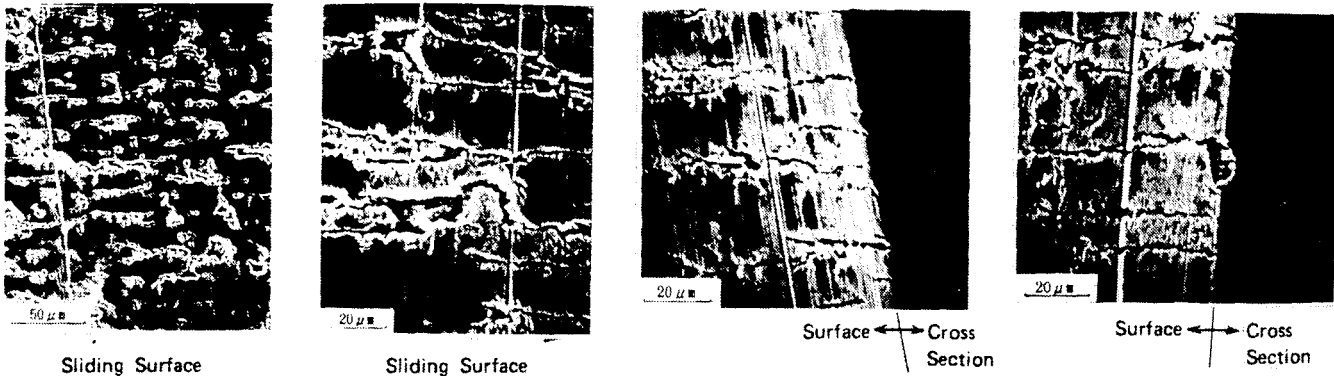
Photo. 6 Observation by SEM of Shot-Peened Test Piece Surface after Test

The shot-peened pieces also exhibit similar plastic flow and the pitting develops from the intergranular oxidation area with only the topmost surface plastically deformed by shot peening.

The cracks observed on the sliding surface, however, are closed in contrast to the open cracks seen in the carburized pieces. This is probably because the residual compressive stress stops the growth or propagation of cracking.

As can be seen from the fatigue diagram, the shot-peened pieces have a longer fatigue life probably because of this effect of the surface residual compressive stress that suppresses cracking and delays crack growth.

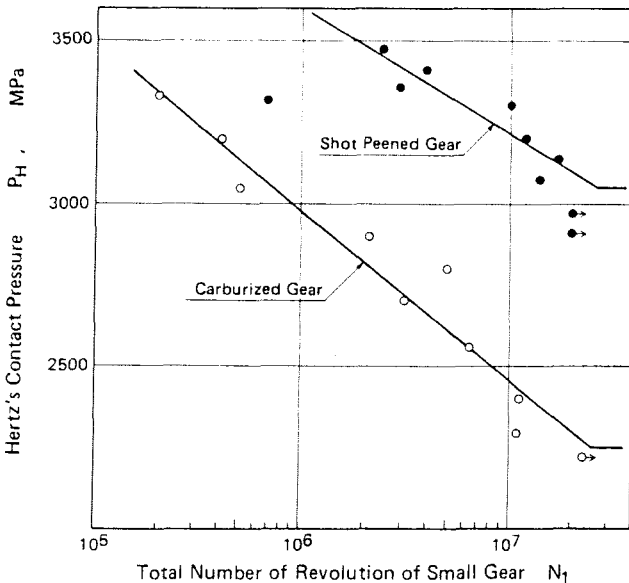
Fig.9 Results of Gear Pitting Fatigue Test

It can be seen that the shot-peened gears have about 1.35-times higher fatigue limit at 2×10^7 cycles and about 28-times longer life under 3200 MPa Hertz's contact pressure.

The shot-peened gear data tends to have a larger scatter than that of the carburized gears.

The problem, therefore, will be how to achieve more uniform shot peening.

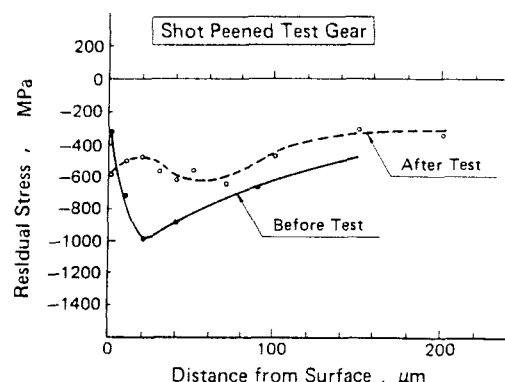
Fig.10 Residual Stress Distribution of Pitting Fatigue Test Gear

As in the roller pitting fatigue test pieces, a residual compressive stress was produced on the surface using shot peening, with a residual compressive stress of about 1000 MPa occurring at a depth of about 20 μm beneath the surface. The test gears were subjected to shot peening under the same conditions as the roller pitting fatigue test pieces and we thought that the difference in the resultant residual stress level was due to the differences in the test piece shapes.

A residual stress distribution pattern after the test similar to one obtained after the roller pitting fatigue test was obtained.

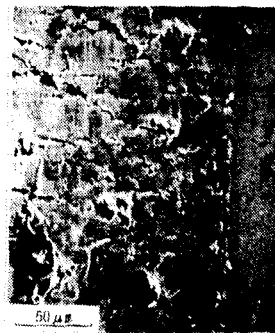
Photo. 9 Observation by SEM of Shot-Peened Test Gear Surface after Test

Photo 9 shows the surface and cross section of pitted portions as observed by electron microscope.

From these photos, it is believed that cracking originated from the intergranular oxidation layer and separation occurred therefrom, leading to pitting as in the roller pitting fatigue tests.

The cracks observed on the sliding surface are closed by the residual compressive stress of shot peening.
