EXFOLIATION CORROSION LOCATED BY SEARCH PEENING

W. WÜBBENHORST

Metal Improvement Company, Inc; Haan-Gruiten, Germany

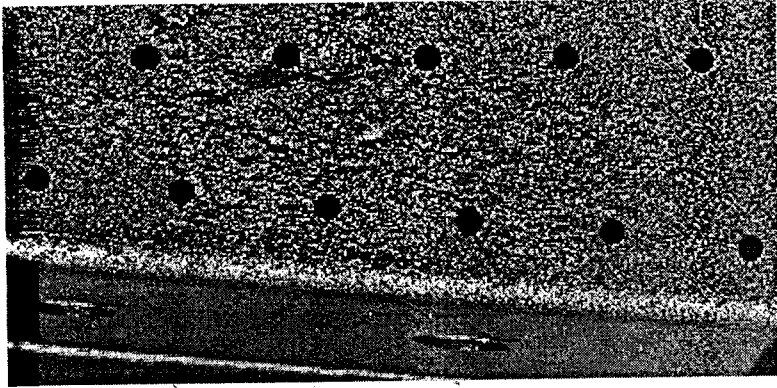
Fig. 1 Exfoliation Corrosion

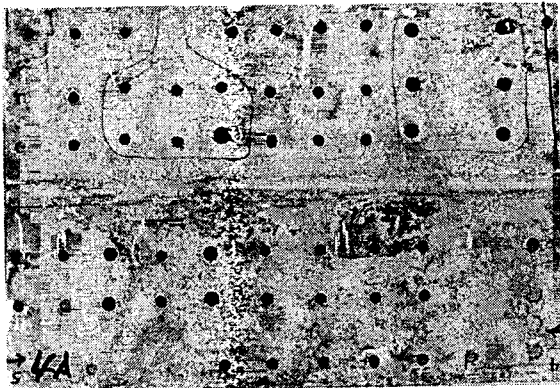
Prior to initiating the search peening technique, Figure 3 illustrates the "as received" condition of the aircraft component surface. (Boeing 747/Keel Beam Plate). Figure 4 is the surface finish of the same component after PMB (**Plastic media paint stripping**) carried out by MIC using techniques for intensity control [1, 2]. Clearly exposed are the corroded and damaged areas. If compared directly with Figure 3, it is noted that corrosion on the material surface has taken place but not all was visible under the paint and areas apparently damaged. - The benefit of controlled PMB stripping in this instance is the lack of surface disturbance enabling accurate assessment of the damaged area.

Fig. 3 As „received“ condition

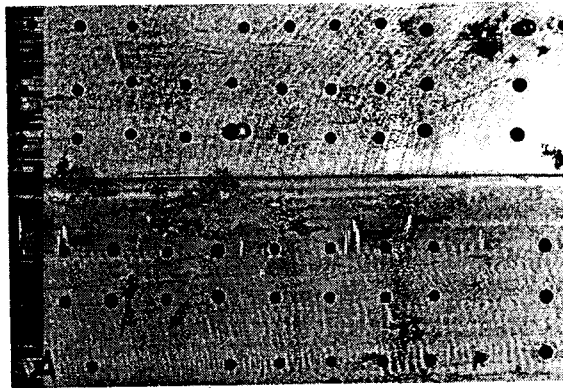
Fig. 4 Plastic Media Paint stripped – Exposing clearly corroded and damaged areas

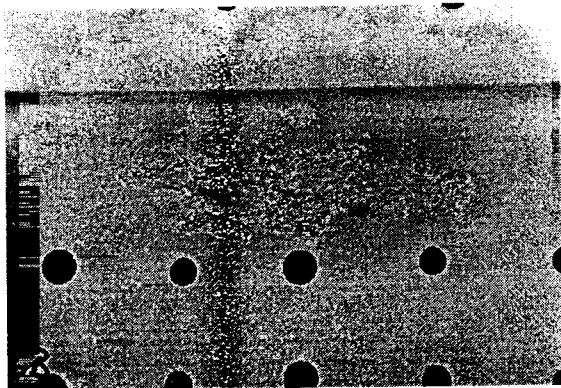
The **search peening technique** is initiated by **aluminium oxide blasting** of the surface to remove any visible oxides from the area concerned, covering all local fastener heads and probably a strip extending 50 mm either side of the fasteners (see Fig. 5). Any further visible surface corrosion will require dressing with normal hand tools, ensuring minimal stress concentration effects.

Fig. 5 Close up of Aluminium Oxid blasted areas showing slight exfoliation

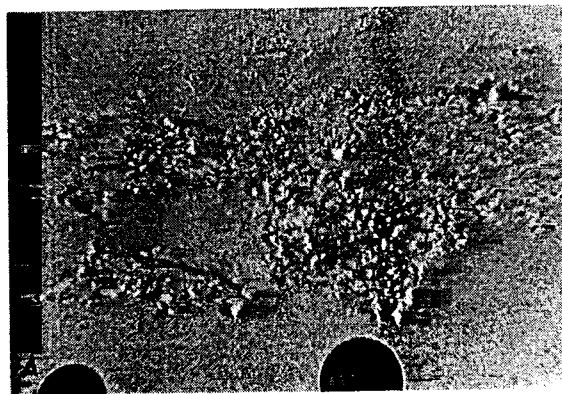
Following satisfactory **dressing**, controlled search peening is then carried out in linear fashion. The **Search Peening** induces surface compressive stresses that stretch and yield the outer material surface. If visible blistering and flaking at the surface is noted, the existence of exfoliation corrosion, that is selectively attacking the aluminium substrate, has been exposed. (As illustrated in Figure 6)

Fig. 6 Closer view after light Shot Peening (MI 110 0,006“ A 200%). Exfoliation very evident and typical of first pass of Shot Peening on such areas.

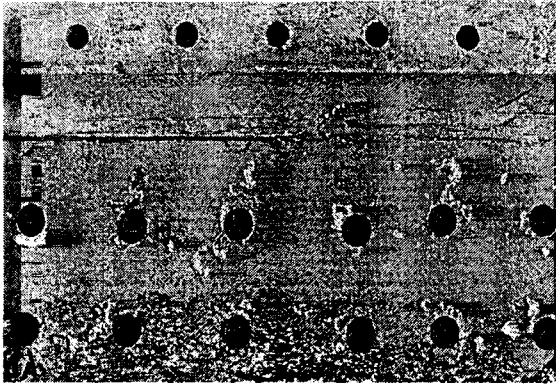
Another example here is Figure 9, where the original component condition is showing signs of edge exfoliation corrosion.

Fig. 9 Plate edge „as received“ condition

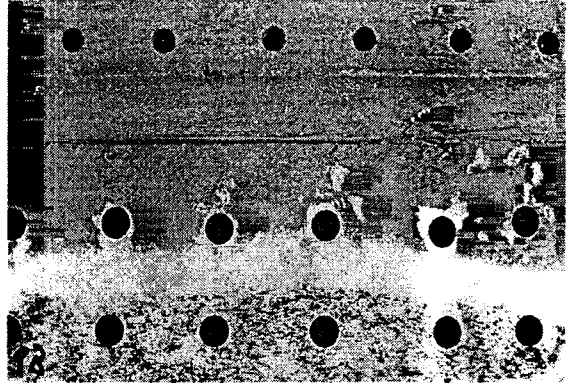
Fig. 10 Aluminium Oxide blasted to remove surface oxides

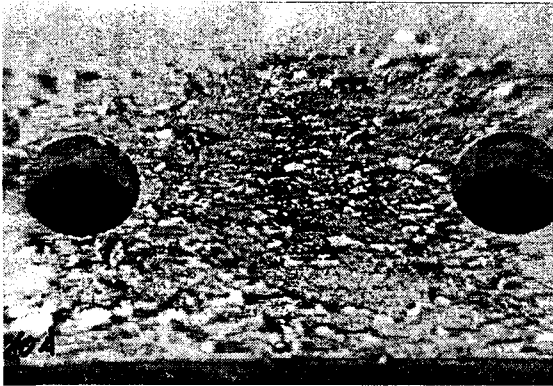
Fig. 11 Close up of Aluminium Oxide blasted area exhibiting exfoliation corrosion already

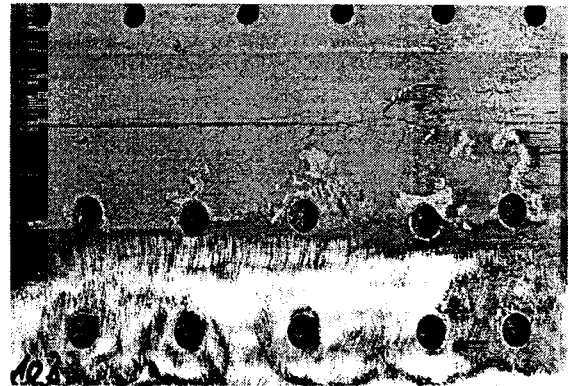
Fig. 12 0.015 ins. (0.038 mm) material removed by dressing

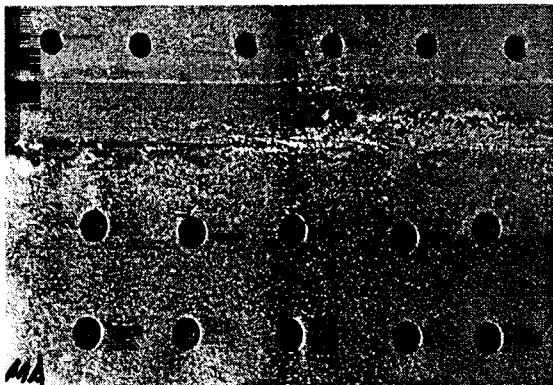
Figure 10 is the aluminium oxide blast of the surface to clear debris and remove surface oxides for inspection and Figure 11 is a close up of this oxide surface. Figure 12 is the same edge now dressed with a removal of some 0.38 mm (0.015 inches). Figure 13 is the area fully shot peened showing further indications of exfoliation. Figure 14 is a close up of the same exposed edge exfoliation. Further dressing and a further pass with the controlled search peening equipment is required. The inspection and process will be continued until no further blistering occurs.

Fig. 13 Controlled Shot Peening (MI 230 / 0.008" A / 200%). Exfoliation still evident in two small areas.

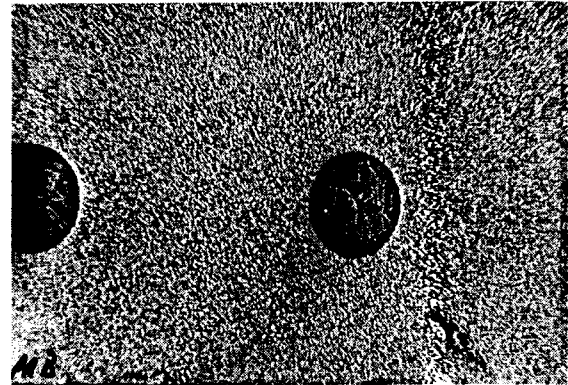
Fig. 14 Close up showing exfoliation more clearly. Further 0.010 ins. (0.254 mm) had to be removed by dressing.
