## **Cold Work Quality Assessment and Fatigue Characterization Using Conformable MWM<sup>®</sup> Eddy-Current Sensors**

James M. Fisher, Mechanical Engineer  
WR-ALC/LBRS, 265 Ocmulgee Ct, Robins AFB, GA 31098-1647  
(912) 926-6814, [james.fisher@robins.af.mil](mailto:james.fisher@robins.af.mil)

Neil Goldfine, PhD, President; Vladimir Zilberstein, PhD, Metallurgist  
JENTEK Sensors, Inc., 110-1 Clematis Avenue, Waltham, MA 02453-7013  
(781) 642-9666, [jentek@shore.net](mailto:jentek@shore.net)

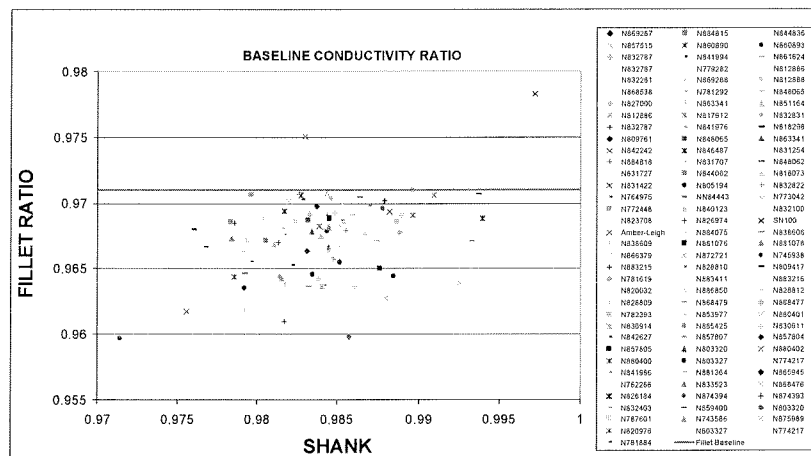
Figure 2. Quality Control Chart for Cold Rolling Integrity.

Thresholds on the conductivity ratio for acceptable cold rolling in the fillet and shank were determined by the C-130 engineering staff using 30 coupons with known residual stress (from either BHD or x-ray diffraction) by determining the conductivity ratio of blades with acceptable and unacceptable cold rolling. These thresholds were used during a 12-month engineering evaluation period in which one of over 800 propeller blades inspected was removed from the overhaul production line for unacceptable cold rolling, as determined by using MWM. Subsequent measurements with BHD revealed that the propeller blade had borderline residual stress. Figure 2 depicts conductivity ratios from a sample of blades including two mishap blades and one coupon that was never cold rolled.

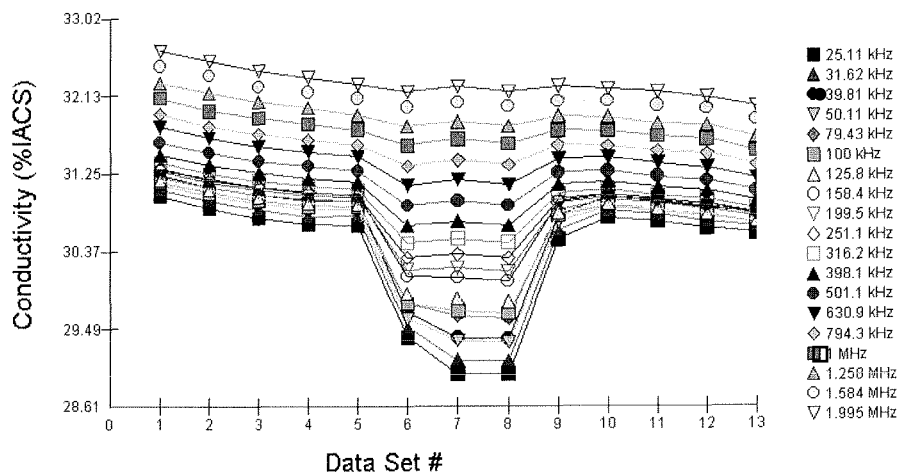
Figure 7. MWM Eddy Current Sensor Multi-Frequency Scan of Subsurface Anomaly in Fitting 1.

*Fitting 1.* In addition to finding crack indications in all of the previously identified locations, there was an additional indication of an anomaly between two of the fasteners. This anomaly was detected by a local drop in conductivity at frequencies below 794 kHz (see Figure 7). Conductivity measured at higher frequencies remained uniform along the scans. Visual inspections of the areas including the ID surface of each bolt hole failed to reveal the source of the anomaly in conductivity. While the fitting was at JENTEK, no clean up or any additional NDI was accomplished in this area.

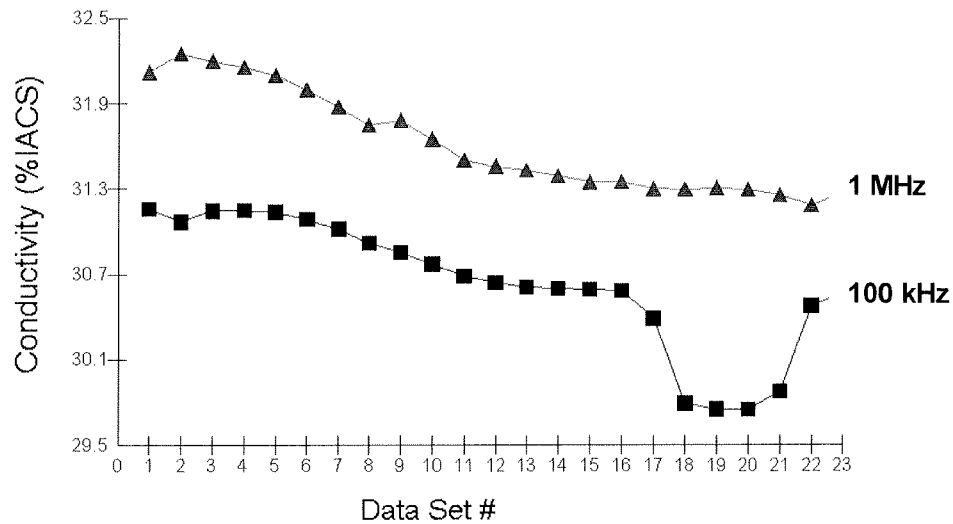
Figure 8. Dual Frequency MWM Eddy Current Scan of Fitting 2, Showing a Subsurface Anomaly.

*Fitting 2.* In addition to finding crack indications in all of the previously identified locations, there were additional indications of anomalies between pairs of adjacent fasteners at three different locations. These anomalies were detected by a drop in conductivity at 100 kHz (Figure 8).

Initial visual inspections of the areas including the inside diameter surface of each bolt hole failed to reveal the source of the anomalies. However, after the bolt holes were cleaned up using a mild abrasive and visually inspected, distinct subsurface cracks were visually identified inside the bolt holes (these “tunneling” cracks did not reach the exposed surface outside the bolt hole). These indications were later verified using traditional high frequency eddy current inspection inside the bolt hole with a bolt hole probe. The cracks appeared to be small radial cracks oriented along the bolt hole axis. The depth of the crack (as measured radially from inside the bolt hole) has not been determined but it appeared to be quite small.

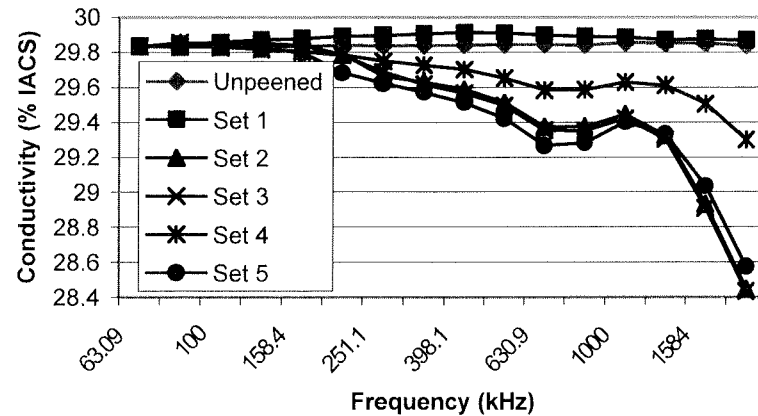
Figure 11. Multifrequency MWM Measurements of Conductivity inside Trunnion #1 after Machining (Prior to Shot Peening).

Two trunnions were used in this analysis. Trunnion #1 was found to have significant corrosion on the inner surface. It was determined that the surface needed to be bored out approximately 0.026 inches and repaired by installing a large bushing. MWM was used to assess process control for the shot peening on Trunnion #1. Trunnion #2 was found to be out of round (egg-shaped) requiring reaming that only affected the upper and lower surfaces which were bored out to approximately 0.009 inches at the center of the bored area. MWM multi-frequency conductivity profiles were obtained for the areas that were and were not reamed on Trunnion #2. Figures 11 and 12 depict the MWM measured conductivity profiles after reaming only (Figure 11) and after reaming and shot peening (Figure 12) on Trunnion #1. Figure 13 depicts the conductivity profile for Trunnion #2.

In Figure 11, the conductivity was essentially unchanged throughout the thickness in some of the areas measured (represented by sets 1 and 2) indicating that all of the shot peening effects have been removed. Other areas (represented by sets 3 through 5) were also essentially unchanged from 63 kHz to 199.5 kHz but had a significant change in conductivity between 199.5 kHz and 2MHz. This relatively large conductivity gradient could be attributed to the effects of aggressive machining, or remaining shallow shot peening.

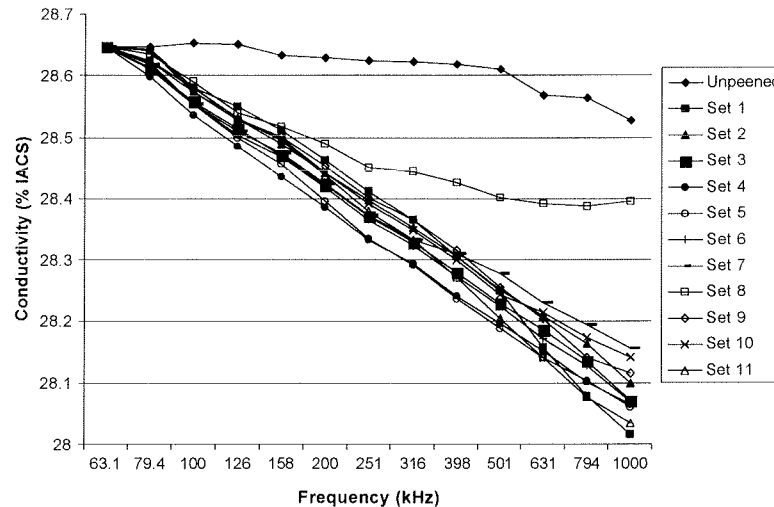
Figure 12. Multifrequency Conductivity of Trunnion #1 after Shot Peening.

In Figure 11, Set 1 was taken on an unpeened surface adjacent to the peened surface as a reference. Sets 2 through 5 represent areas from approximately 6 o'clock to 2 o'clock. Sets 6 through 12 represent areas from 2 o'clock to 6 o'clock, an area which is somewhat awkward for the shot peening equipment to reach. The following observations were made from assessing the data depicted in Figure 11:

- The large conductivity gradient, due to aggressive machining effects, virtually disappears after shot peening probably due to the stress redistribution that occurs as part of the shot peening process (it could also occur due to the removal of very near surface defects).

- Although the conductivity gradient is not as pronounced on the trunnion after shot peening, the conductivity continues to change with frequency throughout the measured spectrum.
- Finally, there is a distinct difference in the conductivity profile represented by measurements in easy-to-access areas and difficult-to-access areas, indicating potential for improving the process controls currently being used.

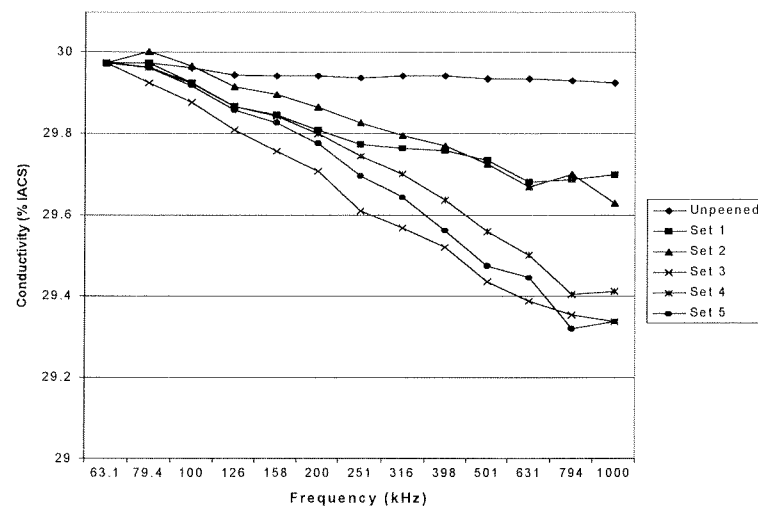
Figure 13. Conductivity Profiles of Trunnion #2

On Trunnion #2, the only set of MWM measurements made was after the partial reaming. As depicted in Figure 12, Set 1 represents the unshot peened lip of the trunnion, which was used as a reference. Sets 2 and 3 represent the conductivity profiles on the side of the trunnion that was not reamed. Sets 4 through 6 represent conductivity profiles of areas that were reamed. Although all but the reference (Set 1) indicates conductivity gradients throughout the profile, Sets 5 and 6 appear to be affected by the machining. When the conclusion might be that reshot peening is not required, it is critical to assess uniformity of preserved shot peening.
