# **FAILURE ANALYSIS OF A GARAGE DOOR SPRING**

**AME 60646: Failure of Materials**

**Matt Landrigan**

**1 December, 2006**

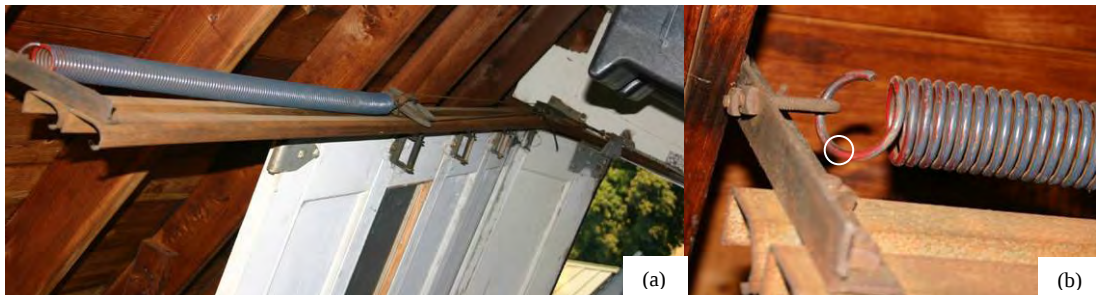
In May of 2006, an extension garage door spring fractured completely through rendering the door unusable until repair. A garage door operates with either two extension springs on either side of the bracket supports or one torsion spring across the top of the door frame. The motor for this particular setup drives a screw gear that pushes the door down when it closes putting tension into the spring (Fig. 1a). The springs are connected to a wire cable which runs over two pulleys redirecting the spring force along the curve of the door track. The springs aid the motor in lifting the door by placing an upward force on the door. The last coil of the spring is bent to form a hook (Fig. 1b).

Nothing unusual occurred on the day of the failure. Unfortunately, no information was available regarding manufacturer, installation date, type of material, or fatigue life although it is safe to say that the fracture is due to fatigue failure since the springs were installed when the house was purchased in May 2005. Both springs are identical looking so it is likely they are the original springs. The door was even lifted with only one spring a couple of times before it was realized that one was broken. The motor was likely installed at a later time than the springs due to modern electrical wiring – an indication that perhaps in the past the loading pattern was not as rigorous as in modern day life. Replacement springs (Overhead Door Company – parent company to Genie Company, motor manufacturer) at the local hardware store are rated for 10,000 cycles. Assuming the springs were installed when the house was built and a conservative usage estimate of

Fig. 1. (a) Installed garage door extension spring in relaxed position. (b) View of operational spring with circle designating area of fracture.

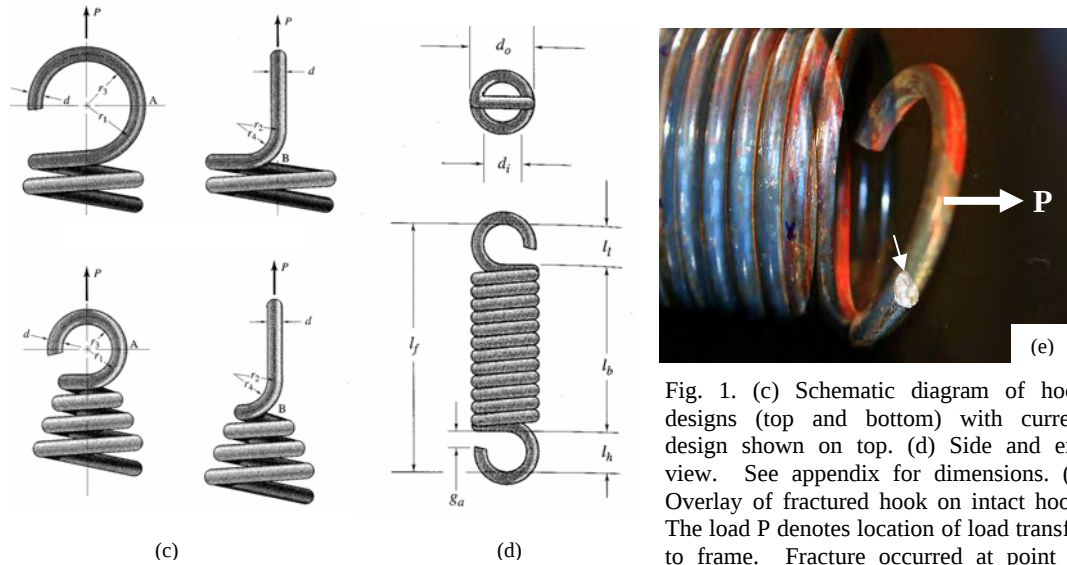
Fig. 1. (c) Schematic diagram of hook designs (top and bottom) with current design shown on top. (d) Side and end view. See appendix for dimensions. (e) Overlay of fractured hook on intact hook. The load  $P$  denotes location of load transfer to frame. Fracture occurred at point of maximum stress on inside of hook (arrow).

Most often helical extension springs fail at the hook and the design of the end hook impacts the stress concentration. This particular spring hook was manufactured by simply bending the last coil outward by 45 degrees. In idealized spring design, the end hook is bent outward forming a right angle with the plane of the previous coil. In the loading condition for this spring design the 45° angle causes a torque to act on the hook as well as the axial load (Fig. 1e). This was an important aspect used to determine the initiation region which will be discussed momentarily. Purely axial loading normally causes failure at the tensile edge furthest from the neutral axis. If a torque is added, the maximum stress shifts around the hook slightly due to the addition of the shear stress.

In reality, this part is very cheap to manufacture and currently retails for about \$15 at the local hardware store. Because it is likely that this spring has lasted at least 27 years, but more likely 54 years, it really would not be cost effective to improve the fatigue life. That being said, the easiest way to improve the fatigue life would be to put tighter manufacturing requirements to avoid tooling marks or other possible surface marks. Secondly, altering the wire material itself improves the fatigue life. Another way to increase the fatigue life is to reduce the stress in the spring hook. Reducing the moment arm (see Eq. 2) such as in Fig. 1c will drastically reduce the stress on the hook. These three aspects will increase the fidelity of the spring, but in this particular application it is not practical to spend the extra manufacturing time and money to improve the fatigue life.

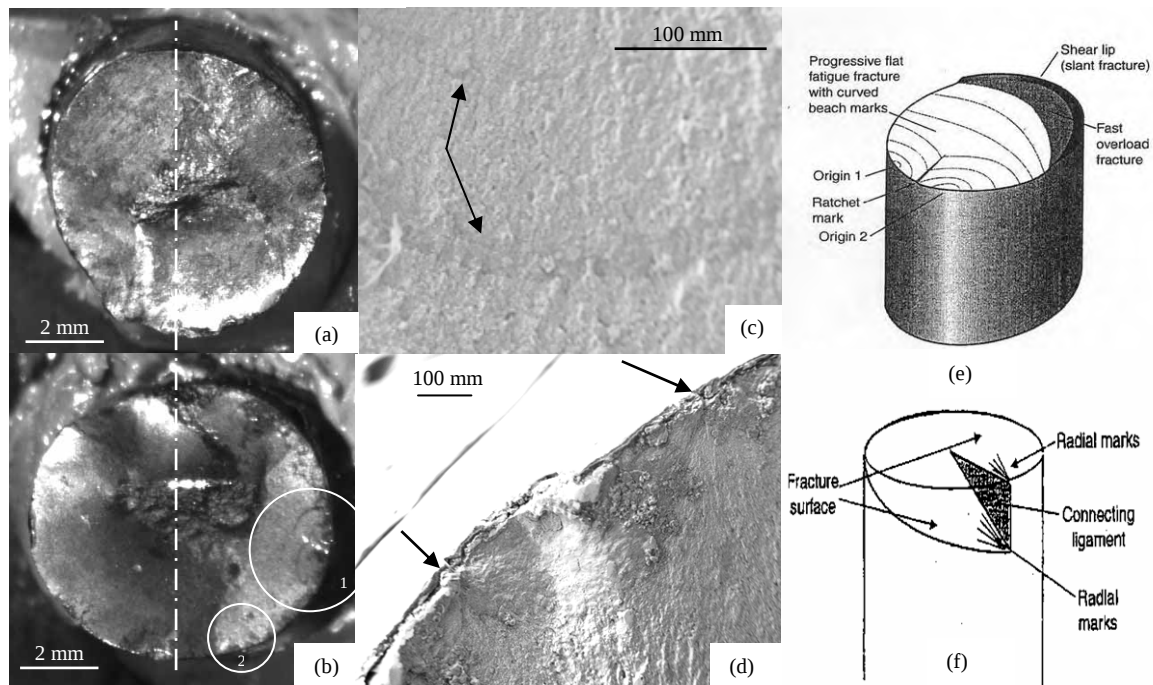
Both fracture surfaces were recovered and aided in the failure analysis. The surface proved to be quite complex with multiple modes of fracture indicative of the highly three dimensional surface (Fig. 2a-b). Areas of fatigue failure and brittle fracture exist. Observation under SEM revealed multiple crack initiation sites. The surface attached to the spring (Fig. 2a) was largely corroded with rust and therefore less visual information was available. The end attached to the hook proved invaluable because optical microscopy revealed rust bands on the inside of the hook – the area of maximum stress (Fig. 2b - circle 1). The rust rings follow two distinct centers (Fig. 2d, pointers) with radial marks leading outward from the centers. The rust rings are separated by a ratchet mark - a ledge between two initiation sites (Fig. 3c-d). Ratchet marks are indicative of initiation sites although it is normal to find beach marks around the marks (Fig. 2e) but there can be radial marks instead (Fig. 2f). As the crack planes propagate, the two planes come together forming a single fracture plane (Fig. 4c).

Inclusions, second phase particles, voids, machining marks or other surface flaws, and geometric anomalies are typical fatigue crack initiation points. Due to surface rust on the outside of the hook, a specific initiation type could not be determined. Because the initiation sites are at the surface, the cracks likely would have initiated because of a surface flaw such as a tooling mark or surface pit which could easily have been caused by corrosion.

Fig. 2. (a) Optical image of surface attached to spring and (b) surface of hook end. The right hand side was in tension. The white dashed line indicates neutral axis and the circle shows the region of initiation. (c) SEM image of rust bands. (d) SEM image of initiation points (pointers) surrounding ratchet mark (white region). Pictorial representations of ratchet marks and beach marks (e)<sup>7</sup> and radial marks (f)<sup>8</sup>.

The other area of interest is circle number 2 (Fig. 2b) where multiple ratchet marks can be seen under optical microscopy and closer under SEM (Fig. 3b). The location for the ratchet lines is understandable because the combined torque and tensile loading of the hook moves the maximum stress region around the outside of the hook closer to the neutral axis.

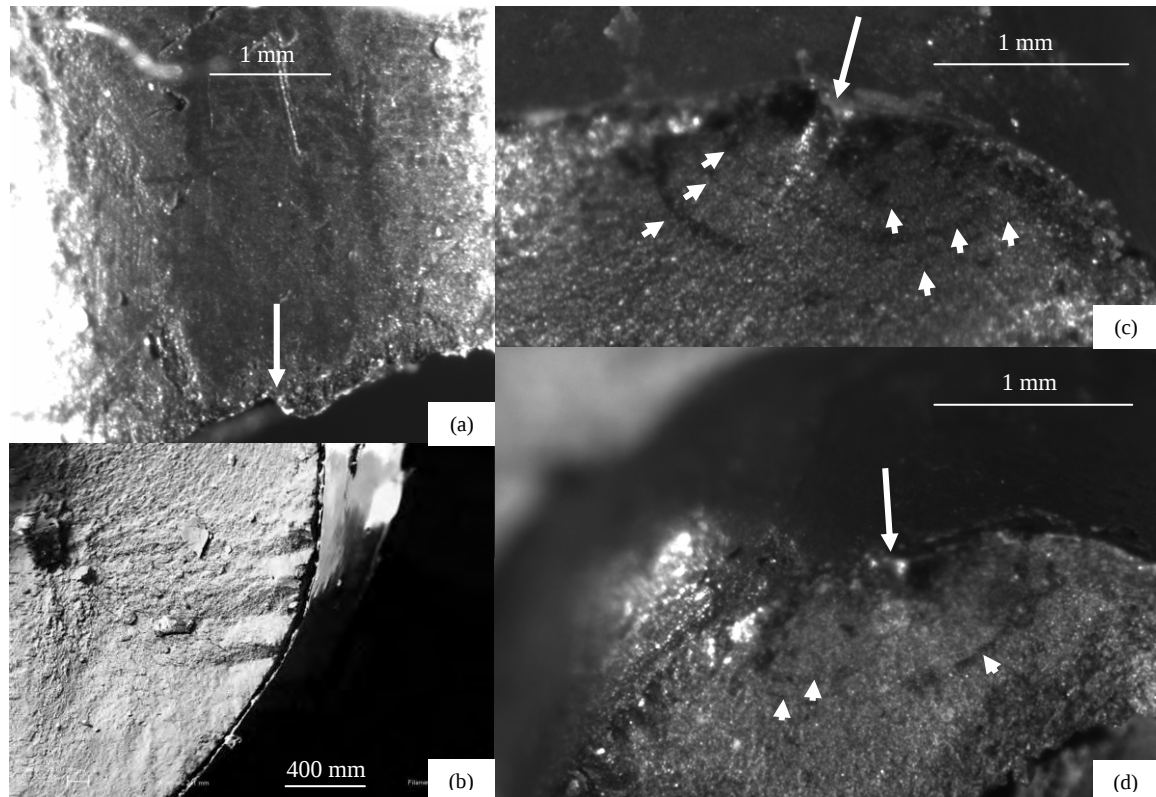
Fig. 3. Fatigue initiation sites. (a) Ratchet mark (arrow) around which rust rings formed. (b) SEM image of multiple ratchet marks from area 2 in Fig. 4b. (c) Fracture surface connected to hook end and (d) surface on spring end. Small markers indicate rust rings and large arrow points to ratchet mark.

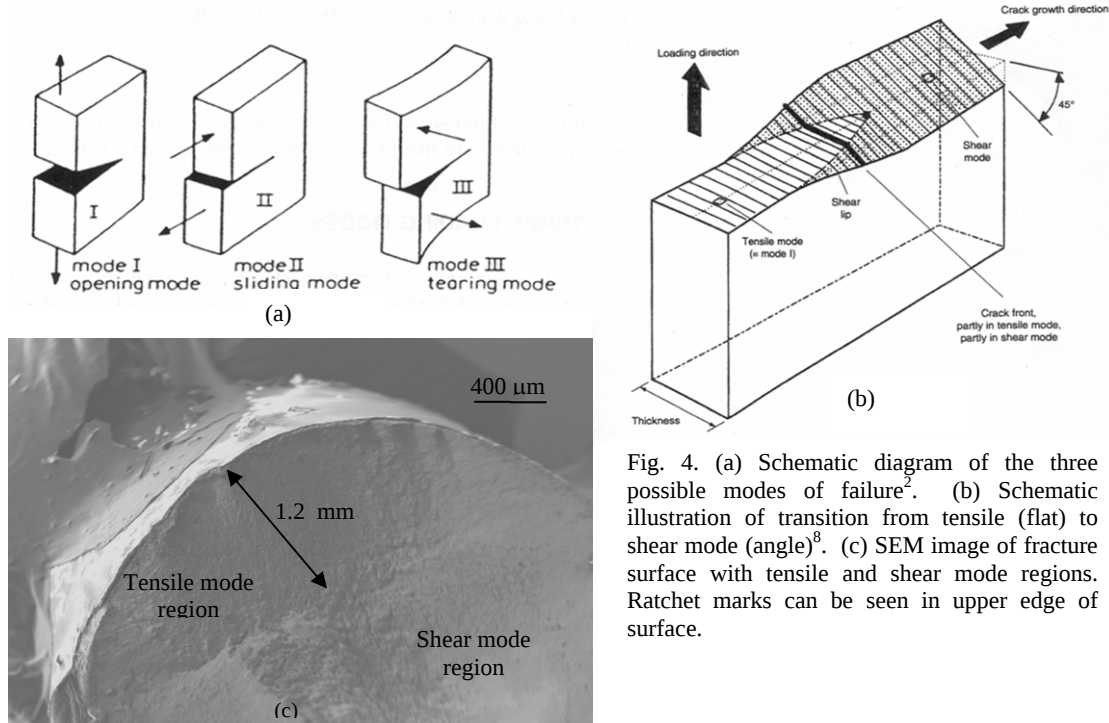
There are three different loading modes by which cracks can form and propagate as shown in Fig. 4a. Mode I is the tensile opening mode, Mode II is the in-plane shearing mode, and Mode III is the out-of-plane shearing mode<sup>2</sup>. With the initiation sites in the tensile region of the hook (Fig. 4c) and the fracture surface perpendicular to the wire direction (Fig. 5), Mode I failure is responsible for the crack initiation.

There are two distinct regions of crack propagation. The presence of rust rings indicated that the crack propagated slowly and allowed time for corrosion to materialize. The fracture surface plane is perpendicular to the wire direction (Fig. 5) showing Mode I crack propagation initially. About one third of the way across the fracture surface (Fig. 4c), the crack switches to Mode II or possibly Mode III failure. The fracture plane switches directions on an angle called the shear lip as shown schematically in Fig. 4b and for this particular surface in Fig. 5. At the same time the crack propagated very quickly

Fig. 4. (a) Schematic diagram of the three possible modes of failure<sup>2</sup>. (b) Schematic illustration of transition from tensile (flat) to shear mode (angle)<sup>8</sup>. (c) SEM image of fracture surface with tensile and shear mode regions. Ratchet marks can be seen in upper edge of surface.

because the fracture surface is rough in this region compared to the area around the rust rings indicating catastrophic failure occurred when the crack switched failure modes.

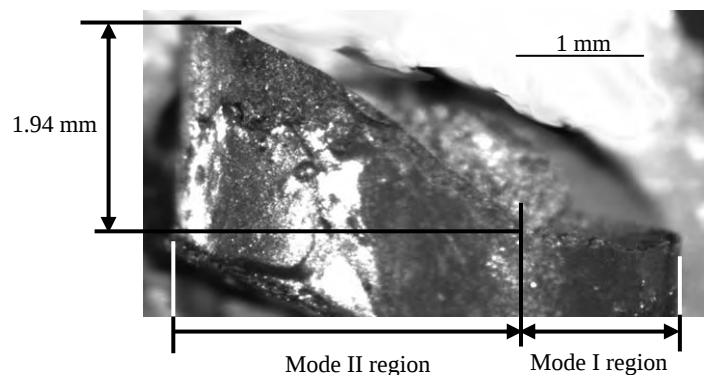
Fig. 5. Side view of fracture surface where Mode I and Mode II regions are visible.

Using the height of the shear region shown in Fig. 5 and Eq. 6 above, along with the hook stress calculated earlier gives a fracture toughness of  $64 \text{ MPa}\sqrt{m}$ . While this would indicate that the spring steel has a stronger fracture toughness than assumed earlier, it is close and therefore a reasonable approximation for the toughness of the spring steel.

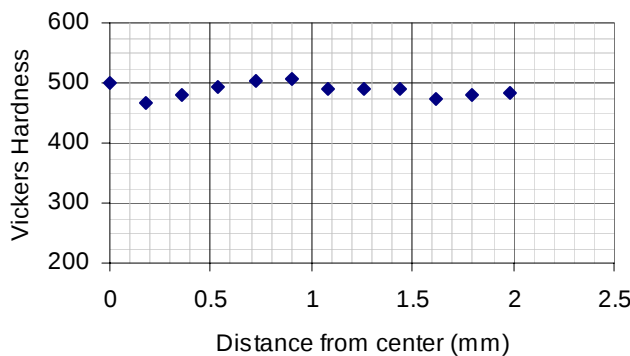
taken a few millimeters below the fracture surface on the spring side of the failure. The sample was embedded and polished to a one micrometer surface finish. The microhardness testing was performed with a one kilogram load for ten seconds. Hardness measurements taken from the center of the wire to the outside edge on the tensile side (Fig. 6) showed uniform strength throughout with an average Vickers hardness number of 488. Converting to Brinell hardness (HB) yields a hardness number of 459.<sup>10</sup> Brinell hardness can be used to estimate the tensile strength (TS) of a material<sup>4</sup>:

This analysis proved very useful because of the lack of background information on the spring material. Using this correlation between the hardness and tensile strength resulted in a tensile strength of 1583 MPa. The standard extension spring stress recommendation for hard drawn steel wire (Fig. 7) of diameter 4.3 mm in light service is 780 MPa, half of the tensile strength. In addition, the range for class 1 hard drawn wire<sup>5</sup> is 1360-1560 MPa and therefore, from a theoretical point of view, the spring was well within the design parameters for this application with similar properties to the hard-drawn steel alloy 4340.

Fig. 6. Results of Vickers Hardness test. Measurements were taken from the center and extending in the radial direction toward the region of maximum tension.

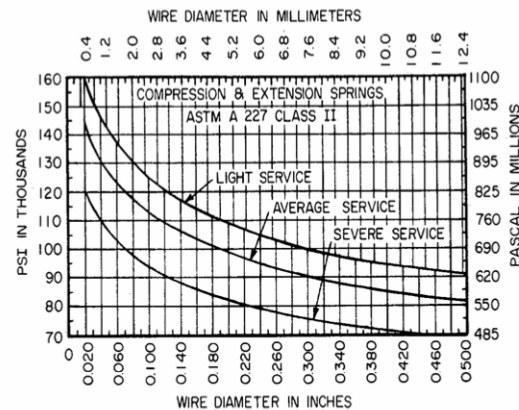
Fig. 7. Recommended design stresses for hard-drawn steel wire – based on ASTM A 227 for compression and extension springs<sup>1</sup>.

transferring through the extension springs is less than the weight of the door. If the motor pulls up as little as 10% of the door weight, that reduces the stress to 790 MPa, essentially the same as recommended in Fig. 7. The motor likely pulls up even more because after the spring failed, the door was lifted a couple of times with only one operational spring and the motor.

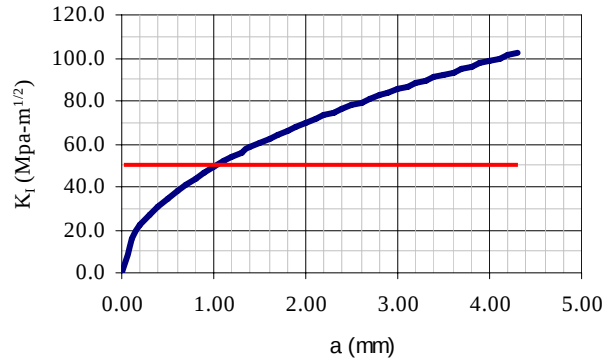
where  $\sigma$  is the far-field stress and  $a$  is the crack length. The fracture toughness,  $K_{IC}$ , for Steel Alloy 4340 is  $50 \text{ MPa}\sqrt{m}$ . Under the hook stress calculated in Eq. 3 and a  $K_{IC}$  of  $50 \text{ MPa}\sqrt{m}$ , the critical crack length to induce catastrophic failure is 1.03 mm (Fig. 8). It should be noted that the Mode I region of failure (Fig. 4c) has a depth of 1.2 mm. Although this isn't exactly the same length, they are on the same order indicating that the fracture toughness estimate is a good approximation.

Fig. 8. The effect of the flaw size on the fracture toughness,  $K_I$  using the stress from Eq. 3.  $K_{IC}$  approximation is in grey.
