# INVESTIGATION OF A SHOT PEENED TURBINE BLADE AFTER LONG-TERM USE

The main application of shot peening technology is the increase of fatigue strength by generating residual compressive stress. We wondered about the long-term durability of this effect under operating environments. So the shot peened turbine blade which was used for long term was investigated. The surface and cross-sectional micro structure were examined by scanning electron microscopy. Also the surface roughness and the depth profiles of peened area were measured. The peening marks were found on the surface. The deformed micro structure appeared as curved lath-martensite near the surface of the cross section. Lastly, the hardening layer due to shot peening was an about 70  $\mu\text{m}$  thick.

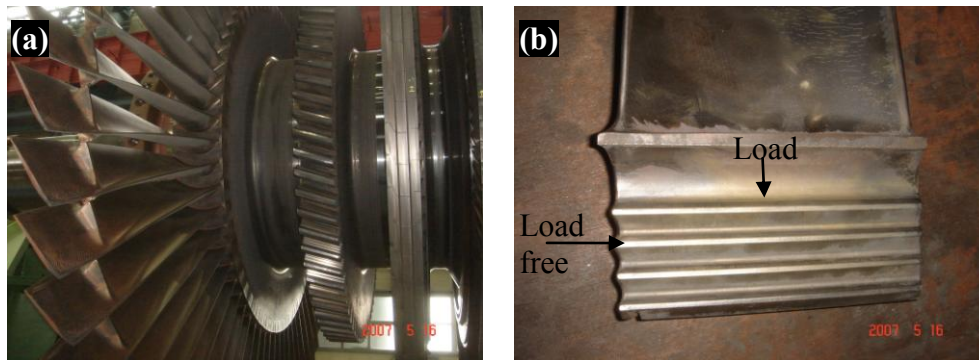
investigated. This blade was used as the first moving blade part of low pressure turbine in nuclear power plant during more than 20 years.

Fig. 1 Photographs of the investigated blade :  
(a) turbine rotor (b) dove tail of shot peened blade

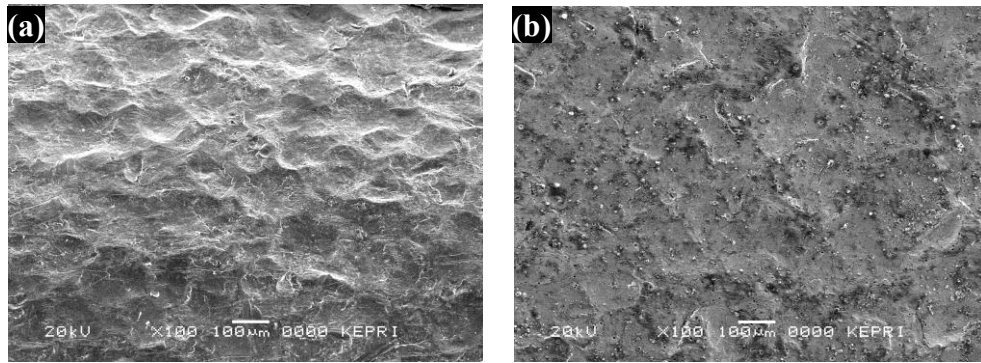
The shot peening was done on the dove tail part of the steam turbine blades for increasing the fatigue strength. The peening-treated part of a dove tail was divided into the two areas. One is the load-free area near the tips of the dove tail profile. The other is the loaded area on the flanks which is in contact with the corresponding dove tail profile of the disc. Fig. 2 shows the surface morphology of the two areas which are described as loaded area and load-free area. The peening marks were evidently existed on the surface of the load-free area (Fig. 2 (a)). The morphology of marks was irregular due to the use of an irregular shot when it was shot peened. This means that the initial working state was maintained. On the other hand, the peening marks on the surface of the loaded area were hardly detectable as shown in Fig. 2. (b). This is due to the interactions with supporting body like wear and sliding with the supporting body during the operation. Fig. 3 shows the measured surface roughness results. The value of roughness in x direction was  $Ra=4.17 \mu\text{m}$  and  $Rz=27.15 \mu\text{m}$ , and in y direction was  $Ra=3.65 \mu\text{m}$  and  $Rz=11.61 \mu\text{m}$ .

Fig. 2. Surface morphologies of the peened dovetail part ;  
 (a) load free area, (b) loaded area

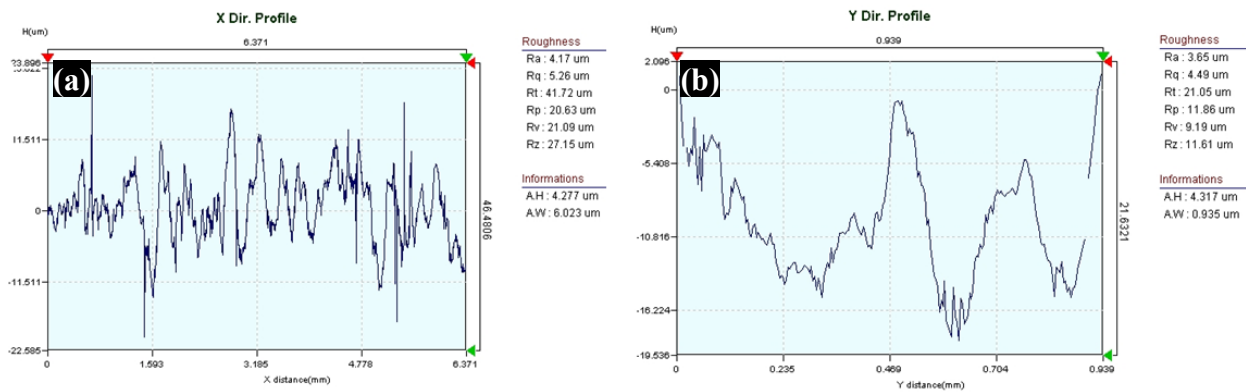
Fig. 3. Surface roughness of the load-free area

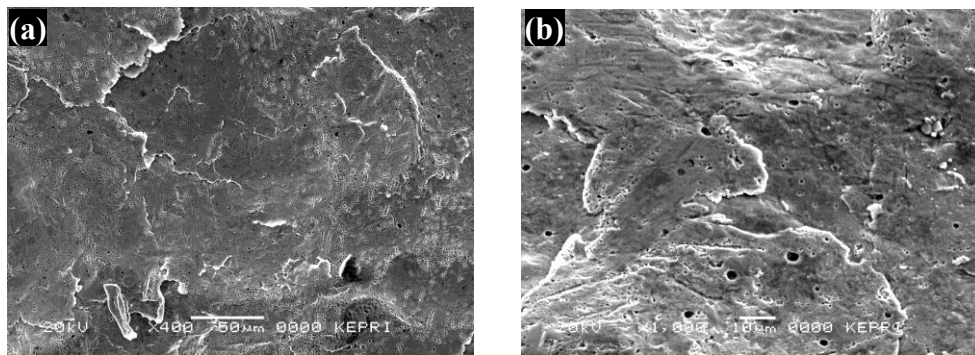
Fig. 4 shows a magnified peening mark on the loaded area. The center of the mark still shows a crater-like topography whereas the circumference is flattened by plastic deformation during operation in contact with the disc. The small holes (Fig. 4. (b)) were only formed in the circumference area. This is due to the tensile stress state at the circumference unlike the compressive stress state at the center. The surface which is imposed to tensile stresses is susceptible to environmental and mechanical attack such as corrosion and abrasion.

Fig. 4. Surface micro structure of peening marks ;  
 (a) center area, (b) circumference area

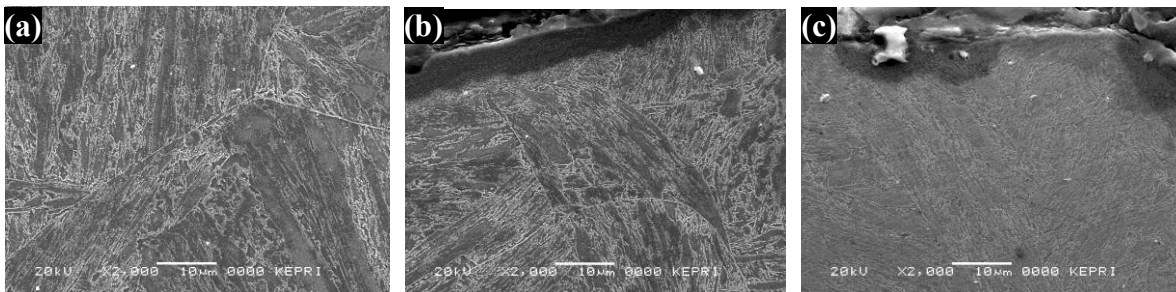
Fig. 5 shows the cross sectional microstructure of peened dove tail part. The base metal has a lath-martensite microstructure with straight grain boundaries (Fig. 5. (a)). This is a

typical micro structure of the original material. Fig. 5. (b) shows the cross sectional microstructure of the near surface in the load-free area. Unlike base metal, the grain boundaries are curved and disappear near the surface. The laths of martensite appeared in a distribution and shape like as the original state. The dark area in the figure seemed to be a nano-scale strain structure which should be investigated in more detail by transmission electron microscopy. These micro structure changes at the near surface of the shot peened area are interpreted as a result of the plastic deformation by shot peening. Fig. 5. (c) shows the micro structure at the near surface of the loaded area. The evidently deformed micro structure as in the load-free area could not be detected. But it was different from that of base metal. In the loaded area, the visible grain boundaries extended to the free surface. Only small remaining areas of dark nano-scal micro structure and of deformed martensite laths remained. This is expected to be a result of removal of the deformed layers by sliding and abrasive wear. The investigator confirmed, however, that the original deformed micro structure was stable during more than 20 years of operation in the load-free areas.

Fig. 5. Cross-sectional microstructure of dove tail ;  
 (a) base metal, (b) load free area and (c) loaded area

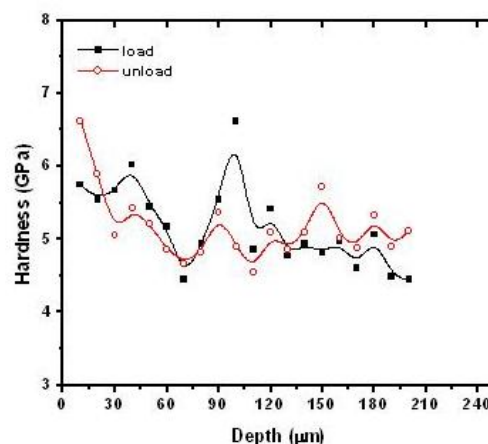
Fig. 6 shows the hardness depth profiles of the loaded and load free area. In lath areas, the thickness of the work-hardened layer appeared to be about  $70 \mu\text{m}$ . The hardness level of the load-free area was slightly higher than that of the loaded area.

Fig. 6. Hardness of loaded and load-free area with depth
