# FAILURE ANALYSIS OF A GARAGE DOOR SPRING

AME 60646: Failure of Materials

Matt Landrigan

1 December, 2006

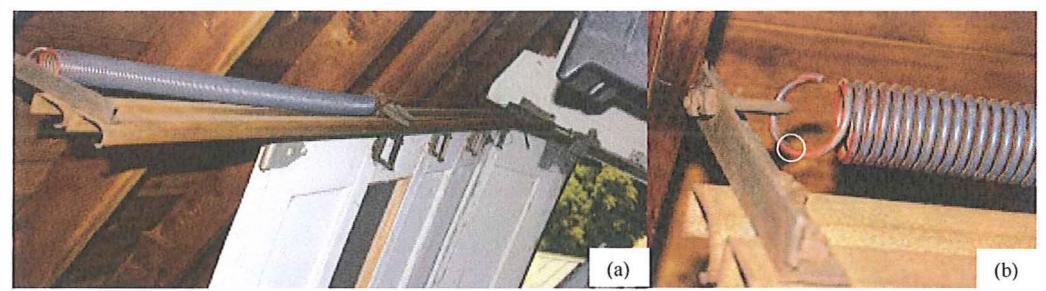
In May of 2006, an extension garage door spring fractured completely through rendering the door unusable until repair. A garage door operates with either two extension springs on either side of the bracket supports or one torsion spring across the top of the door frame. The motor for this particular setup drives a screw gear that pushes the door down when it closes putting tension into the spring (Fig. 1a). The springs are connected to a wire cable which runs over two pulleys redirecting the spring force along the curve of the door track. The springs aid the motor in lifting the door by placing an upward force on the door. The last coil of the spring is bent to form a hook (Fig. 1b).

Nothing unusual occurred on the day of the failure. Unfortunately, no information was available regarding manufacturer, installation date, type of material, or fatigue life although it is safe to say that the fracture is due to fatigue failure since the springs were installed when the house was purchased in May 2005. Both springs are identical looking so it is likely they are the original springs. The door was even lifted with only one spring a couple of times before it was realized that one was broken. The motor was likely installed at a later time than the springs due to modern electrical wiring – an indication that perhaps in the past the loading pattern was not as rigorous as in modern day life. Replacement springs (Overhead Door Company – parent company to Genie Company, motor manufacturer) at the local hardware store are rated for 10,000 cycles. Assuming the springs were installed when the house was built and a conservative usage estimate of

Fig. 1. (a) Installed garage door extension spring in relaxed position. (b) View of operational spring with circle designating area of fracture.

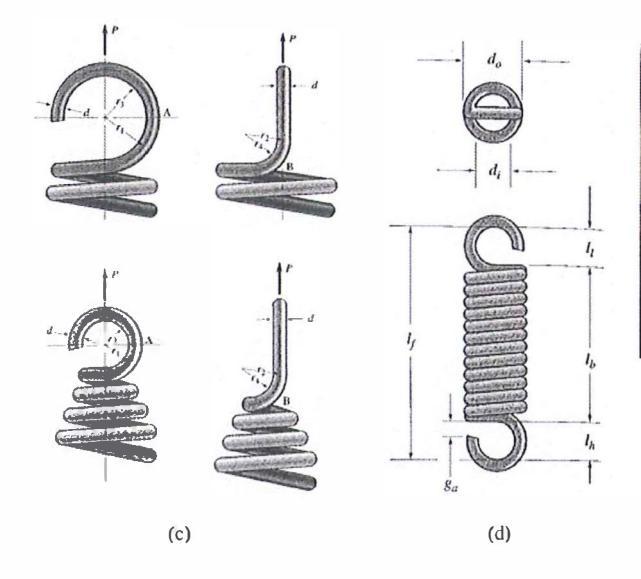
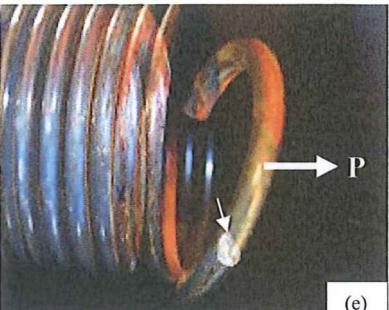
Fig. 1. (c) Schematic diagram of hook designs (top and bottom) with current design shown on top. (d) Side and end view. See appendix for dimensions. (e) Overlay of fractured hook on intact hook. The load P denotes location of load transfer to frame. Fracture occurred at point of maximum stress on inside of hook (arrow).

Most often helical extension springs fail at the hook and the design of the end hook impacts the stress concentration. This particular spring hook was manufactured by simply bending the last coil outward by 45 degrees. In idealized spring design, the end hook is bent outward forming a right angle with the plane of the previous coil. In the loading condition for this spring design the 45° angle causes a torque to act on the hook as well as the axial load (Fig. 1e). This was an important aspect used to determine the initiation region which will be discussed momentarily. Purely axial loading normally causes failure at the tensile edge furthest from the neutral axis. If a torque is added, the maximum stress shifts around the hook slightly due to the addition of the shear stress.

In reality, this part is very cheap to manufacture and currently retails for about \$15 at the local hardware store. Because it is likely that this spring has lasted at least 27 years, but more likely 54 years, it really would not be cost effective to improve the fatigue life. That being said, the easiest way to improve the fatigue life would be to put tighter manufacturing requirements to avoid tooling marks or other possible surface marks. Secondly, altering the wire material itself improves the fatigue life. Another way to increase the fatigue life is to reduce the stress in the spring hook. Reducing the moment arm (see Eq. 2) such as in Fig. 1c will drastically reduce the stress on the hook. These three aspects will increase the fidelity of the spring, but in this particular application it is not practical to spend the extra manufacturing time and money to improve the fatigue life.

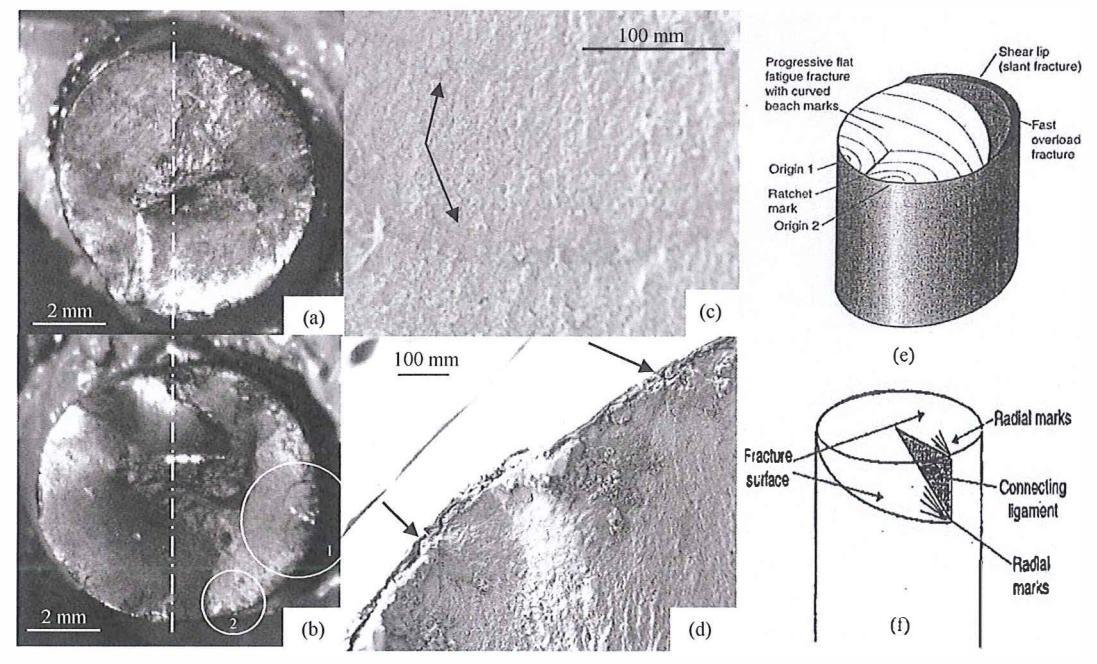
Both fracture surfaces were recovered and aided in the failure analysis. The surface proved to be quite complex with multiple modes of fracture indicative of the highly three dimensional surface (Fig. 2a-b). Areas of fatigue failure and brittle fracture exist. Observation under SEM revealed multiple crack initiation sites. The surface attached to the spring (Fig. 2a) was largely corroded with rust and therefore less visual information was available. The end attached to the hook proved invaluable because optical microscopy revealed rust bands on the inside of the hook – the area of maximum stress (Fig. 2b - circle 1). The rust rings follow two distinct centers (Fig. 2d, pointers) with radial marks leading outward from the centers. The rust rings are separated by a ratchet mark - a ledge between two initiation sites (Fig. 3c-d). Ratchet marks are indicative of initiation sites although it is normal to find beach marks around the marks (Fig. 2e) but there can be radial marks instead (Fig. 2f). As the crack planes propagate, the two planes come together forming a single fracture plane (Fig. 4c).

Inclusions, second phase particles, voids, machining marks or other surface flaws, and geometric anomalies are typical fatigue crack initiation points. Due to surface rust on the outside of the hook, a specific initiation type could not be determined. Because the initiation sites are at the surface, the cracks likely would have initiated because of a surface flaw such as a tooling mark or surface pit which could easily have been caused by corrosion.

Fig. 2. (a) Optical image of surface attached to spring and (b) surface of hook end. The right hand side was in tension. The white dashed line indicates neutral axis and the circle shows the region of initiation. (c) SEM image of rust bands. (d) SEM image of initiation points (pointers) surrounding ratchet mark (white region). Pictorial representations of ratchet marks and beech marks (e)<sup>7</sup> and radial marks (f)<sup>8</sup>.

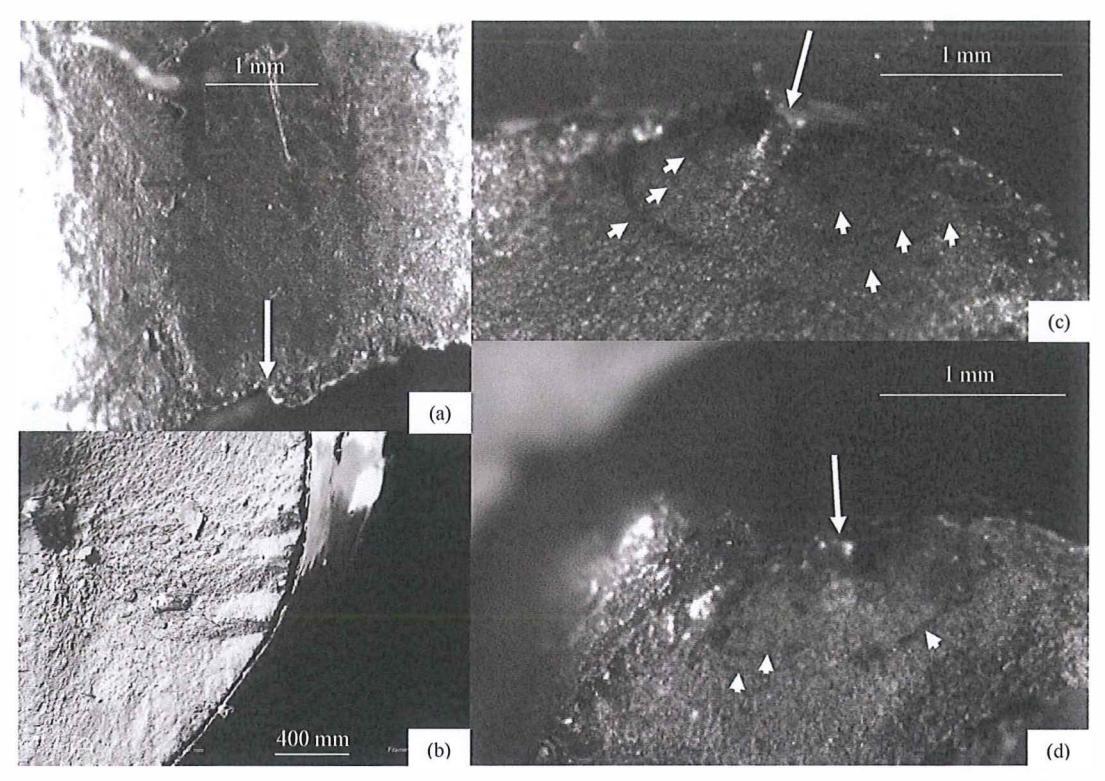
Fig. 3. Fatigue initiation sites. (a) Ratchet mark (arrow) around which rust rings formed. (b) SEM image of multiple ratchet marks from area 2 in Fig. 4b. (c) Fracture surface connected to hook end and (d) surface on spring end. Small markers indicate rust rings and large arrow points to ratchet mark.

The other area of interest is circle number 2 (Fig. 2b) where multiple ratchet marks can be seen under optical microscopy and closer under SEM (Fig. 3b). The location for the ratchet lines is understandable because the combined torque and tensile loading of the hook moves the maximum stress region around the outside of the hook closer to the neutral axis.

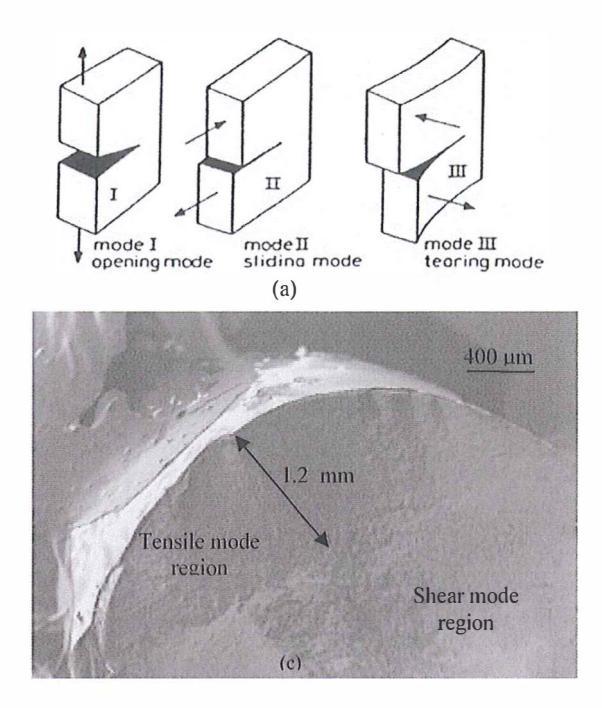
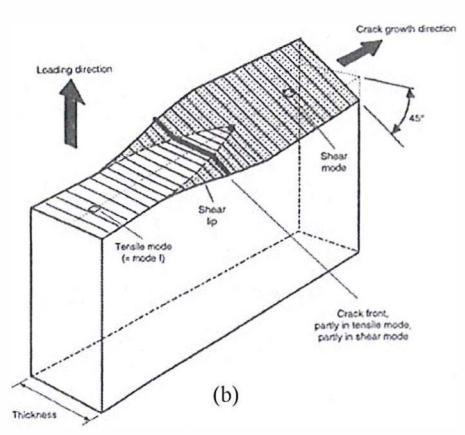
There are three different loading modes by which cracks can form and propagate as shown in Fig. 4a. Mode I is the tensile opening mode, Mode II is the in-plane shearing mode, and Mode III is the out-of-plane shearing mode<sup>2</sup>. With the initiation sites in the tensile region of the hook (Fig. 4c) and the fracture surface perpendicular to the wire direction (Fig. 5), Mode I failure is responsible for the crack initiation.

There are two distinct regions of crack propagation. The presence of rust rings indicated that the crack propagated slowly and allowed time for corrosion to materialize. The fracture surface plane is perpendicular to the wire direction (Fig. 5) showing Mode I crack propagation initially. About one third of the way across the fracture surface (Fig. 4c), the crack switches to Mode II or possibly Mode III failure. The fracture plane switches directions on an angle called the shear lip as shown schematically in Fig. 4b and for this particular surface in Fig. 5. At the same time the crack propagated very quickly

Fig. 4. (a) Schematic diagram of the three possible modes of failure<sup>2</sup>. (b) Schematic illustration of transition from tensile (flat) to shear mode  $(angle)^8$ . (c) SEM image of fracture surface with tensile and shear mode regions. Ratchet marks can be seen in upper edge of surface.

because the fracture surface is rough in this region compared to the area around the rust rings indicating catastrophic failure occurred when the crack switched failure modes.

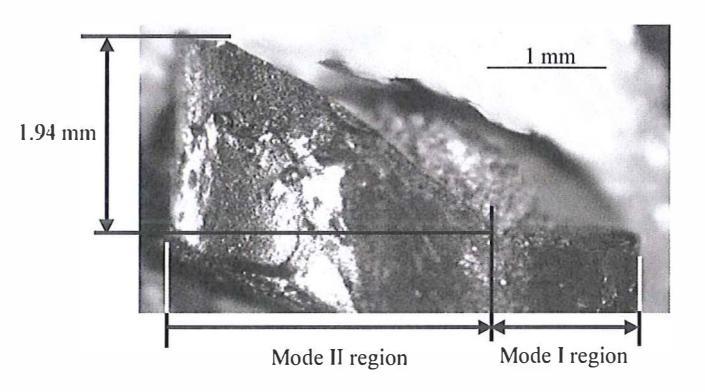
Fig. 5. Side view of fracture surface where Mode I and Mode II regions are visible.

Using the height of the shear region shown in Fig. 5 and Eq. 6 above, along with the hook stress calculated earlier gives a fracture toughness of 64 MPa $\sqrt{m}$ . While this would indicate that the spring steel has a stronger fracture toughness than assumed earlier, it is close and therefore a reasonable approximation for the toughness of the spring steel.

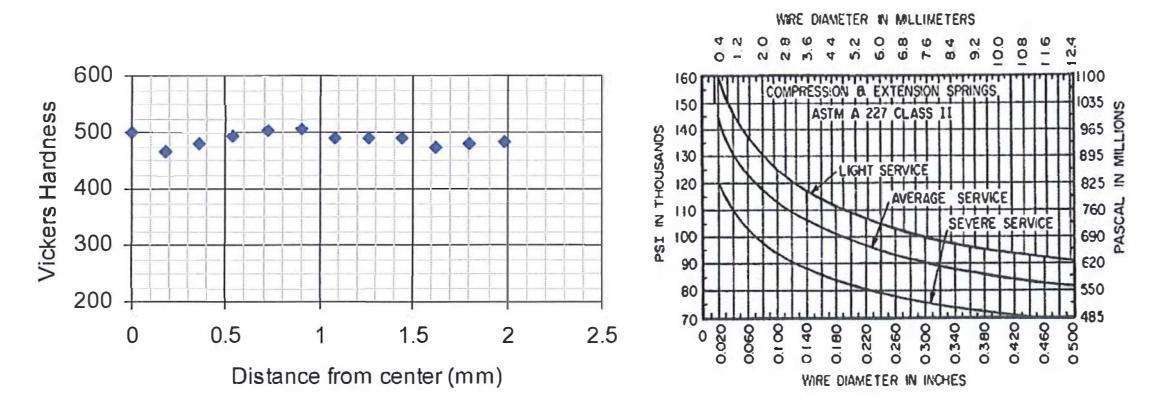
taken a few millimeters below the fracture surface on the spring side of the failure. The sample was embedded and polished to a one micrometer surface finish. The microhardness testing was performed with a one kilogram load for ten seconds. Hardness measurements taken from the center of the wire to the outside edge on the tensile side (Fig. 6) showed uniform strength throughout with an average Vickers hardness number of 488. Converting to Brinell hardness (HB) yields a hardness number of 459.<sup>10</sup> Brinell hardness can be used to estimate the tensile strength (TS) of a material<sup>4</sup>:

This analysis proved very useful because of the lack of background information on the spring material. Using this correlation between the hardness and tensile strength resulted in a tensile strength of 1583 MPa. The standard extension spring stress recommendation for hard drawn steel wire (Fig. 7) of diameter 4.3 mm in light service is 780 MPa, half of the tensile strength. In addition, the range for class 1 hard drawn wire<sup>5</sup> is 1360-1560 MPa and therefore, from a theoretical point of view, the spring was well within the design parameters for this application with similar properties to the hard-drawn steel alloy 4340.

Fig. 6. Results of Vickers Hardness test. Measurements were taken from the center and extending in the radial direction toward the region of maximum tension.

Fig. 7. Recommended design stresses for hard-drawn steel wire – based on ASTM A 227 for compression and extension springs<sup>1</sup>.

transferring through the extension springs is less than the weight of the door. If the motor pulls up as little as 10% of the door weight, that reduces the stress to 790 MPa, essentially the same as recommended in Fig. 7. The motor likely pulls up even more because after the spring failed, the door was lifted a couple of times with only one operational spring and the motor.

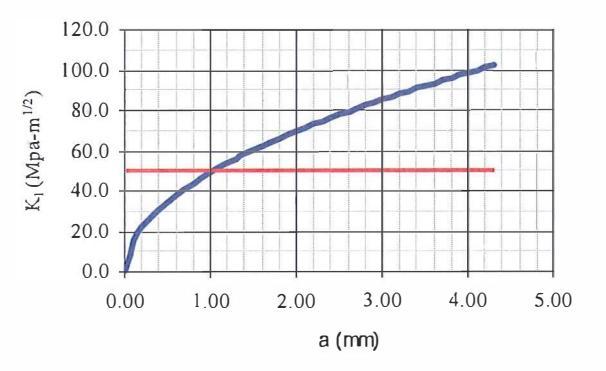
Fig. 8. The effect of the flaw size on the fracture toughness,  $K_{I}$  using the stress from Eq. 3.  $K_{IC}$  approximation is in grev.

where  $\sigma$  is the far-field stress and *a* is the crack length. The fracture toughness, K<sub>IC</sub>, for Steel Alloy 4340 is 50 MPa  $\sqrt{m}$ . Under the hook stress calculated in Eq. 3 and a K<sub>IC</sub> of 50 MPa  $\sqrt{m}$ , the critical crack length to induce catastrophic failure is 1.03 mm (Fig. 8). It should be noted that the Mode I region of failure (Fig. 4c) has a depth of 1.2 mm. Although this isn't exactly the same length, they are on the same order indicating that the fracture toughness estimate is a good approximation.
