Prestressing Processes and Fracture Barriers

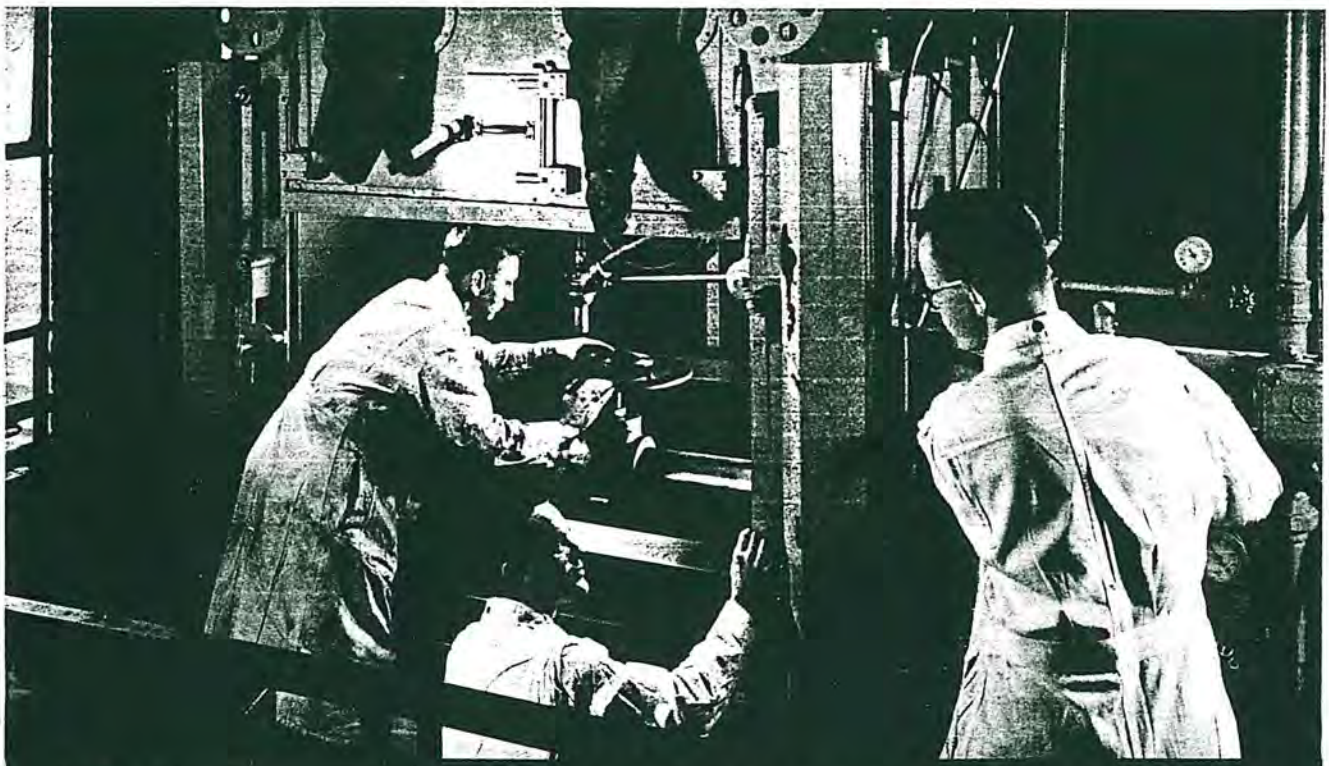
Fig. 1—Laboratory set up used in projects for determining effect of shot blasting on the fatigue life of automotive parts.

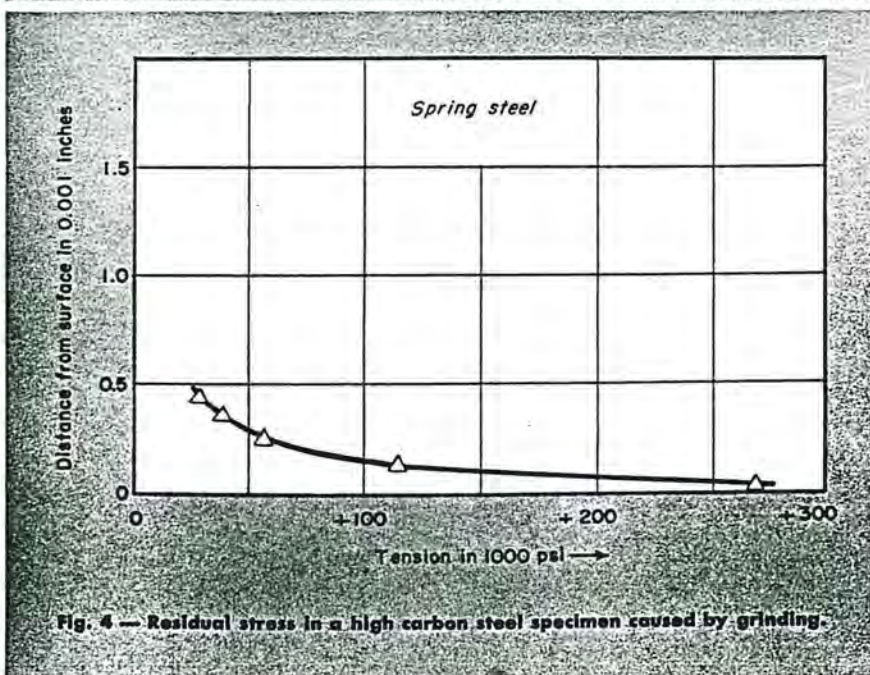
Fig. 4 — Residual stress in a high carbon steel specimen caused by grinding.

Measurements of the residual stress that resulted from grinding a high carbon steel specimen (Ref. 1 and 2) are shown in Fig. 4. These show that the surface residual stress developed by grinding is tensile, that the stress magnitude is approximately 25,000 psi, and that its maximum depth is 0.0005 inch.

stress from grinding that is shown in Fig. 4 is also shown extending leftward in Fig. 3, but with exaggerated depth. The combination is presented for the purpose of indicating the probable stress pattern in the Allison gear teeth.

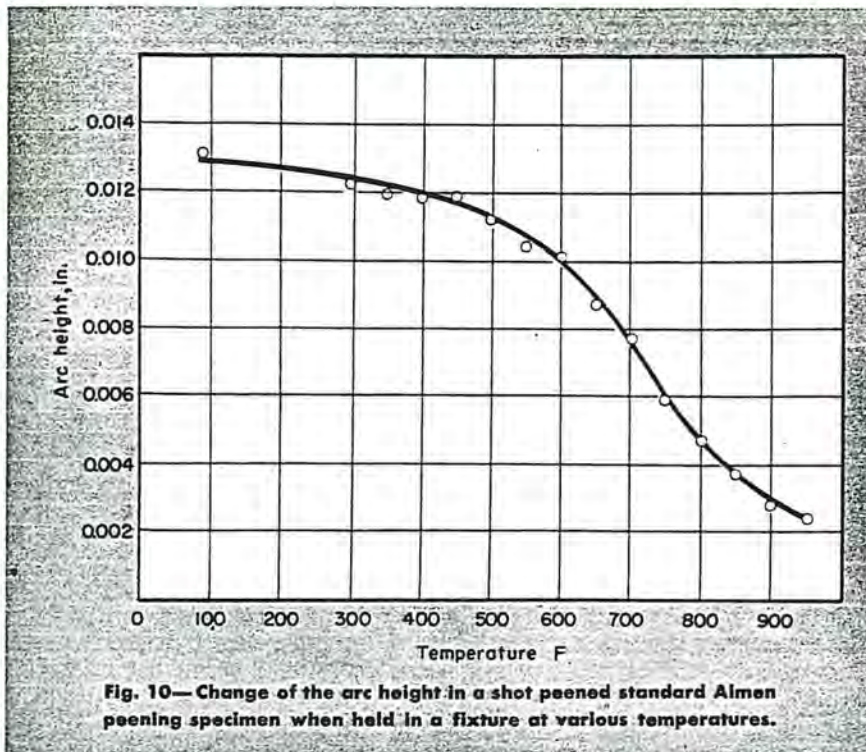
Fig. 10— Change of the arc height in a shot peened standard Almen peening specimen when held in a fixture at various temperatures.

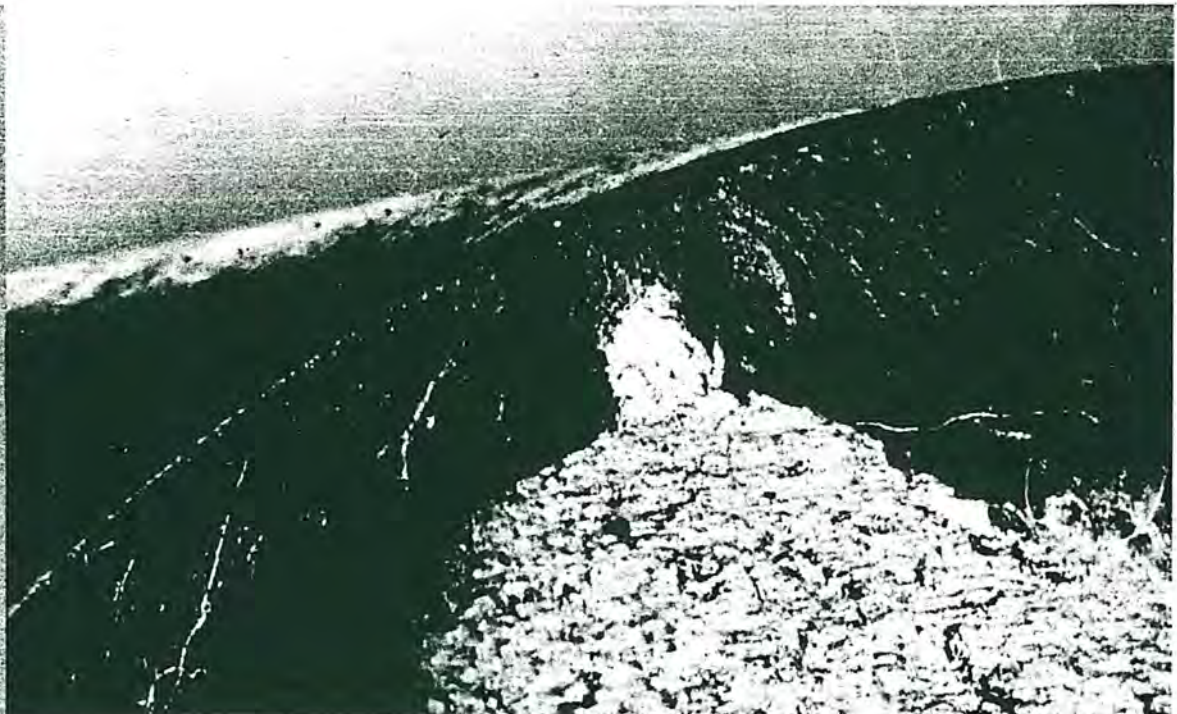
Fig. 17—Sub-surface fatigue fracture that originated in tensile stressed layer of an induction hardened torsion bar suspension spring.

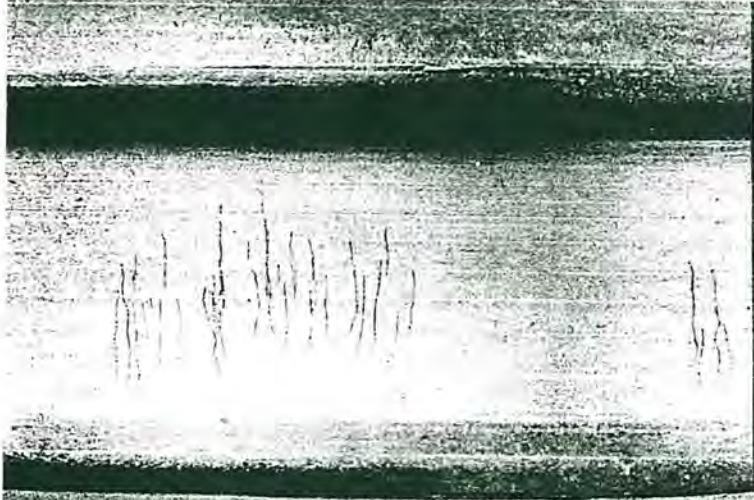
Fig. 27—Cracks in railway wheel rim. Thermal contraction of surface heated by brakes caused tensile stress sufficient to fracture rim.

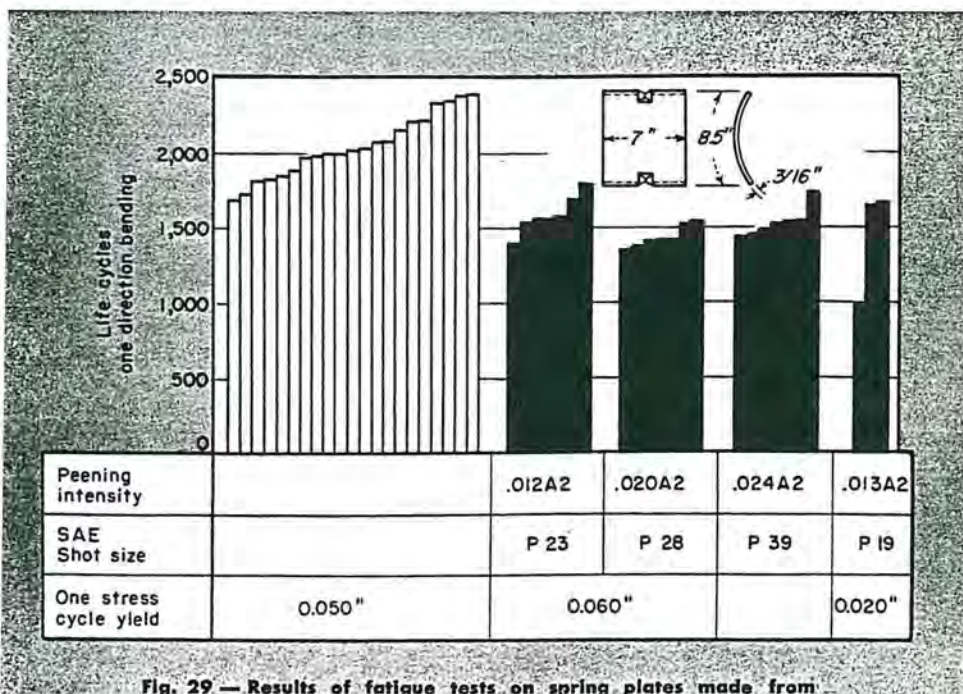
Fig. 29 — Results of fatigue tests on spring plates made from
