## *Appendix I*

### *Effects of Residual Stress on Rolling Bodies*

J. O. ALMEN

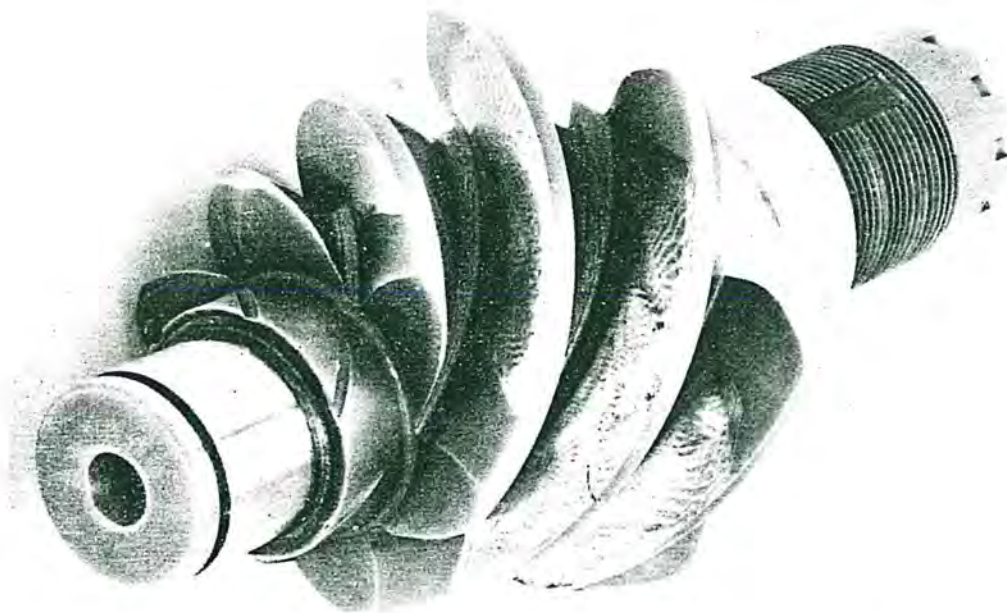
Fig. 5. Rippled hypoid pinion showing plastic flow of hard steel ( $R_c$  60-62).

The hypoid truck pinion seen in Fig. 5 shows the plastic flow of the tooth surfaces that occurred during dynamometer durability tests. Such extensive plastic deformation without seizure (welding) was possible because of the then (about 1936) recently developed E. P. lubricants. The rippled markings suggest ‘stick-slip’ friction, high temperature and residual compressive stress.

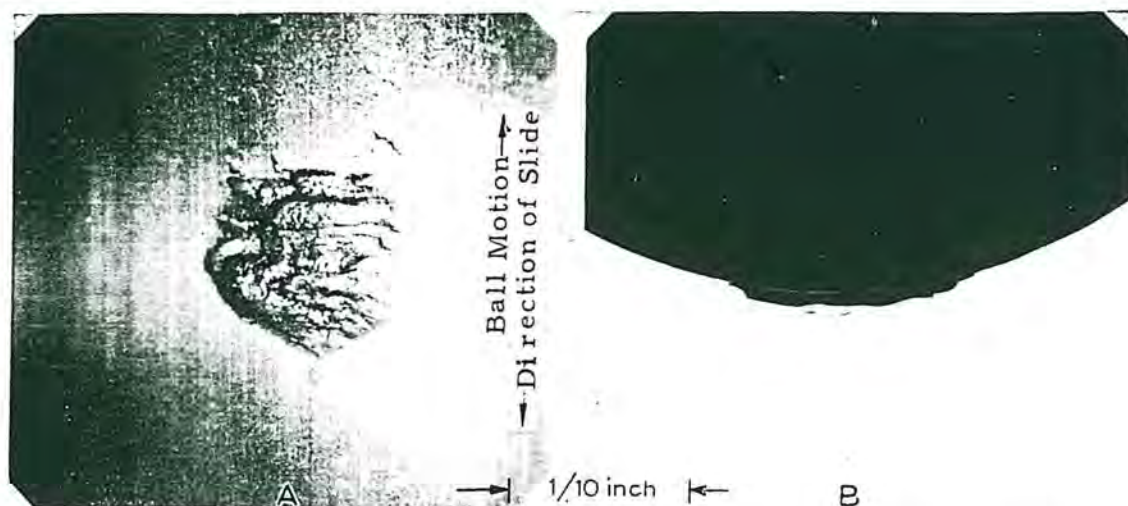
Fig. 10. Typical ball bearing failure. A - Spalled area on inner race of ball bearing. Note upward extension of original spall by succession of breaks due to sliding friction of balls. B - Cross section through bearing race near center of spall. Such spalls or pits are fatigue fractures originating in subsurface defects where local plastic yielding has developed residual tensile stress.

The caption of Fig. 10 directs attention to a succession of cracks in the upper half of the spalled area of a ball bearing inner race. These cracks were caused by the tangential force of friction from negative sliding of the balls against the race as is indicated by arrows in the photo and as has been described above. Each crack began near the upper edge of a pit in undamaged metal and grew in length and depth until the wall of the cavity broke away, thus increasing the tangential length of the spall.

Ball-bearing manufacturers agree that pits and cavities in their bearings begin as fatigue cracks extending from subsurface defects such as inclusions and voids. These cracks grow outward at acute angles, thus detaching metal to form cavities or pits. In Fig. 10 the lower  $\frac{1}{3}$  or  $\frac{1}{2}$  of the spall presumably grew from a subsurface defect and later its area was extended upward, as seen in the photo, by successive cracks adjacent to its upper wall.

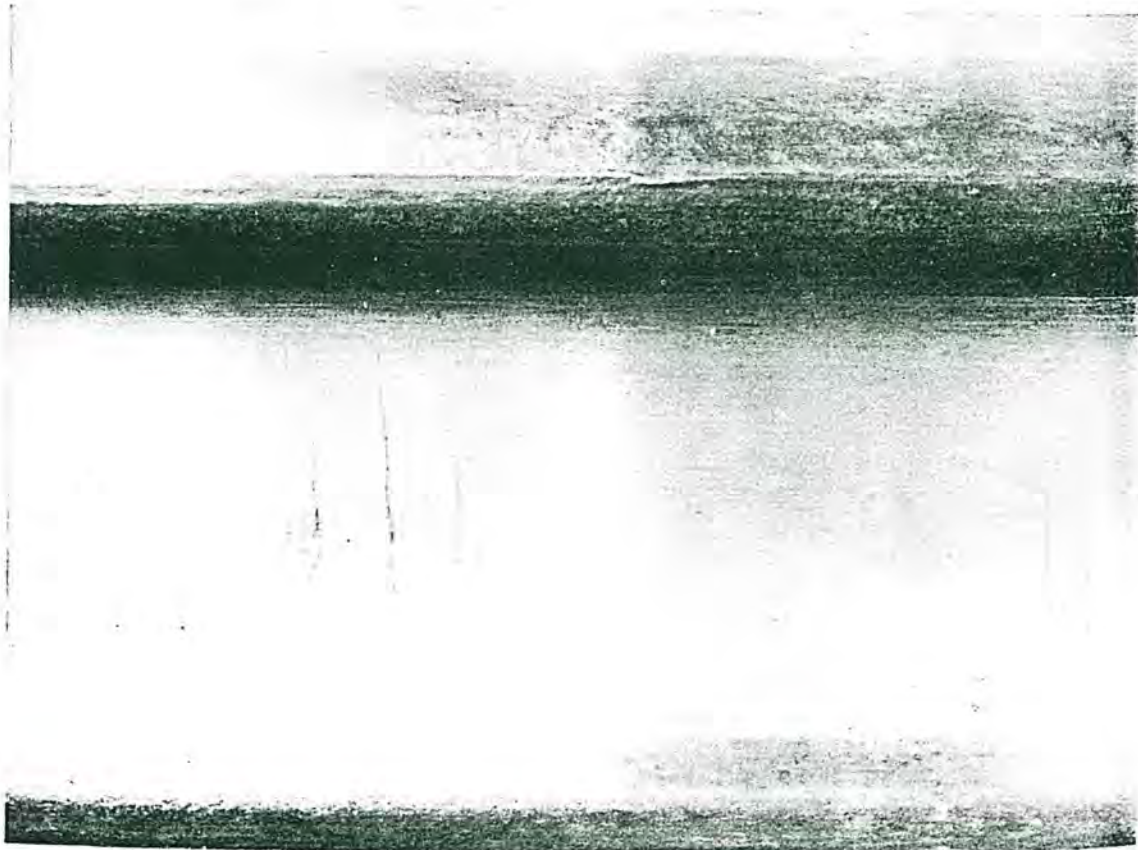
Fig. 21. Cracks in railway wheel rim. Thermal contraction of surface heated by brakes caused tensile stress sufficient to fracture.

Fig. 21 shows the heat checks in the rim of a car wheel caused by severe brake application. The brake shoes heat a thin surface layer of the wheel to a very high temperature. The tendency of this hot layer to expand in response to its elevated temperature is prevented by the underlying cold metal. The hot metal must, therefore, undergo plastic deformation consisting of slight thickening of the hot layer. The result is that upon cooling the relatively thin surface layer is residually stressed in tension and cracks appear as is shown in the illustration.

growing crack is an insurmountable barrier to its progress. Surface cracks such as are shown in Fig. 21 can and do grow to complete wheel failure when the residual compressive stress is lost by excessive brake heating. When this happens there remains no barrier to the extension of surface cracks.

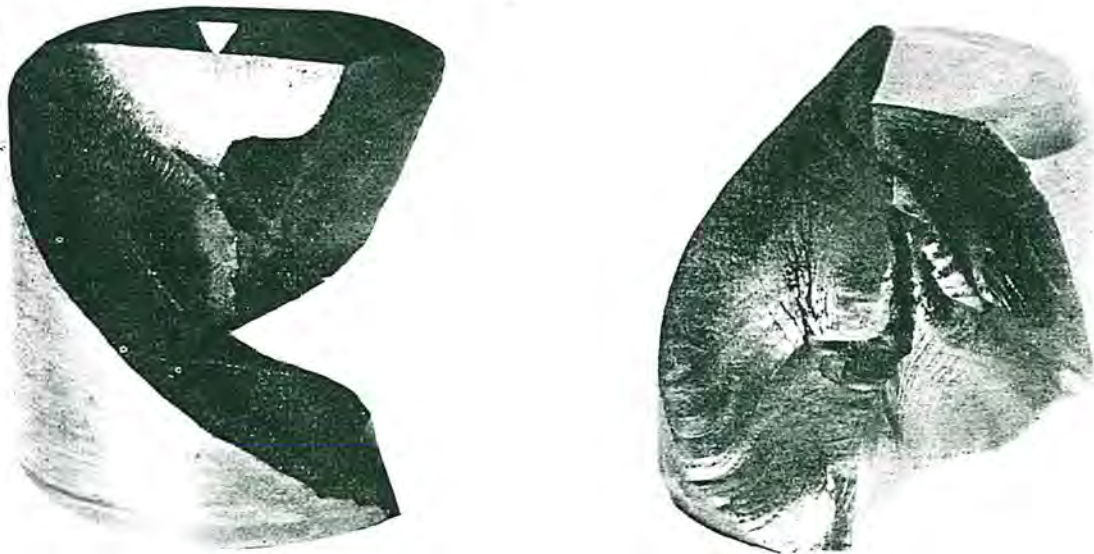
Fig. 22. "Explosive" fracture of bearing roller caused by unfavorable residual stresses

Fig. 22 shows a roller from a roller bearing used in the traction motor of a locomotive made by the Electromotive Division, General Motors Corporation. The roller, which measured 1.5 in. diameter by 1.5 in. in length, burst while in normal service as is seen in the figure. The fracture origin was on the axis of the

roller at its upper end as is seen at the left. The bearing was made from a carefully selected, high grade, *deep hardening* steel and its failure presented a very serious and, to me, interesting problem.
