# **Guidelines for the Installation, Inspection, Maintenance and Repair of Structural Supports for Highway Signs, Luminaries, and Traffic Signals**

This document provides guidance for the installation, inspection, maintenance, and repair of structural supports for highway signs, luminaries and traffic signals. The primary purpose is to provide owners with information that can assist them in managing their inventory, identifying potential problem areas, and ensuring safe and satisfactory performance of these types of ancillary highway structures. The primary reason for compiling this guidance is increasing problems with wind induced vibration, fatigue, and even structural collapse of these support systems, as seen in Figure 1. Documented problems with these structures include questionable design and details, poor fabrication practices, and poor installation techniques.

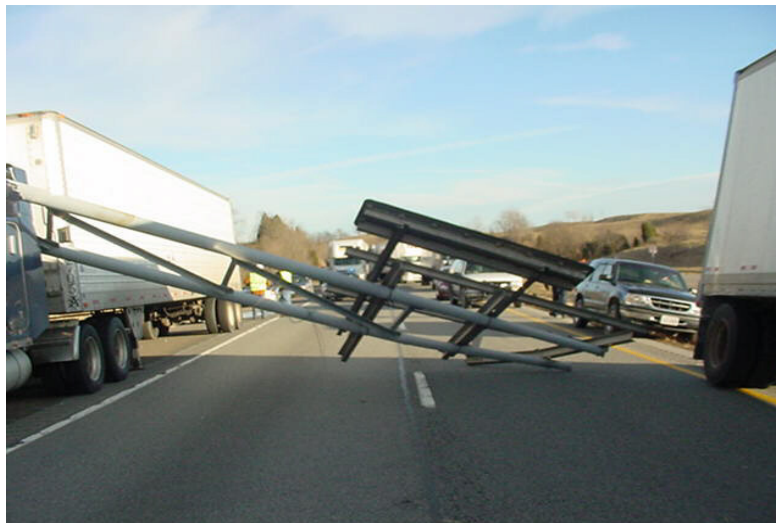
**Figure 1. Cantilever Sign Structure Failure.**

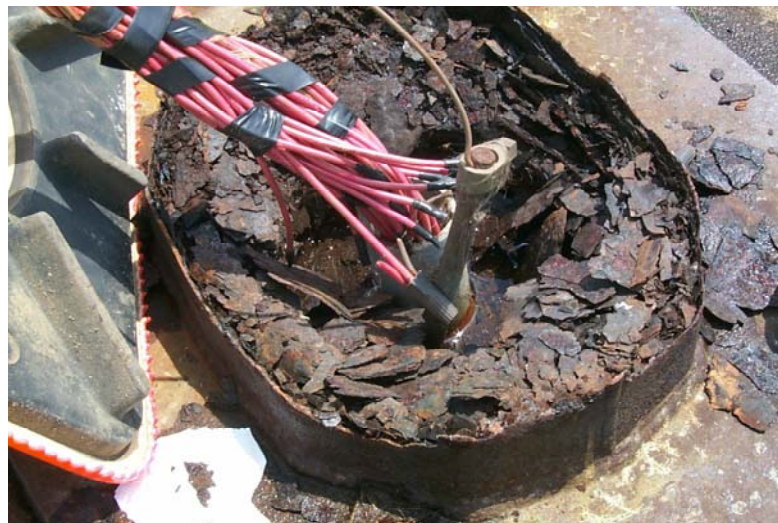
Areas of particular concern for corrosion of weathering steel ancillary structures are the internal corrosion of tubular members, and corrosion in the mating surface of slip joint connections. Tubular members will corrode on the inside if water or an electrolyte is able to continuously contact the surface. Members should contain drain holes and be detailed so that locations are not created where moisture can pool, or debris collect. Figure 2 shows the base of a weathering steel light pole that collapsed due to corrosion at its base. Slip joints draw water into the joint through capillary action. As this area does not dry well, pack rust develops which can generate sufficient force to split the tube vertically, starting at the bottom of the joint. Painting the slip joint surface before assembly, or sealing the bottom edge of the joint are two methods of improving the performance of this area.

Weathering steel bases may also experience premature corrosion when they are buried in soil or covered by vegetation.

**Figure 2. Failure of Weathering Steel Pole. Note the Corrosion Product.**

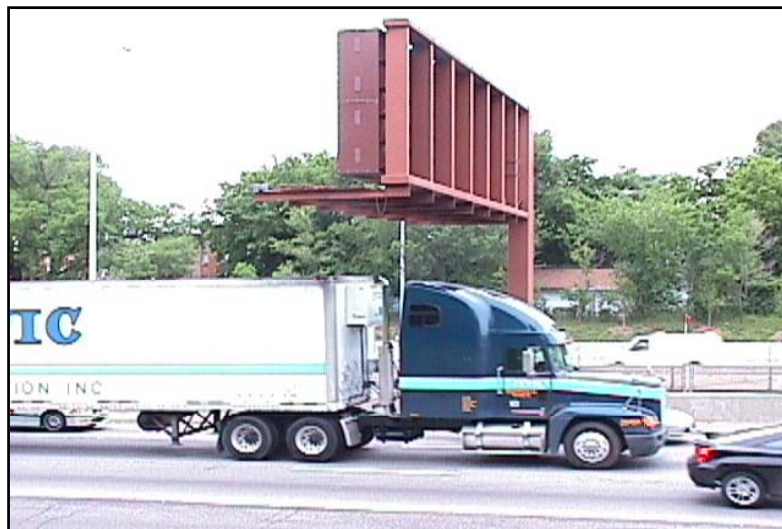
The passage of trucks beneath support structures induces both horizontal and vertical gust loads on the structure, creating a motion that is primarily vertical but may also include a significant horizontal component as well. The magnitude of the horizontal truck gust is negligible relative to the natural wind gust and is therefore ignored in the specifications. The vertical truck gust load in the specifications is an equivalent static pressure range applied to the underside of the mast arm or truss and any attachments. Due to the large depth of variable-message signs (VMS) in the direction of traffic flow (up to 1.2 m for older signs), the support structures are the most susceptible to truck-induced wind gust fatigue because they present a large area in the horizontal plane, as seen in Figure 3.

**Figure 3. Truck Passing Under VMS.**

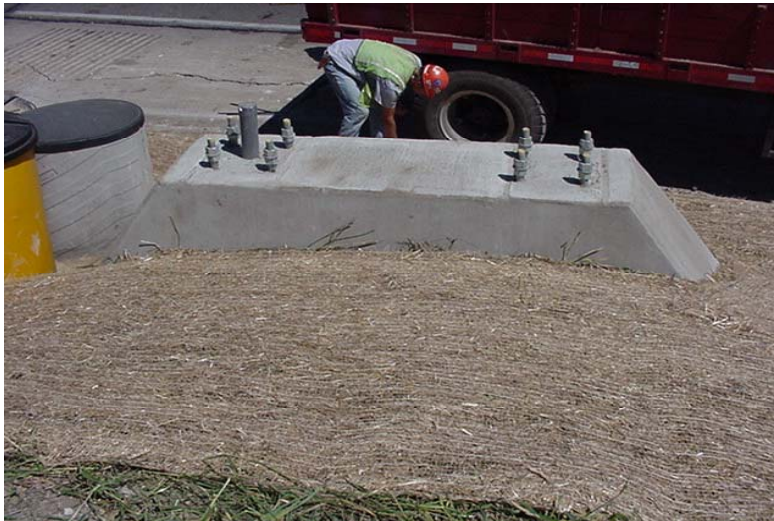
The erector should verify that the foundations are set to the proper elevation and anchor rods are set in the correct pattern and orientation, are of the correct size, and are plumb with the specified extension and thread length above the top of concrete, as seen in Figure 5.

**Figure 5. Foundation Ready for Structure Installation.**

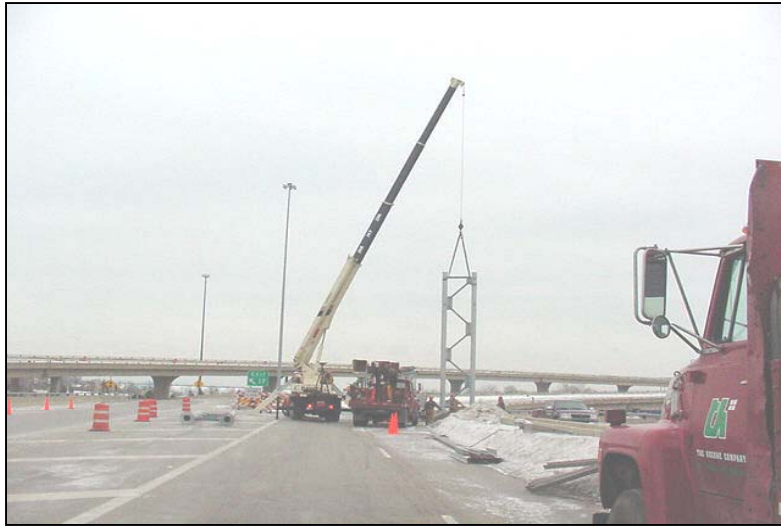
**Figure 6. End Frame Being Set Onto Its Foundation.**

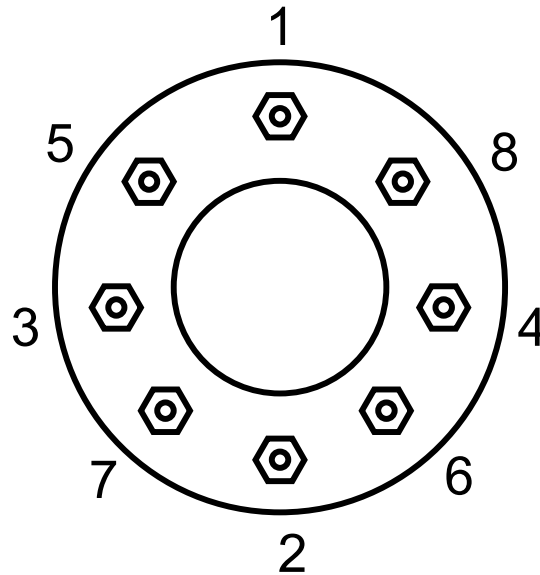
sheets of other metals) should not be placed between these flanges, even to try to achieve better contact. Tightening of bolts should be performed in a manner that brings the faying surfaces up “evenly.” For flange type connections, a star tightening pattern as shown in Figure 8 is recommended.

**Figure 8. Star Pattern Tightening Sequence.**

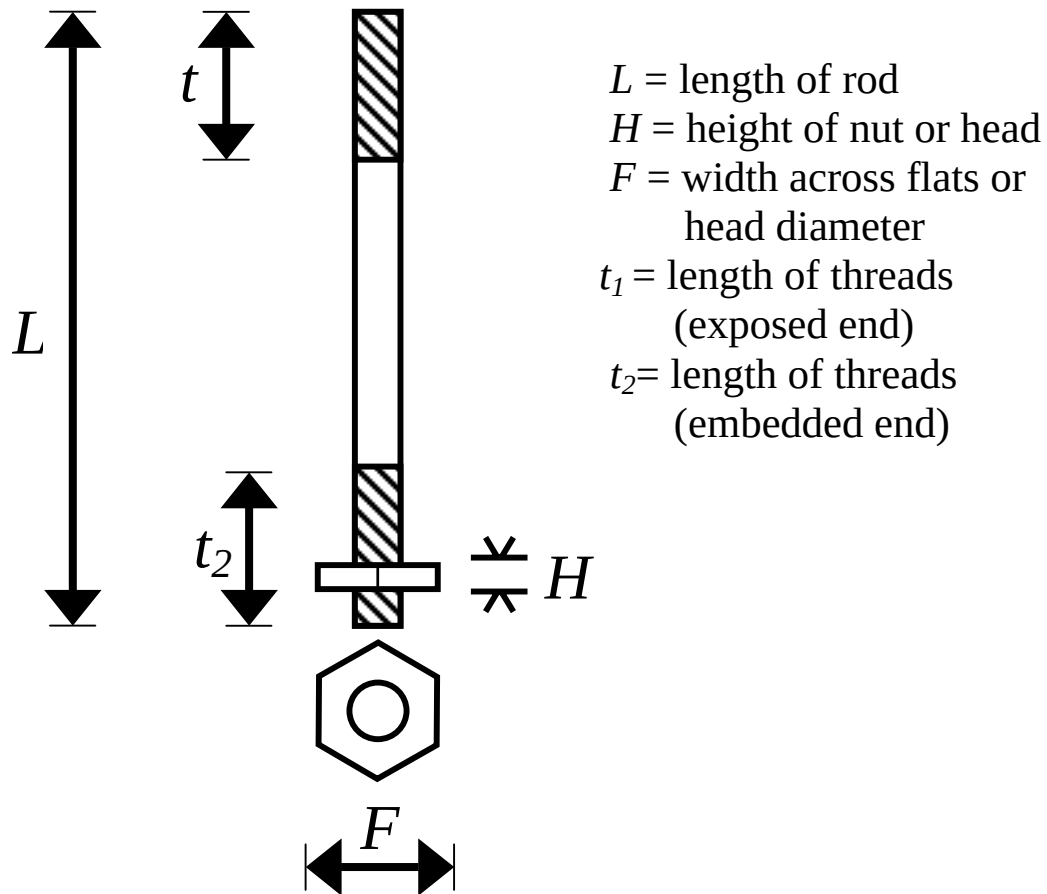
Figure 10. Headed Anchor Rod.

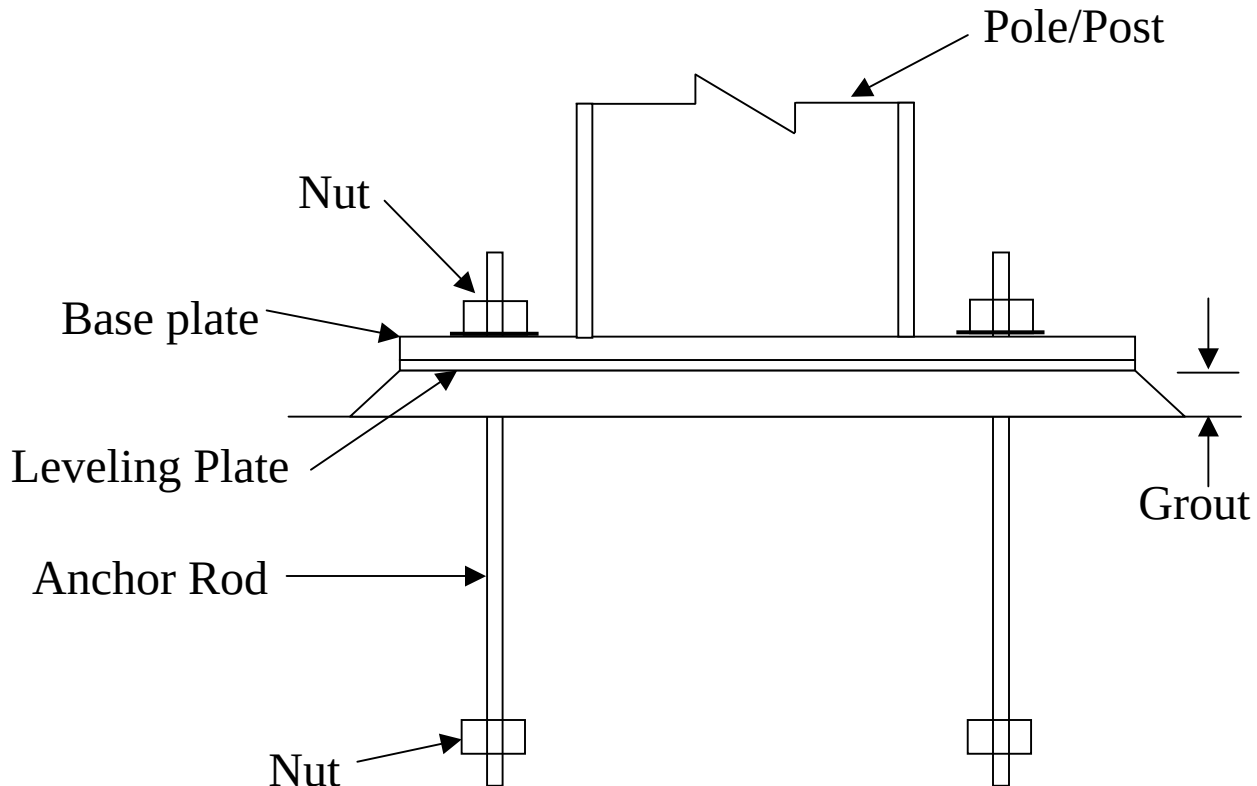
The threaded-shear-and-uplift joint rests directly on the concrete or on a grout pad (Figure 11). The base plate is held down by nuts atop the base plate. Single nuts are most common, but double nuts are sometimes used. For proper joint performance, the base plate must be in direct contact with the grout and not be supported by leveling nuts or shim packs. One technique to achieve full grout support is to set the base on shim packs to proper elevation, grout the base and then remove the shims and grout the resulting voids. Only then can the anchor rods be fully pretensioned. Use of proprietary prepackaged grout mixes, so called “non-shrink grout” is recommended and should be carefully installed to manufacturers’ recommendations. The threaded-shear-and-uplift joints can develop some resistance to bending moment as a couple between compressive bearing force on the grout and tensile forces in the anchor rods. It may be difficult to retain the pretension in the anchor rods under cyclic loads as the base plate wears the grout. For these reasons, this type of joint is not recommended by NCHRP Report 469 for large cantilevered support structures, although it is still commonly used for many luminaries and small traffic signal supports. This type of joint is suitable for bridge support structures where there are multiple posts.

**Figure 11. Threaded-Shear-and-Uplift Joint.**

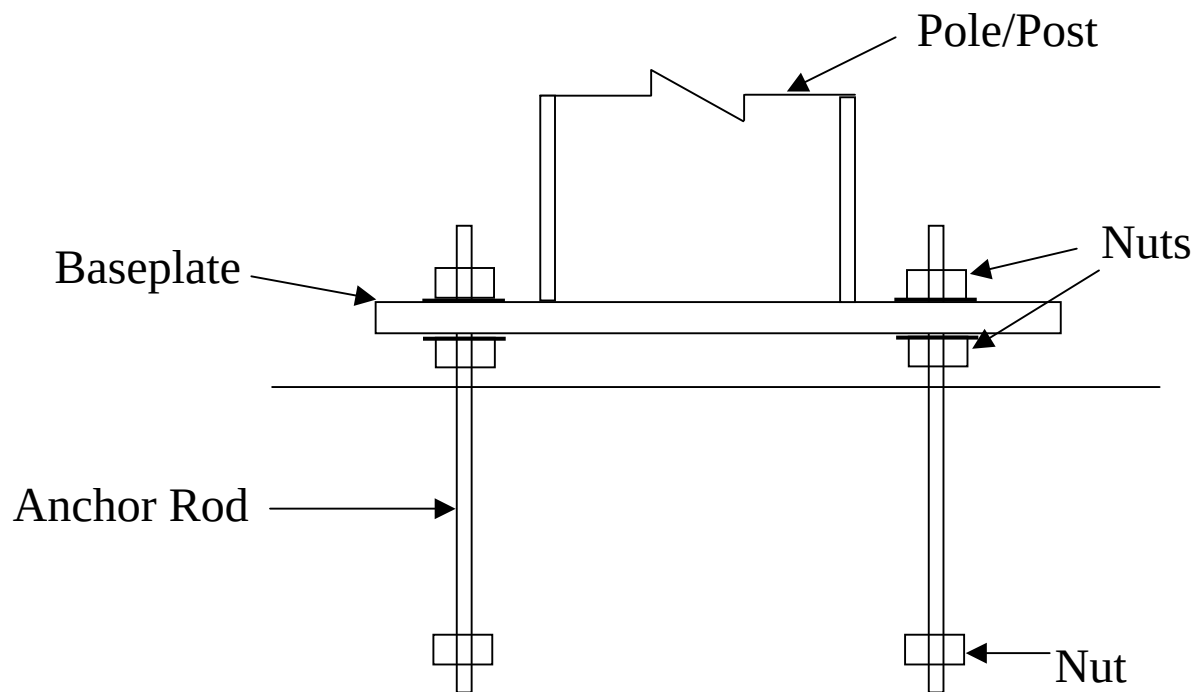
In double-nut-moment joints, the base plate stands off from the concrete foundation and bears on leveling nuts (Figure 12). Thus, the base plate is attached to anchor rods through double nuts: the leveling nut and a top nut (or nuts). This type of joint may be suitable for any type of support structure and is required for cantilevered support structures designed by the 2001 Specifications. Washers should be used under both nuts, and beveled washers should be used if the misalignment exceeds 1:40 for the double-nut-moment joints. Double-nut-moment joints are easy to level and plumb and are also very reliable for transmitting moment to the foundation; therefore, they are satisfactory for non-redundant structures and seismic or fatigue-loaded structures such as highway sign, signal, and light supports.

**Figure 12. Double-Nut-Moment Joint.**

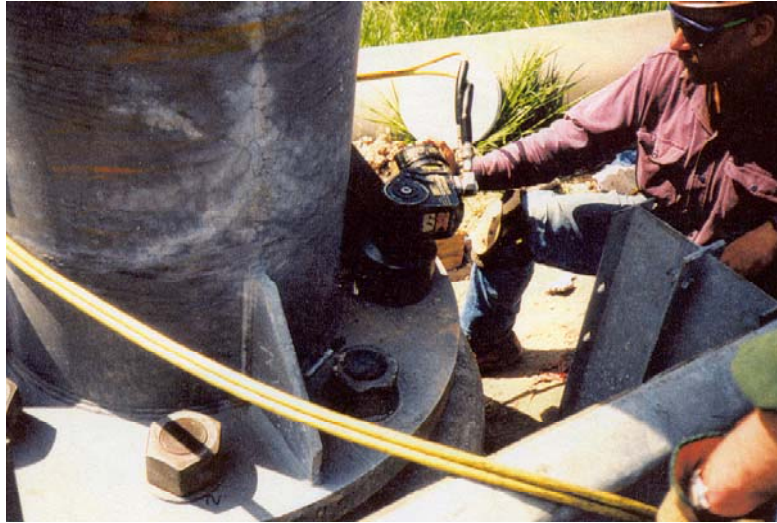
- ◆ A hydraulic torque wrench (Figure 15) or
- ◆ A box end "slug" or "knocker" wrench with a 3 meter (10-ft), long pipe or extension handle.

**Figure 15. A Hydraulic Torque Wrench Tightening Anchor Rod Nuts to Achieve Needed Rotation.**

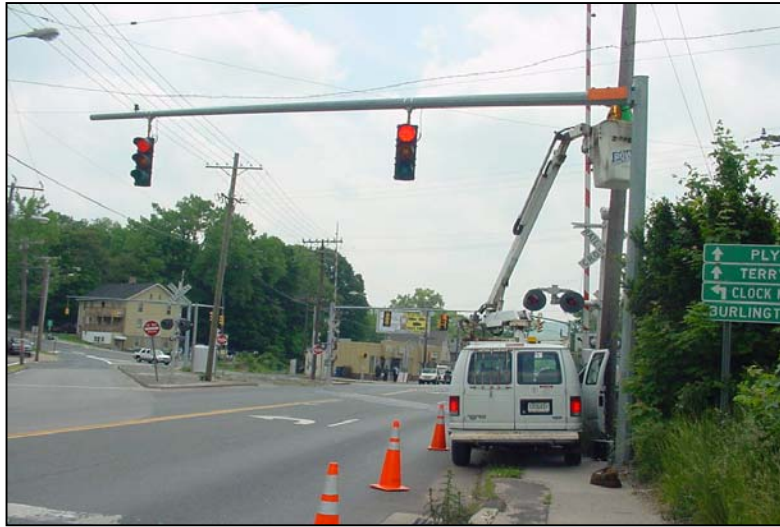
The inspection of mast arm structures and signal supports proceeds generally the same as for a sign structure, working from the base on up, see Figure 26. For many of the mast arm and signal supports, the anchor rod nuts are covered by a cap. These must be removed to examine the top nuts, even if removal results in damage. Damaged caps should be reported for future replacement, or the inspection team may be supplied with spares for installation.

**Figure 26. Inspection of a Mast Arm Structure.**

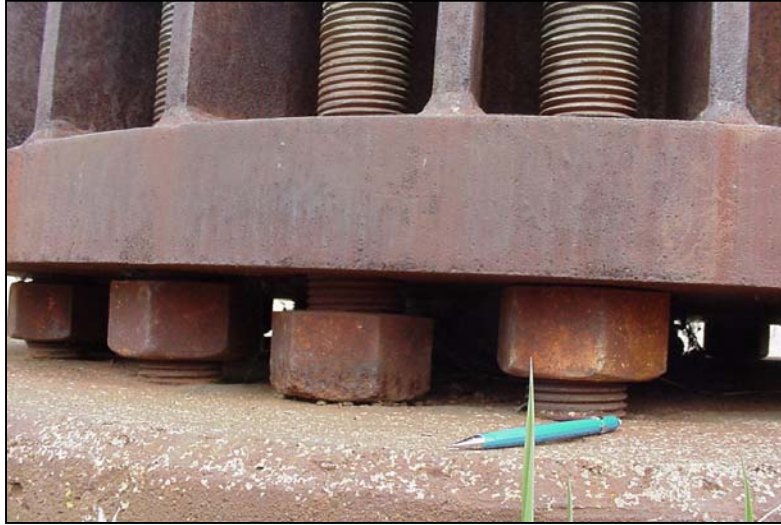
For luminaire supports of modest height, say under 40 feet, anchor bolt inspection may require removal of bolt covers. Because these poles may oscillate however slightly in even modest winds, it is recommended that anchor bolt nuts be checked at both the beginning and end of the inspection. Leveling nuts should also be checked if accessible. Figure 28 shows loose leveling nuts on a high mast structure.

**Figure 28. Loose Leveling Nuts on a High Mast Structure.  
(Note: Top Nuts on Chairs Out of Photo)**

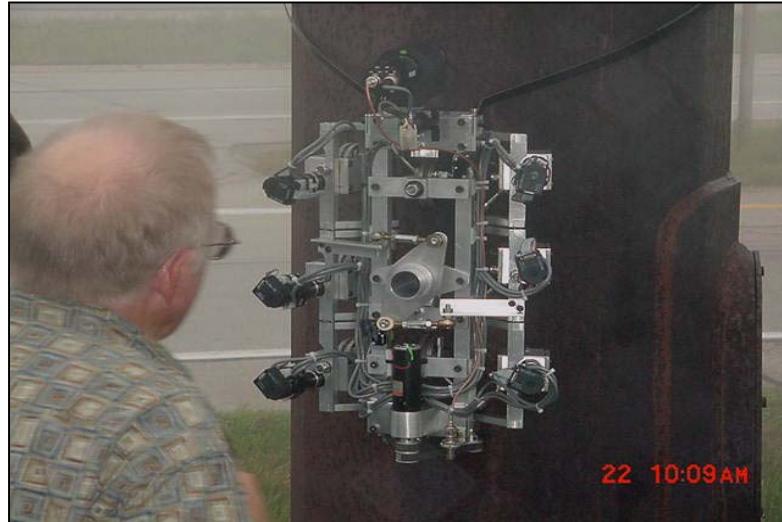
while carrying a video camera and possibly other inspection equipment. Figure 31 shows one such device, developed by the Virginia Transportation Research Council. At present, these devices are difficult to maneuver and position and require increased inspection time. With continued development; however, they may become a tool for routine inspections, particularly of slip joints.

**Figure 31. Remotely Operated Inspection Device.**

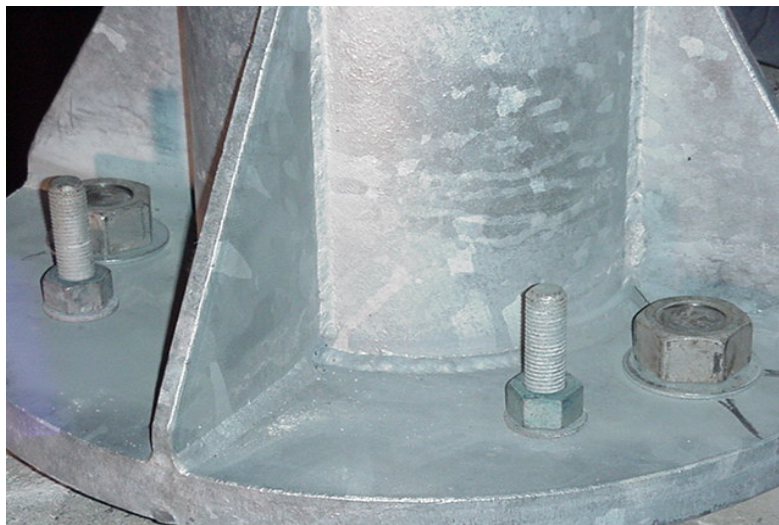
A rod that is found to be fractured or does not meet required embedment lengths presents a serious condition. One method of adding anchor rods is to drill through the base plate and into the foundation so that new rods can be epoxy grouted into place, see Figure 35. Installation may be hindered by closely spaced base plate stiffener plates and may cut reinforcing steel in the foundation.

**Figure 35. Base plate with Added Anchor Rods.**

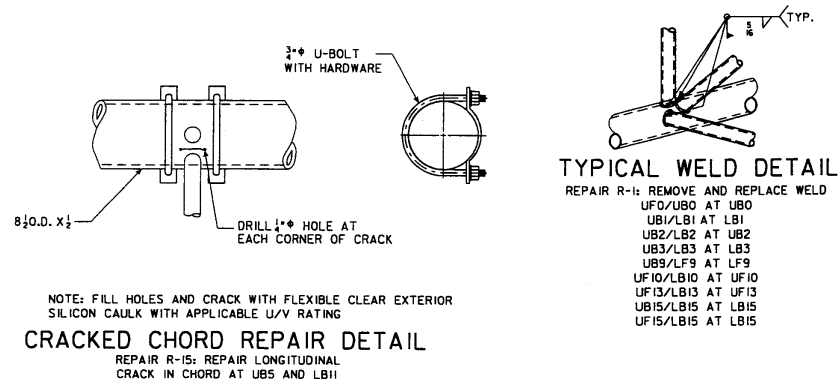
A drilled hole is often used to arrest a crack that goes through the entire thickness of the weld material. For small cracks this may be enough to arrest the crack permanently, but offers only a temporary fix for larger cracks. The diameter of the hole to be drilled is often taken as 20mm (.75 inch); however, a more structure specific hole size can be calculated based on the stress range, edge distance and yield strength of the material. The inside of the drilled hole should be tested with dye penetrant to assure that the crack end was removed. Figure 36 illustrates actual crack repair details.

**Figure 36. Repair Detail for Overhead Sign Truss Chord Crack.**

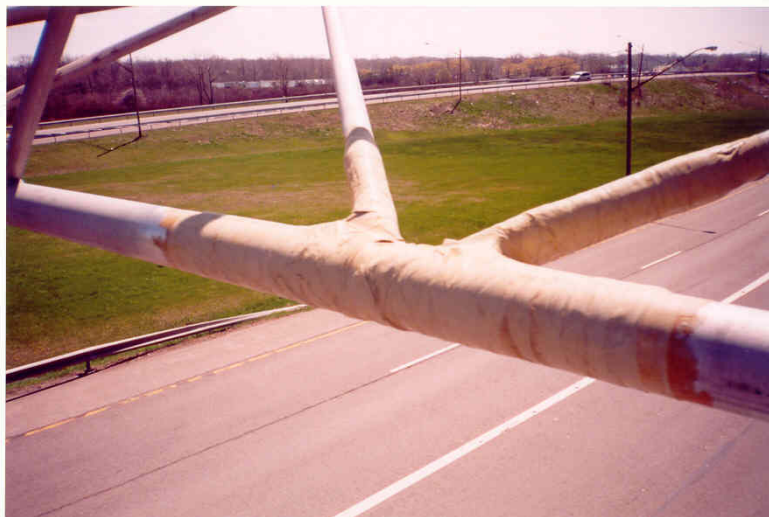
A good example of such an application is repair to an aluminum sign truss bridge. During inspection it was found that the welds connecting the diagonals to the chord had cracked over a significant portion of their length. FRP was chosen as a repair technique. The application included member cleaning and application of the FRP material using strips wrapped around the members. Figure 37 below shows the completed application. These repairs, initially thought to be just temporary for one year or less, are now being considered as a permanent repair solution.

**Figure 37. Repair of Truss Members Using FRP.**

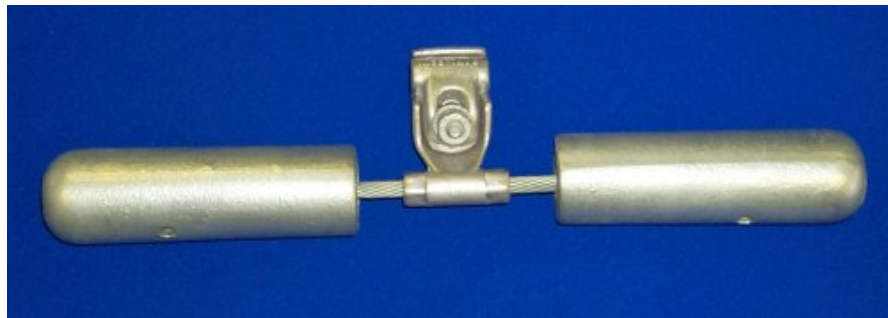
The most common type of dampener found on ancillary structures is the Stockbridge damper, also called a dog bone damper, see Figure 38. There are two weights on the end of a flexible shaft that can be tuned based on the natural frequency of the structure and thereby offer maximum effect. They are also very easy to install on existing structures as a retrofit.

**Figure 38. Stockbridge Damper.**

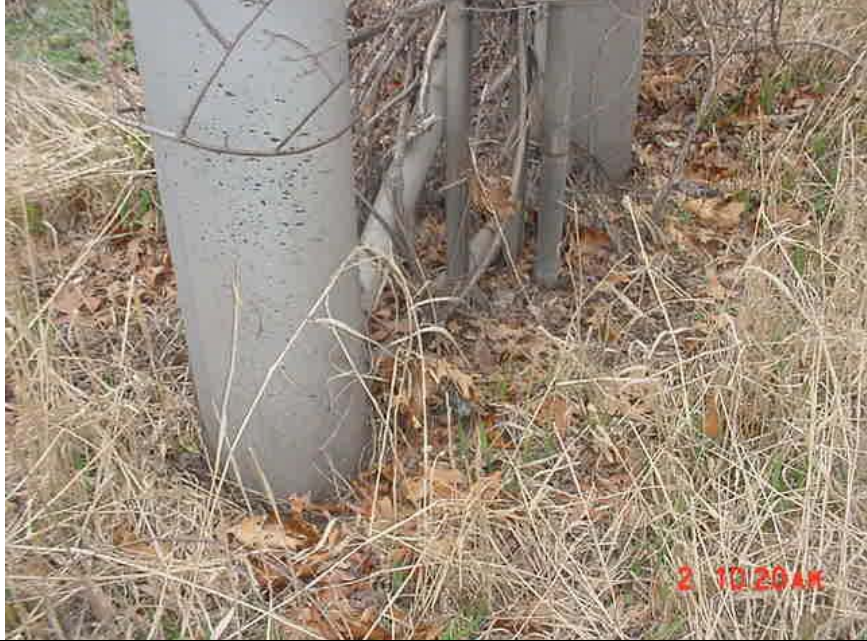
| | <p><b>Figure A1</b></p> <p>Buried Foundation<br/>S.01 rate as '0', Not Applicable.<br/>However, if opposite tower foundation is exposed, rate S.01 for that foundation, state in notes buried foundation and recommend as Priority 3 to expose.</p> |

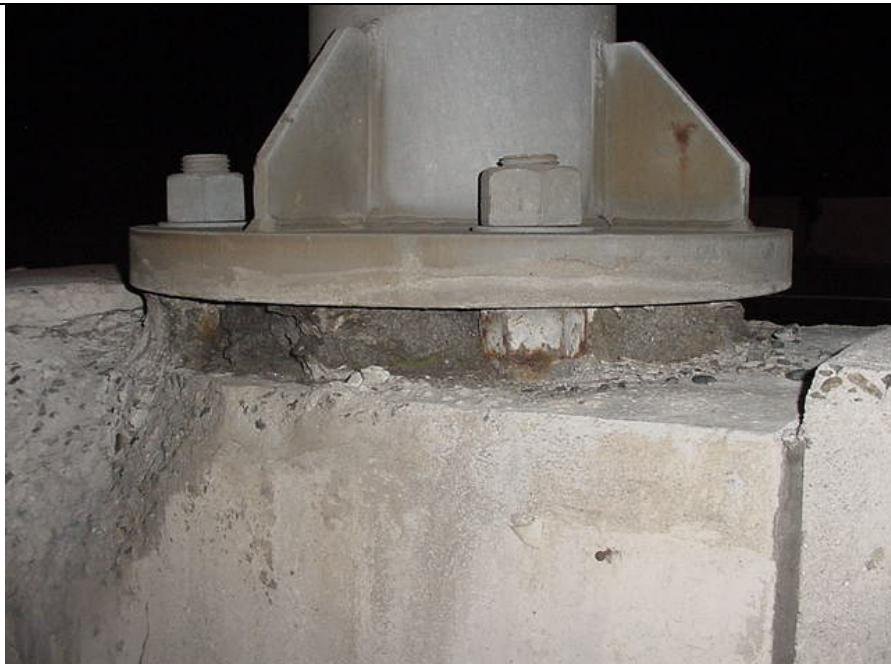
| | <p><b>Figure A2</b></p> <p>Deteriorated Grout Pad<br/>S.01 rate as 3, Priority 2 repair.<br/>Note also leveling nut corrosion (S.02 Item).</p> |

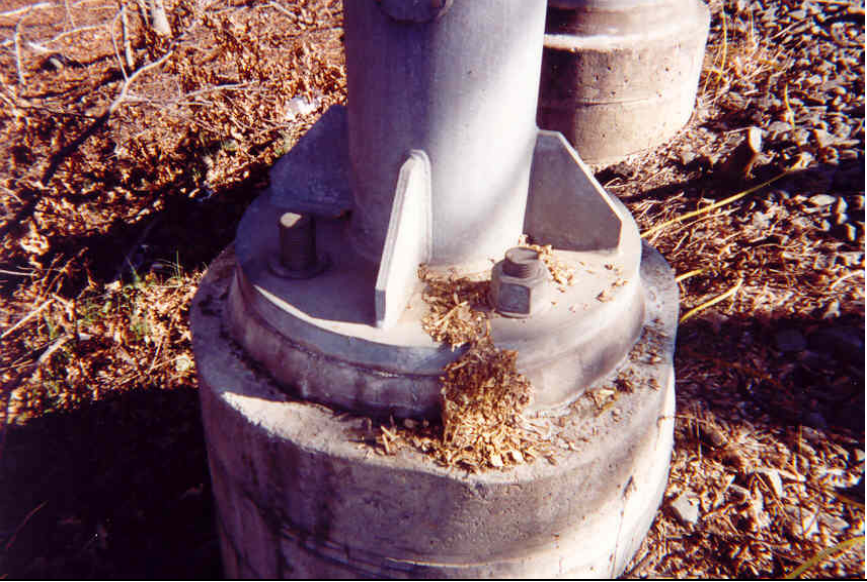
| | <p><b>Figure A3</b><br/>Missing Anchor Nut.<br/>If Span structure, rate as 2, Priority Repair 2. If Cantilever structure, rate as 3, Priority Repair 1.</p> |

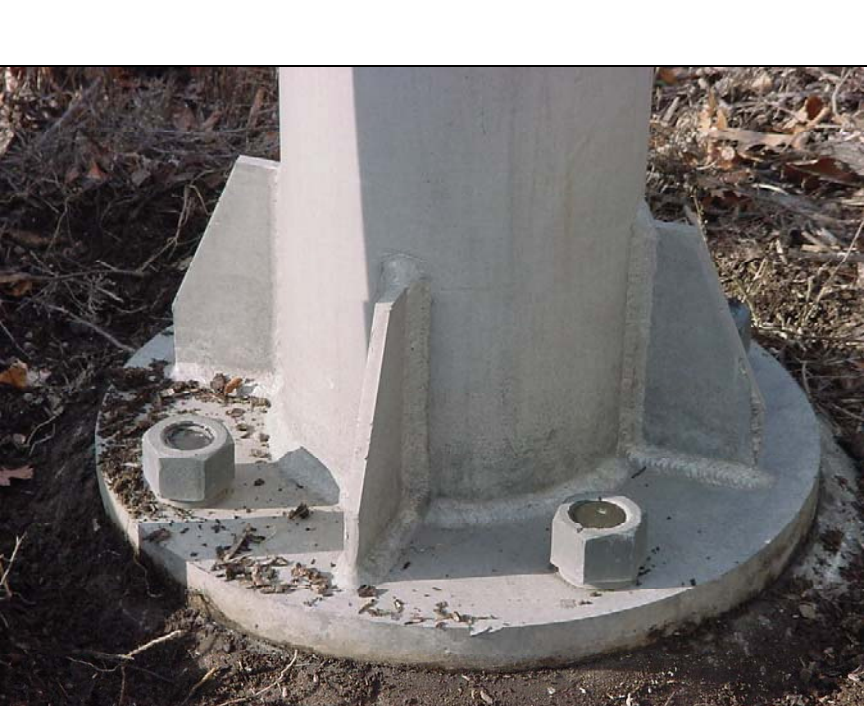
| | <p><b>Figure A4</b><br/>Anchor rods not fully engaged.<br/>If 80% threaded, note on report, rate S.02 as '1', no repair.</p> <p>Loose Nuts (Washers Slip)<br/>Less than 50% slip, rate S.02 as '2', Priority Repair 2.<br/>More than 50% slip, rate S.02 as '2', Priority Repair 1.</p> |

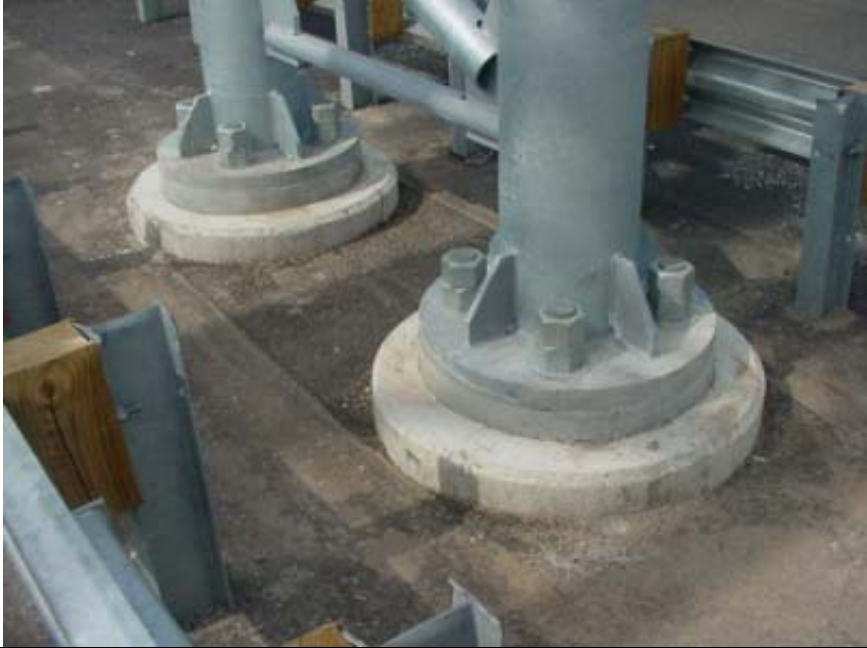
| | <p><b>Figure A5</b></p> <p>Steel Base Plates<br/> Rate as '1', Good Condition<br/> No weld cracks, no cracks in base plate, and no visible warping.</p> |

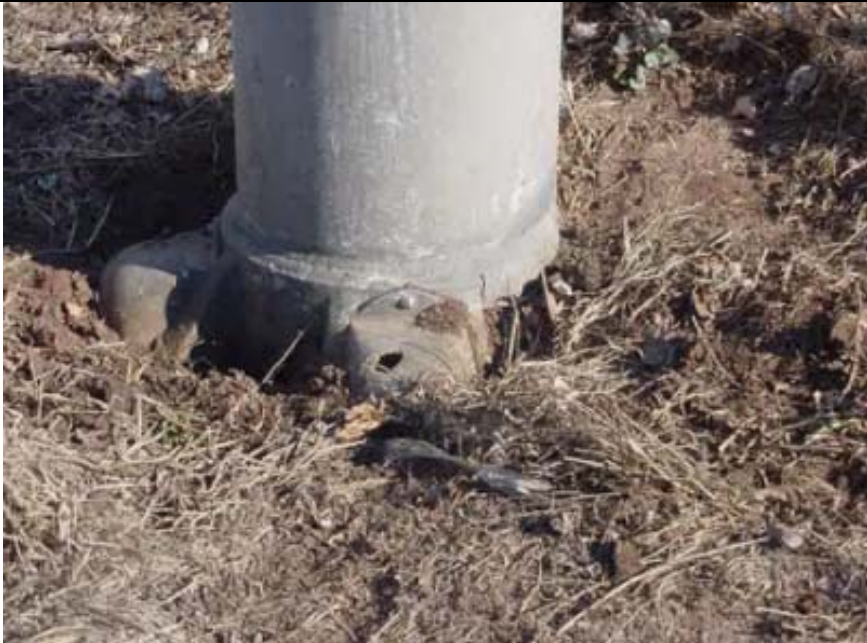
| | <p><b>Figure A6</b></p> <p>Buried Aluminum Base Plate<br/> Rate as '0', Not Applicable.<br/> However, if a span and opposite tower base plate is exposed, rate for that base plate, state in notes buried base plate and recommend as Priority 3 to expose. In any case all buried elements should be exposed per specification/plans.</p> |

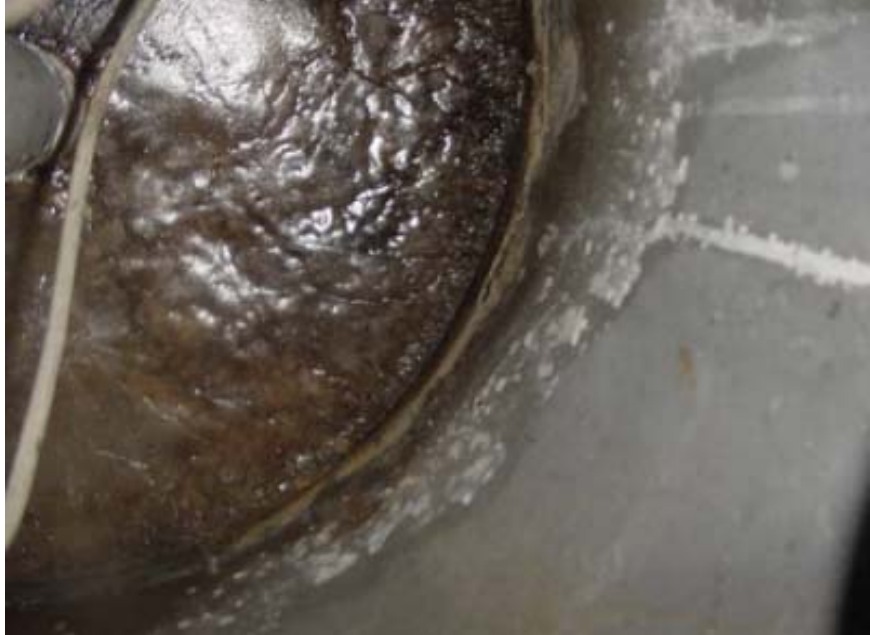
| | <p><b>Figure A7</b></p> <p>1" to 2" Band of surface corrosion at base of post. D-meter results indicate no overall section loss.<br/>Rate 2, Small reduction of reliability.</p> <p>However, if overall section loss in cantilever &gt; 25%, rate 4, repair priority 1.</p> |

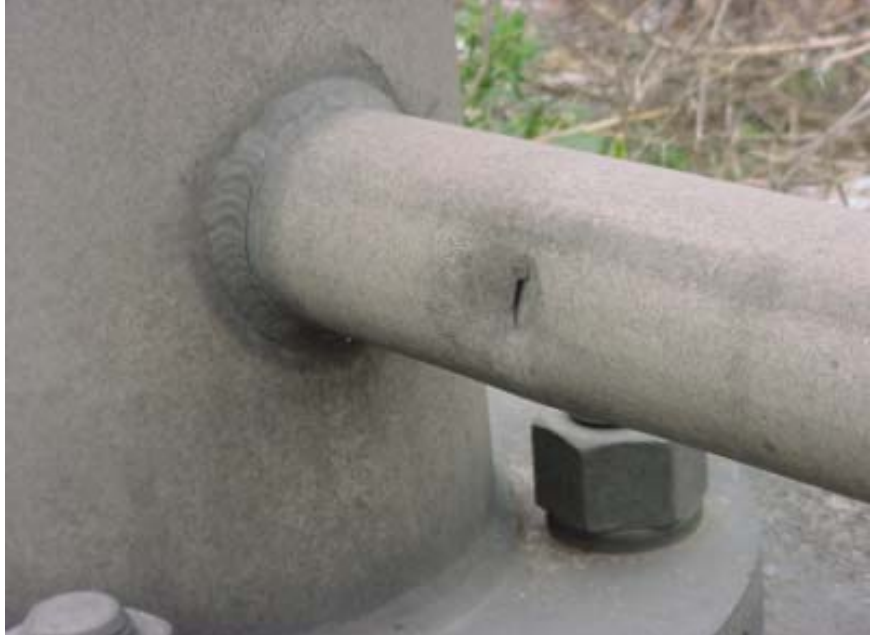
| | <p><b>Figure A8</b></p> <p>Dent, tear, and weld crack in first strut on tower.</p> <p>Rate as 2, Repair on Priority 3 basis.</p> |

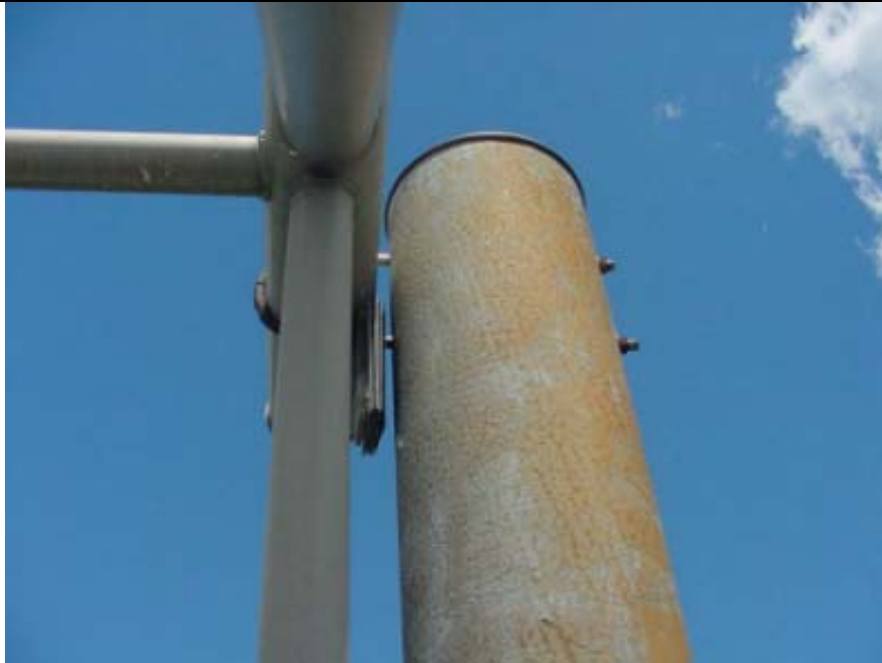
| Tower to Truss/Chord/Arm Connection(s) – S.05 | |
|---|---|
| | <p><b>Figure A9</b></p> <p>Gap between upper chord and shim pack and inadequate shim plate placement.<br/> Rate 2, Repair priority 3.<br/> Repair recommendation would be to properly place and add shim plates as necessary.</p> |

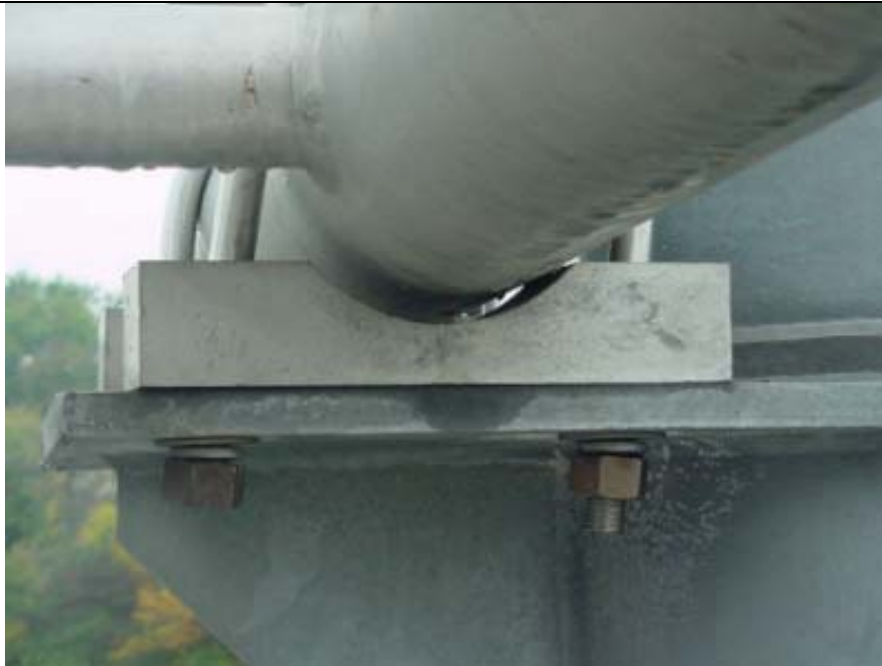
| Tower to Truss/Chord/Arm Connection(s) – S.05 | |
|---|---|
| | <p><b>Figure A10</b></p> <p>Gap between lower chord and saddle block, loose u-bolt.<br/> Rate 2, Repair as priority 3.<br/> Repair recommendation would be to add shims under saddle block to close gap at chord.<br/> The inspector would tighten the u-bolt during inspection.</p> |

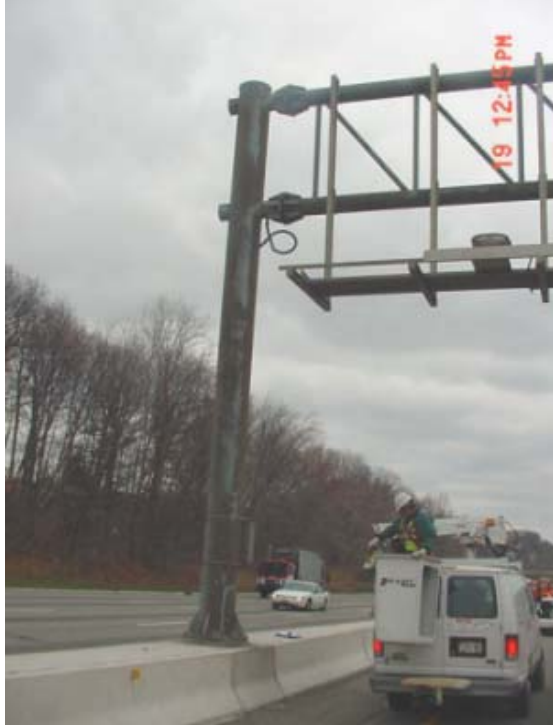
| | <p><b>Figure A11</b></p> <p>Minor surface corrosion observed on dual trussed arms.</p> <p>Rate 1</p> |

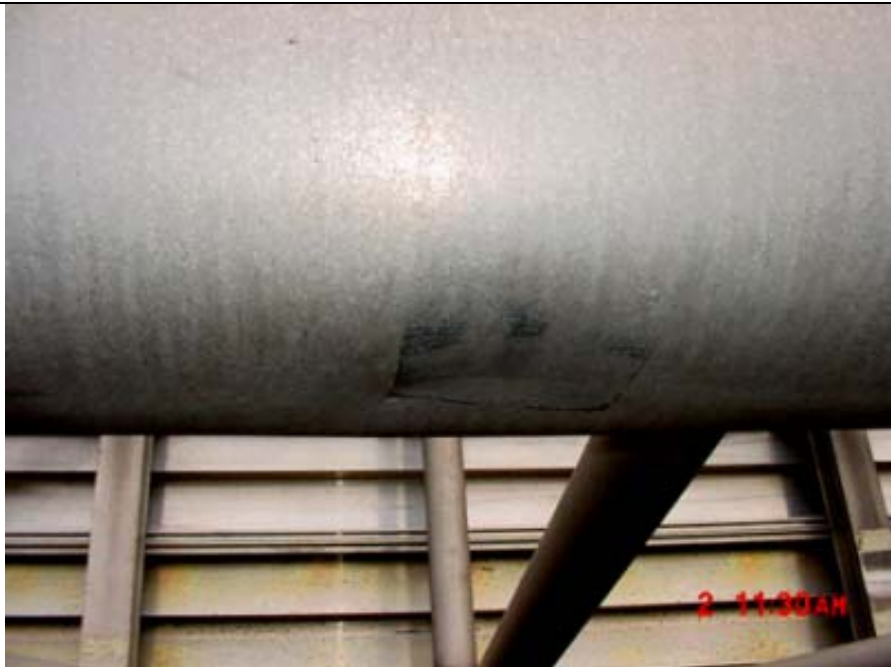
| | <p><b>Figure A12</b></p> <p>Minor 4" diameter ding in lower chord. Right rear end cap missing.</p> <p>Rate 2, Repair priority 3</p> |

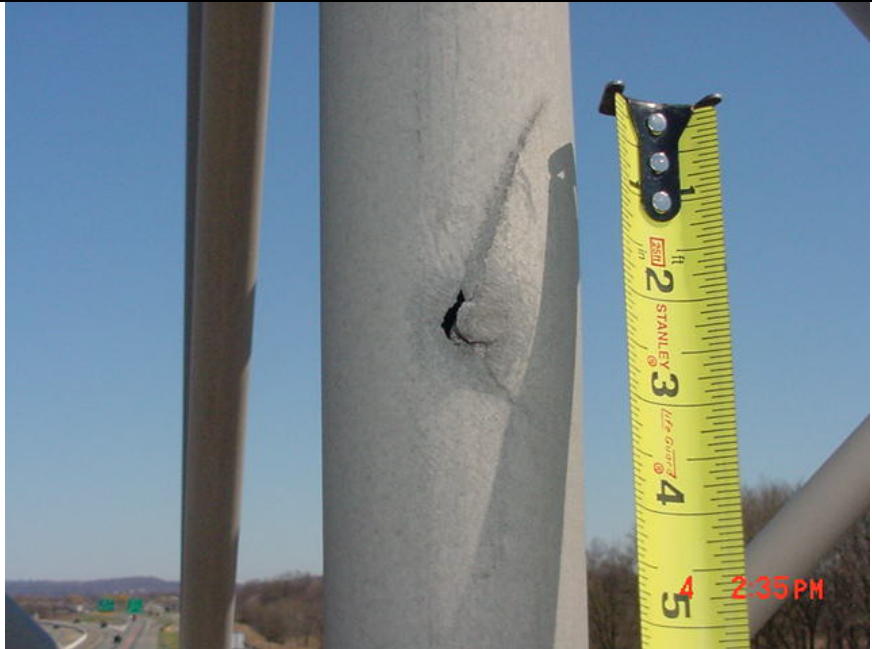
| | <p><b>Figure A13</b></p> <p>1.5" and 2.5" tears in strut member.</p> <p>Rate 3, Repair Priority 1</p> <p>Note: This strut has a cracked weld at the lower chord.</p> |

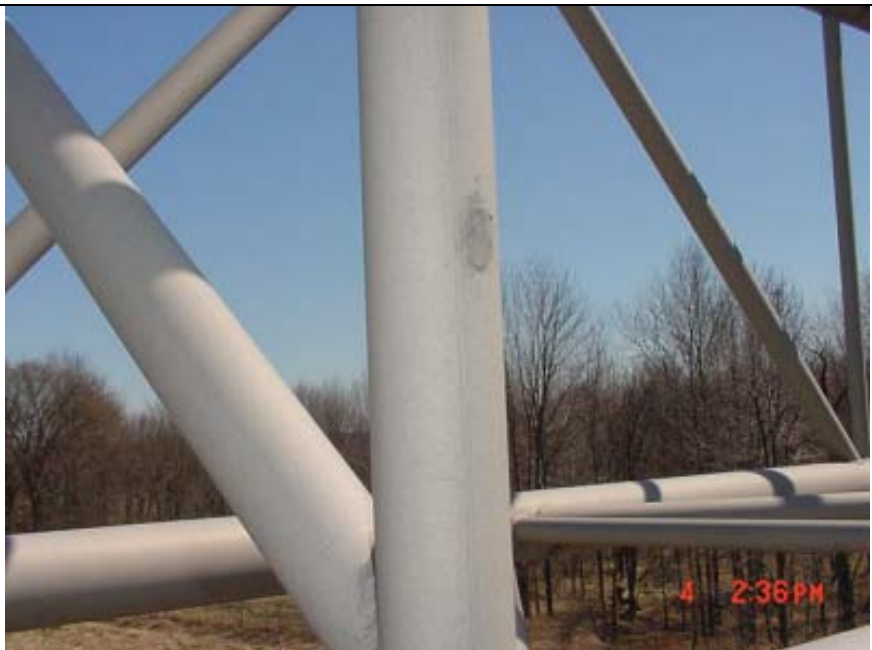
| | <p><b>Figure A14</b></p> <p>2" +/- diameter defect in aluminum strut.</p> <p>Rate 1</p> <p>Note: The rating of 1 is for a structure with no other deficient struts. This structure's struts are actually rated 3 due to this and other deficiencies.</p> |

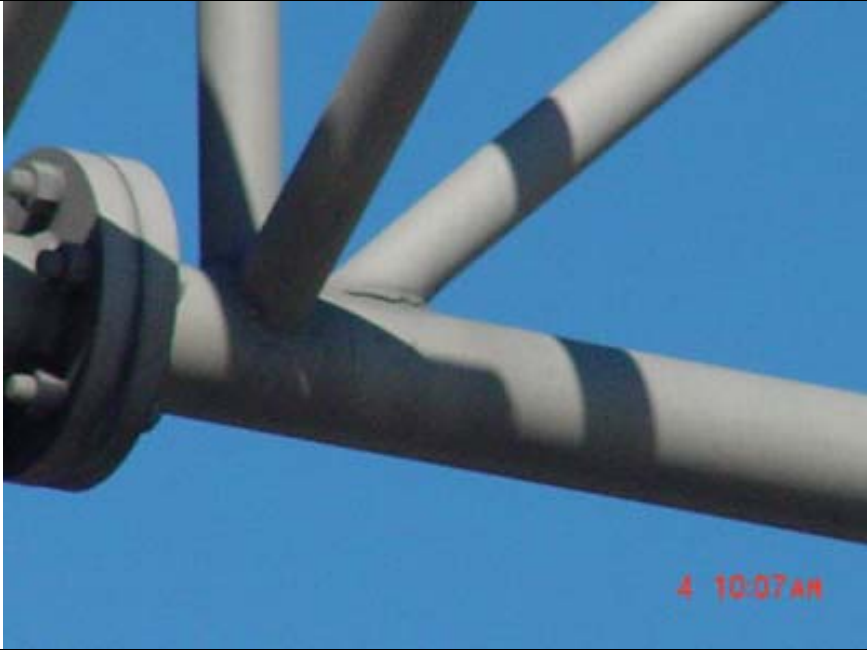
| <p><b>Cracks – S.08</b></p> | <p><b>Figure A15</b></p> <p>Weld crack in member U14 - L15 at L15. The weld crack is approximately 4" long x 1/8" wide and is propagating into the diagonal 1/2".</p> <p>Rate 4, Repair priority 1</p> |

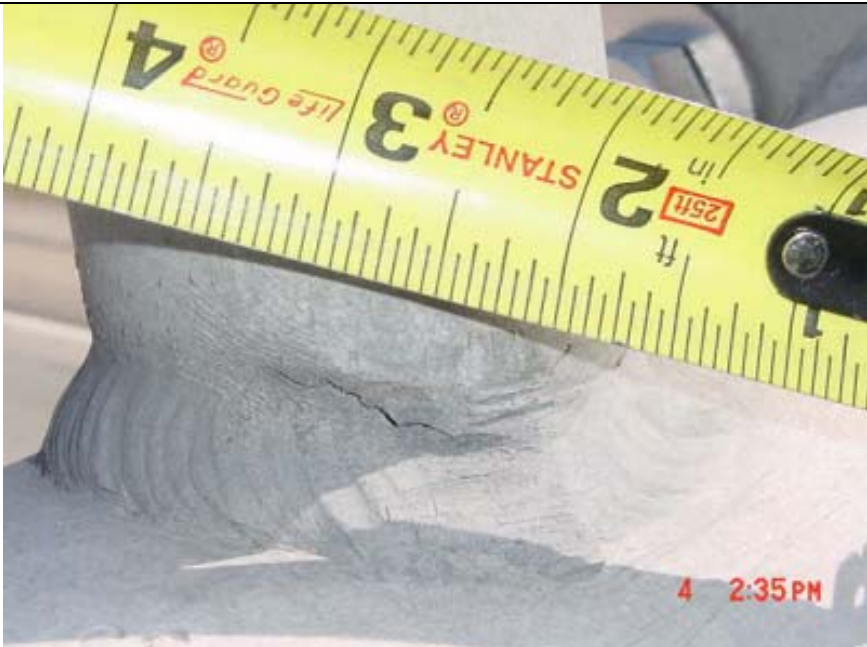
| | <p><b>Figure A16</b></p> <p>1" long weld crack at lower chord.</p> <p>Rate as 3, Repair priority 1</p> |

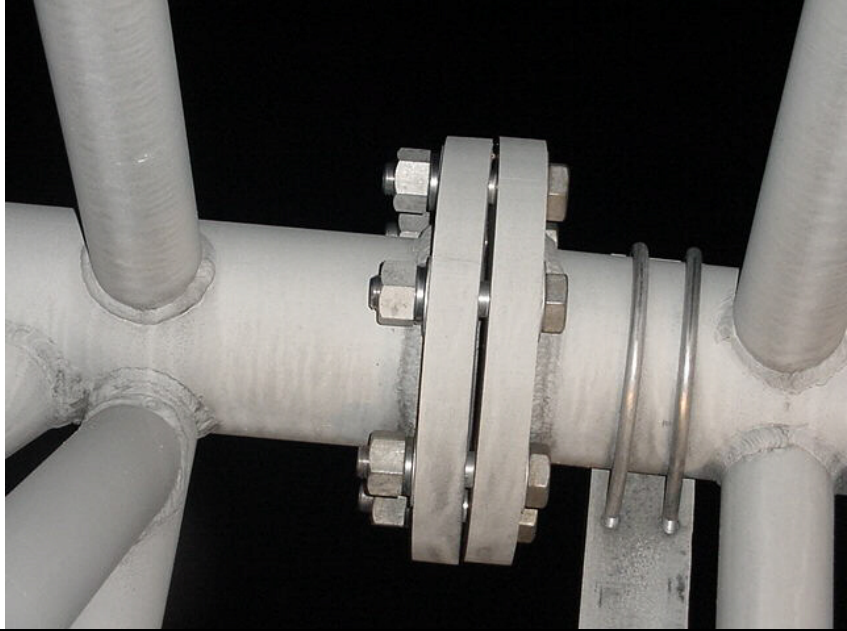
| Chord Splice Connection(s) – S.09 | |
|---|---|
| | <p><b>Figure A17</b></p> <p>Three loose fasteners that could not be tightened by the inspector. Gap in chord splice.</p> <p>Rate 3, Repair priority 2</p> |

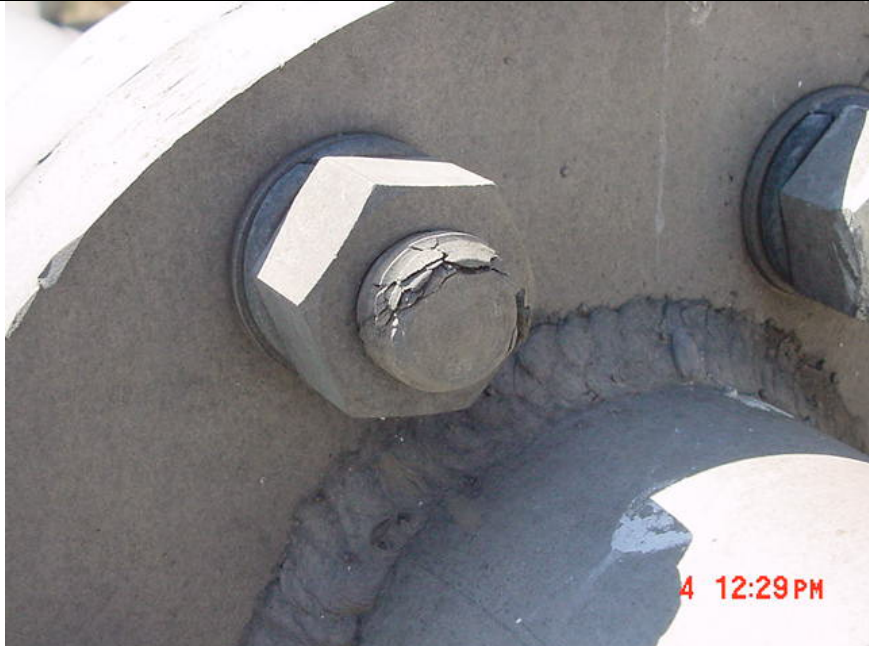
| Chord Splice Connection(s) – S.09 | |
|---|---|
| | <p><b>Figure A18</b></p> <p>One of several severely deteriorated splice bolts.</p> <p>Rate 4, Repair priority 1</p> |

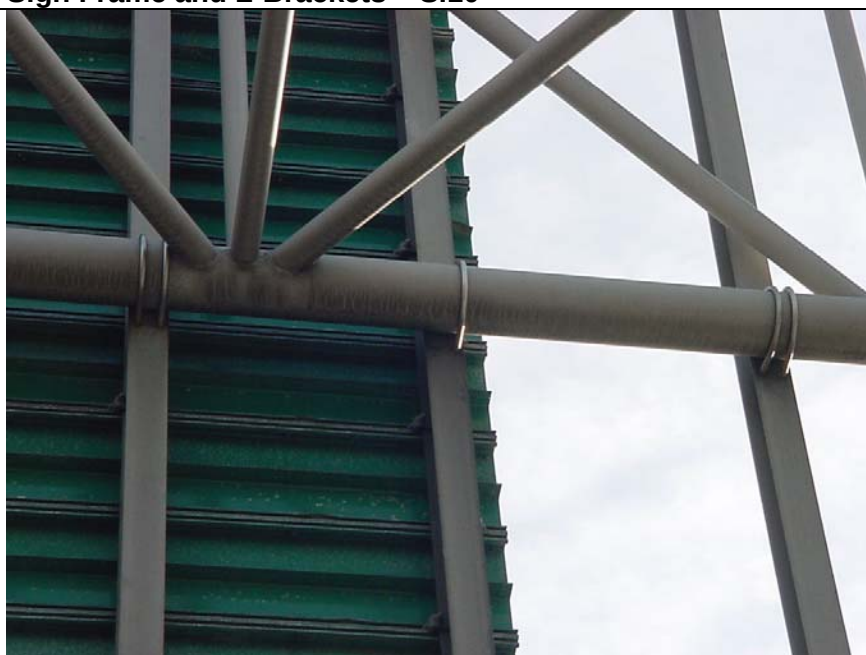
| <p><b>Sign Frame and L-Brackets – S.10</b></p> | <p><b>Figure A19</b></p> <p>Missing one U-bolt at the lower chord to vertical sign member.</p> <p>Rate 1, Repair priority 3</p> |
