# **Guidelines for the Installation, Inspection, Maintenance and Repair of Structural Supports for Highway Signs, Luminaries, and Traffic Signals**

This document provides guidance for the installation, inspection, maintenance, and repair of structural supports for highway signs, luminaries and traffic signals. The primary purpose is to provide owners with information that can assist them in managing their inventory, identifying potential problem areas, and ensuring safe and satisfactory performance of these types of ancillary highway structures. The primary reason for compiling this guidance is increasing problems with wind induced vibration, fatigue, and even structural collapse of these support systems, as seen in Figure 1. Documented problems with these structures include questionable design and details, poor fabrication practices, and poor installation techniques.

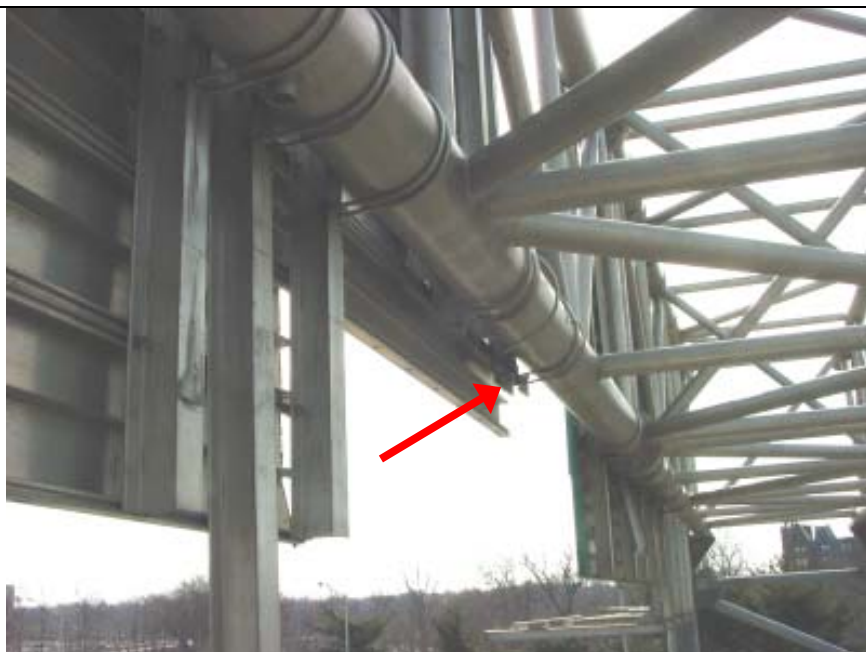
| | <p><b>Figure A20</b></p> <p>Sign 5 exhibits severe impact damage with missing members and hardware. Arrow shows broken bracket.</p> <p>Rate 3, Repair priority 2</p> |

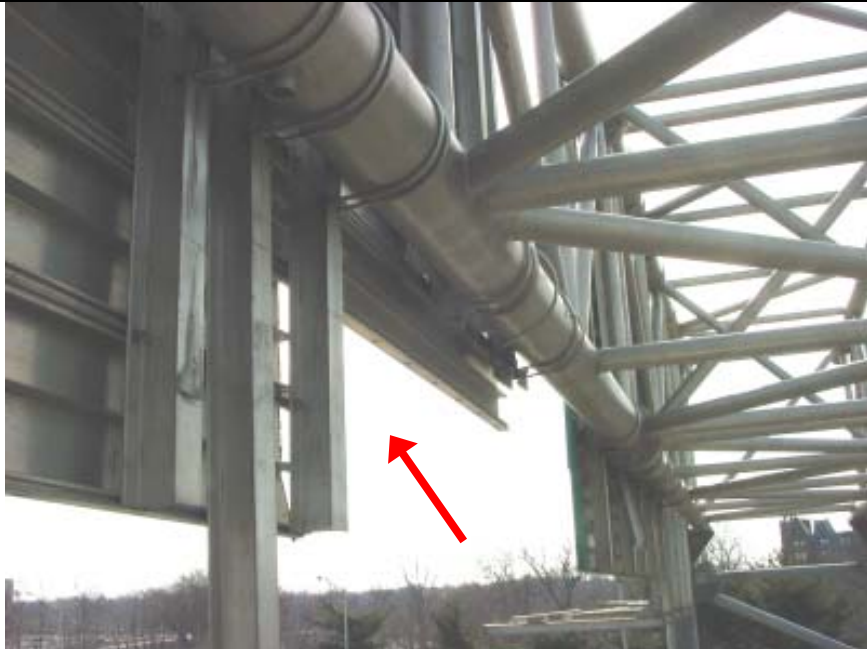
| | <p><b>Figure A21</b></p> <p>Sign 5 exhibits severe impact damage with approx. 1/2 the lower section of the sign panel missing, see arrow.</p> <p>Rate 3, Repair priority 2</p> |

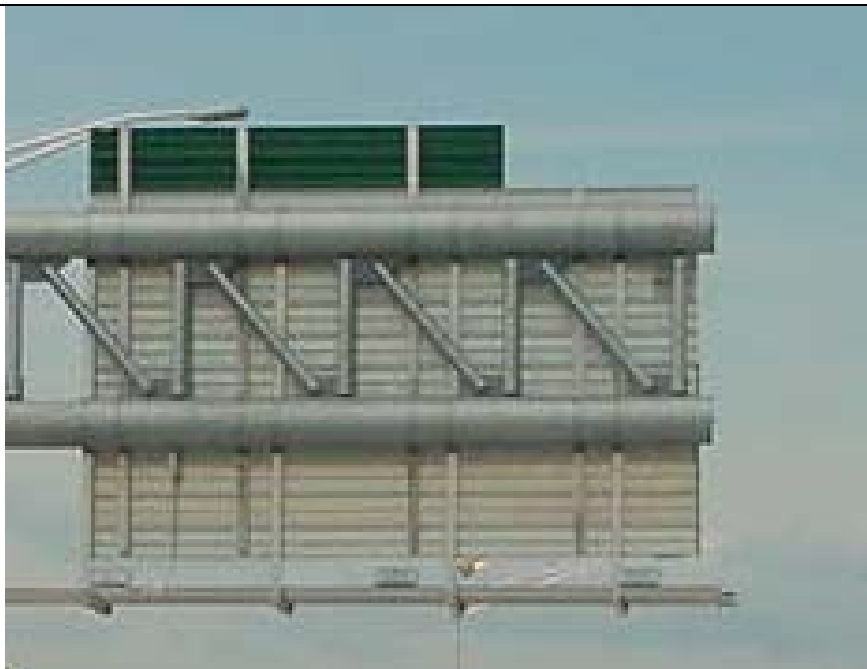
| | <p><b>Figure A22</b></p> <p>Sign panel No. 2 was reused from old sign structure and is in fair condition.</p> <p>Rate 1</p> |

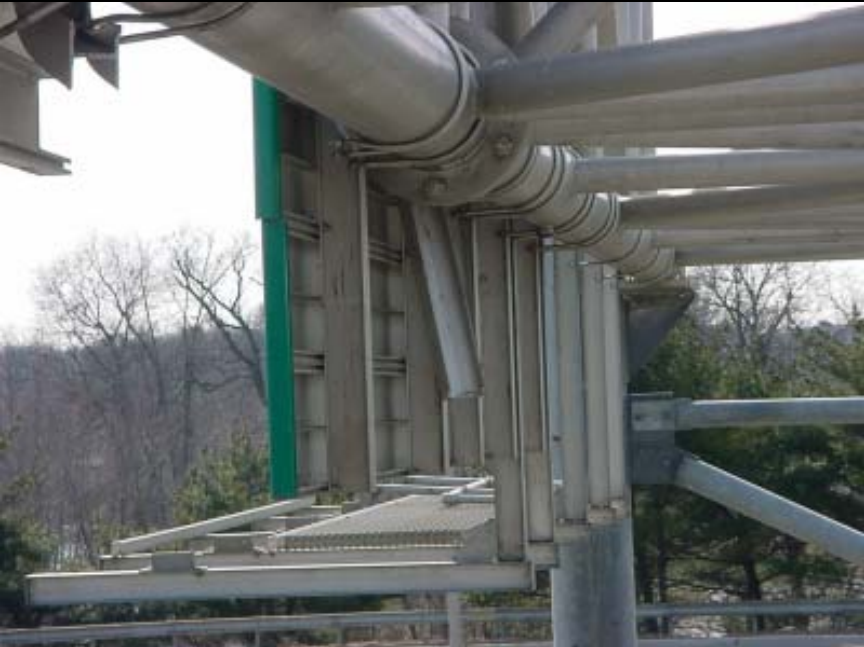
| <p><b>Catwalk – S.12</b></p> | <p><b>Figure A23</b></p> <p>Portion of catwalk over main line above lanes 1,2 and 3 exhibits severe impact damage, and has apparently been removed from this section.</p> <p>Rate 4, Repair priority 3</p> |

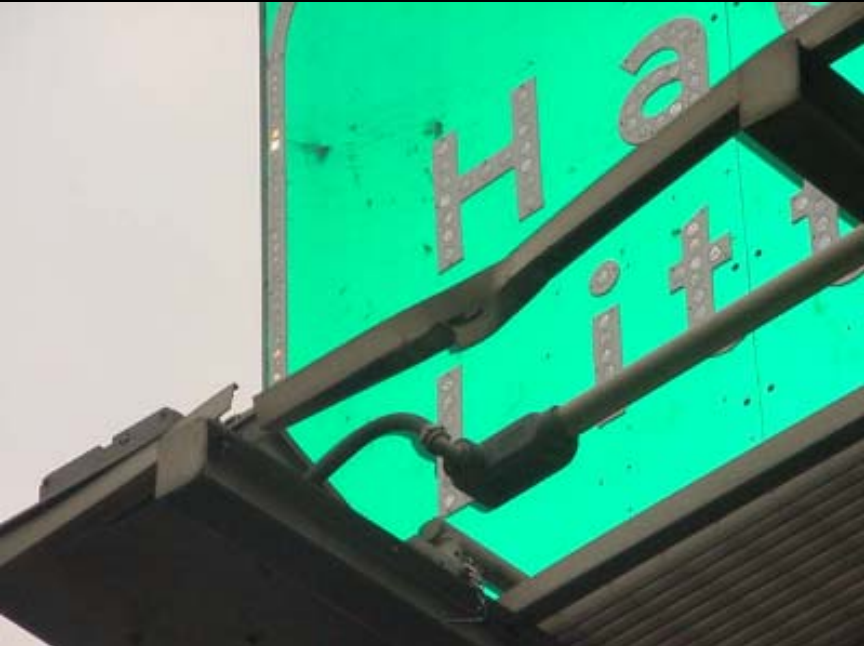
| | <p><b>Figure A24</b></p> <p>The catwalk nosing exhibits moderate impact damage between the left most and middle light fixtures.</p> <p>Rate 2, Repair priority 3</p> |

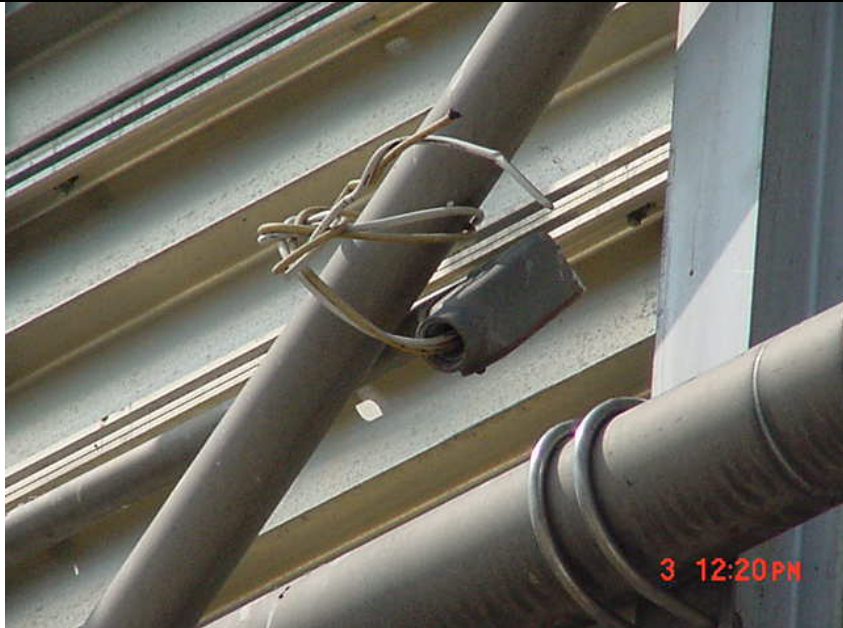
| | <p><b>Figure A25</b></p> <p>Lighting and framework has been removed. A section of abandoned conduit at the center of the truss is held in place by electrical wires on one end and one u-clamp at the other.</p> <p>Rate 0, Repair priority 2<br/>Repair priority 2 due to the inadequate attachment of the abandoned conduit.</p> |

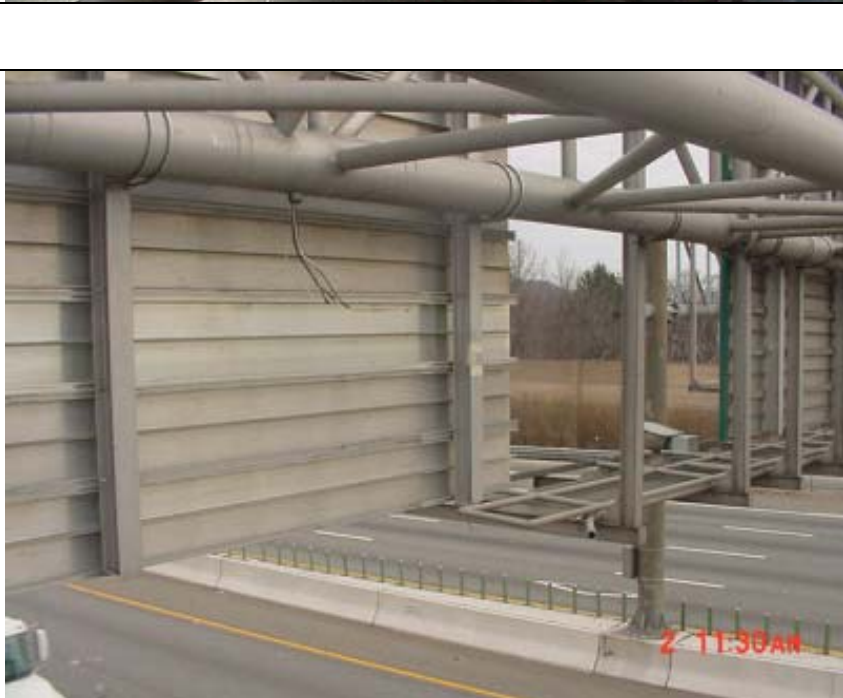
| | <p><b>Figure A26</b></p> <p>Lighting for sign #1 is missing due to impact damage. Exposed wires present.</p> <p>Rate 4, Repair priority 2</p> |

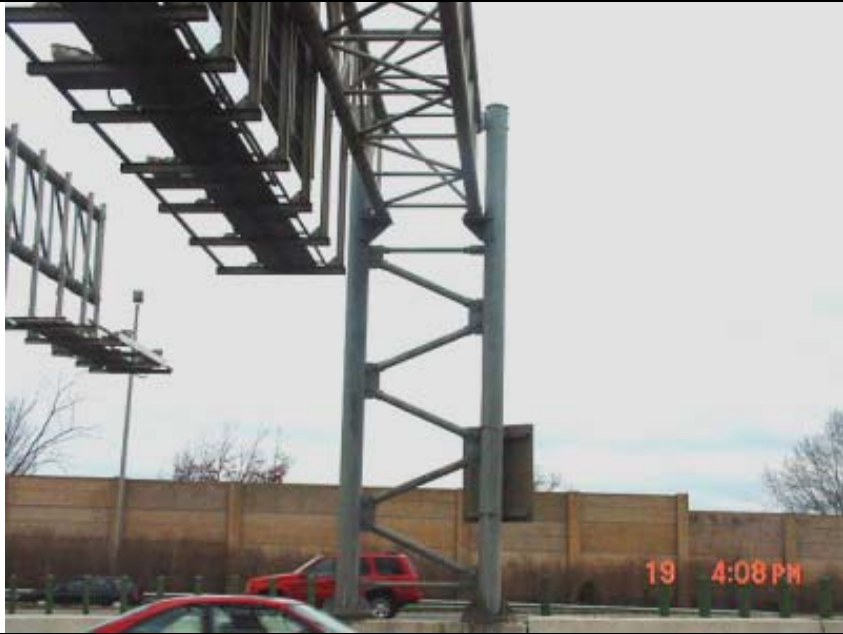
| | <p><b>Figure A27</b></p> <p>Left rear post "No trucks in left lane" sign u-bolts are too large and sign is free to rotate.</p> <p>Rate 2, Repair priority 3</p> |

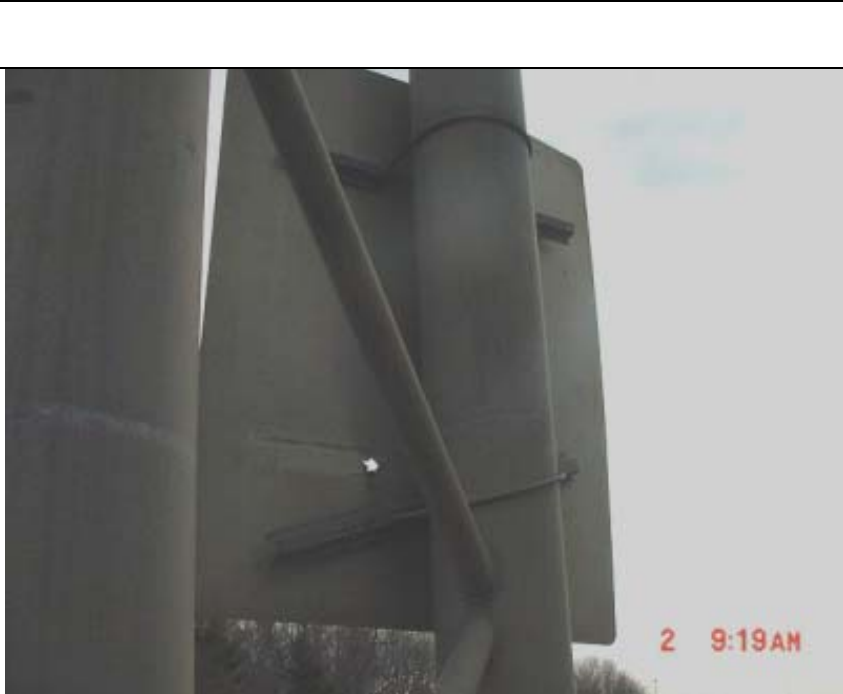
| | <p><b>Figure A28</b></p> <p>"No Trucks In Left Lane" (4' x 5') sign attached to the left rear post (facing the westbound traffic) exhibits moderate impact damage.</p> <p>Rate 3, Repair priority 3</p> |

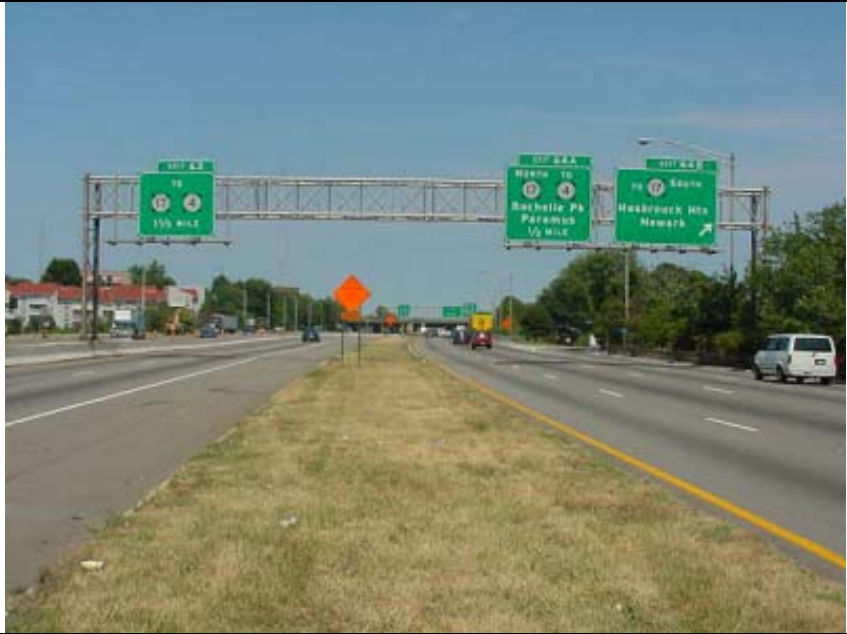
| <p><b>Vertical Clearance, Camber and Alignment – S.16</b></p> | <p><b>Figure A29</b></p> <p>Adequate camber, alignment and vertical clearance over all lanes under span.</p> <p>Rate 1</p> |

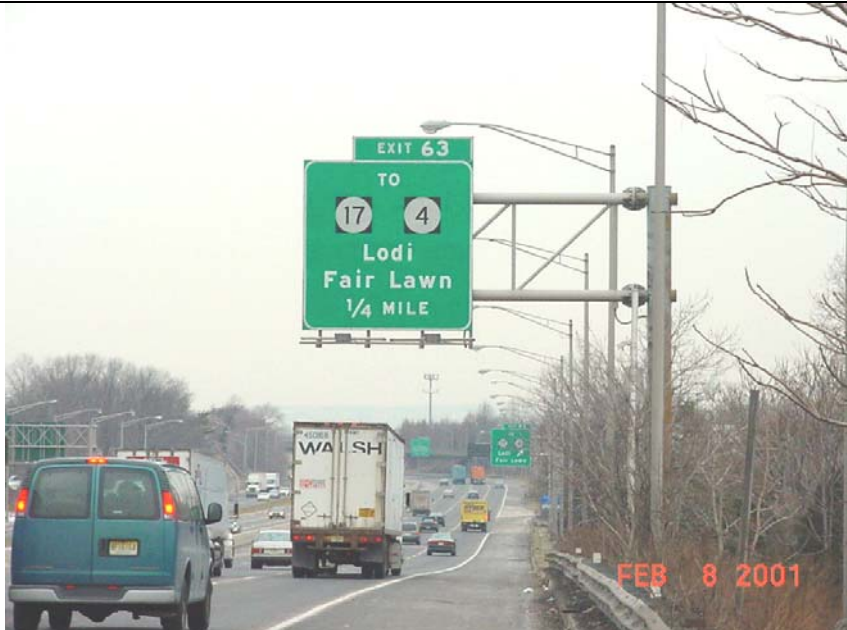
| | <p><b>Figure A30</b></p> <p>Adequate camber, alignment and vertical clearance over all lanes under the cantilever.</p> <p>Rate 1</p> |

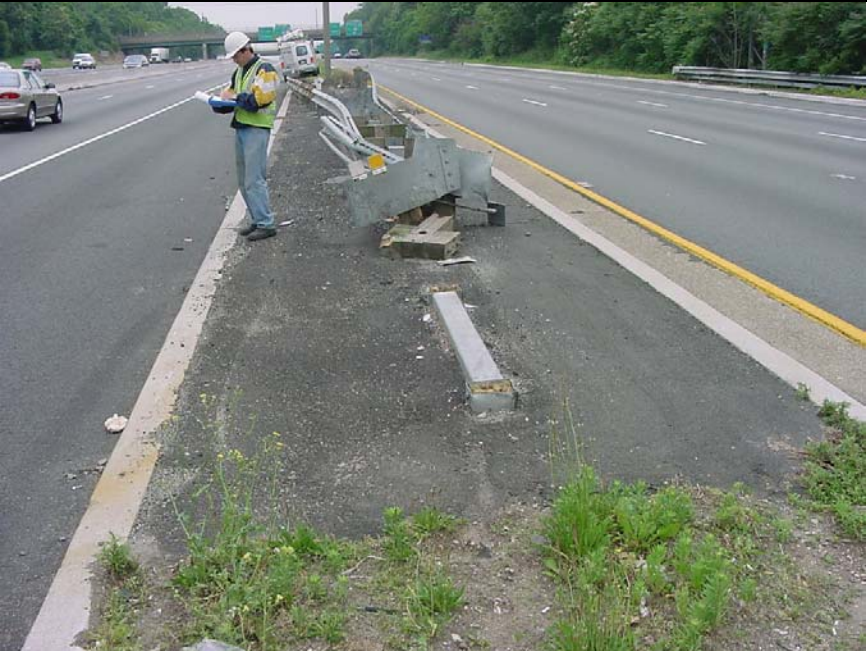
| <p><b>Protection – S.17</b></p> | <p><b>Figure A31</b></p> <p>Severe impact damage to guide rail. Damage to guide rail directly effects the protection of sign structure and motorist.</p> <p>Rate 4, Repair priority 1</p> <p>Note: This guide rail has since been replaced.</p> |

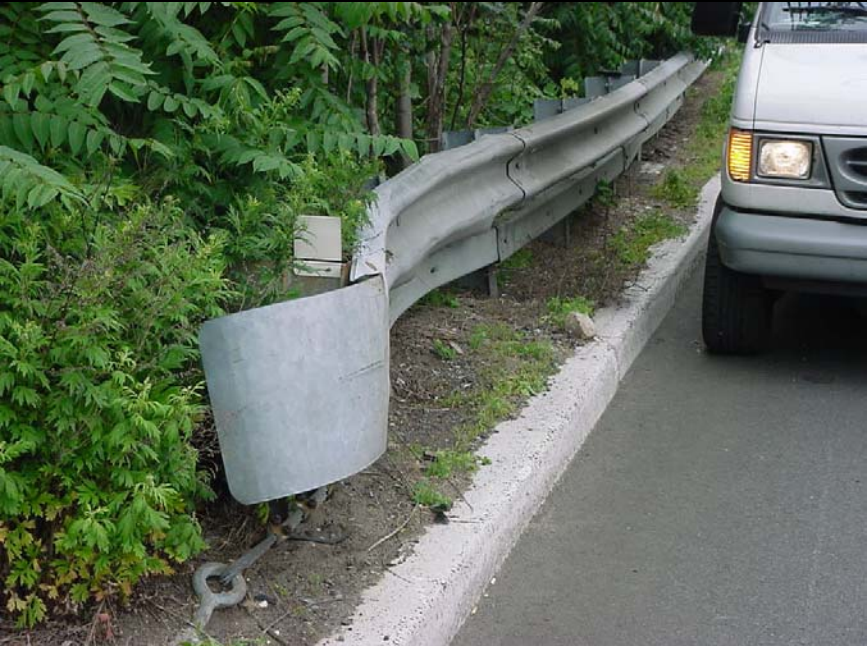
| | <p><b>Figure A32</b></p> <p>Eastbound Loc. Rt Side: Impact damage to guide rail 3yds east of tower. Damage doesn't significantly impact protection of structure or motorist.</p> <p>Rate 2</p> |

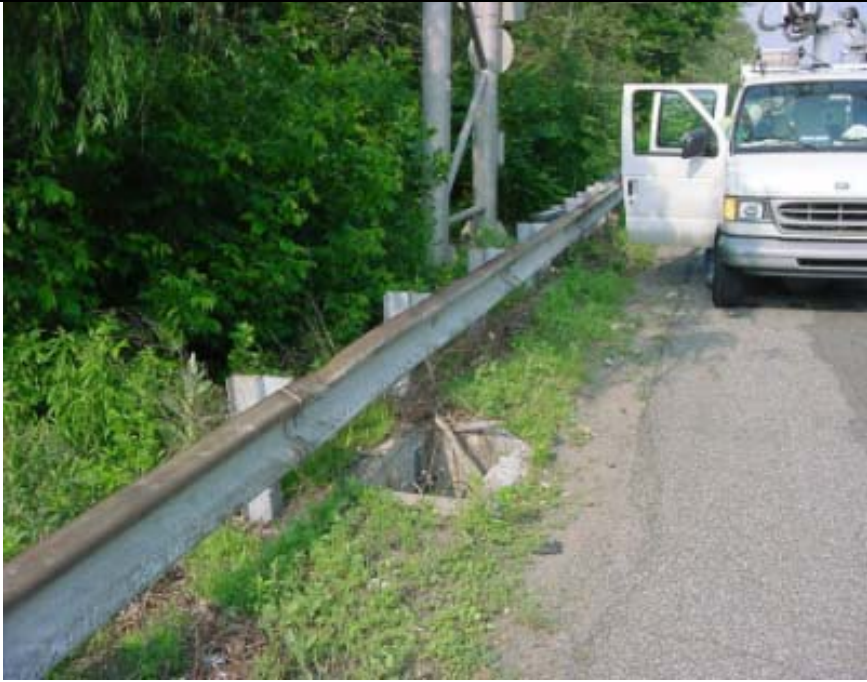
| | <p><b>Figure A33</b></p> <p>24 feet east of sign structure is an abandoned service pit with no cover.</p> <p>Rate 4, Repair priority 2</p> <p>The service pit/vault should be closed to protect the motorists.</p> |

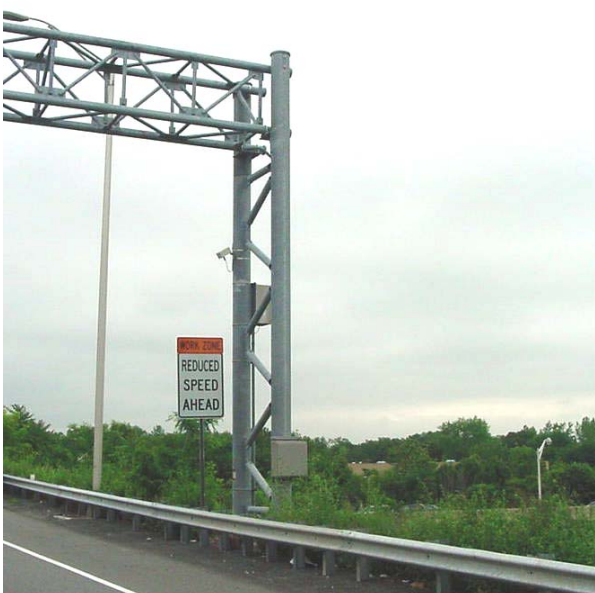
| | <p><b>Figure A34</b></p> <p>RTMS traffic device attached to right rear post.</p> <p>Rate 1</p> |

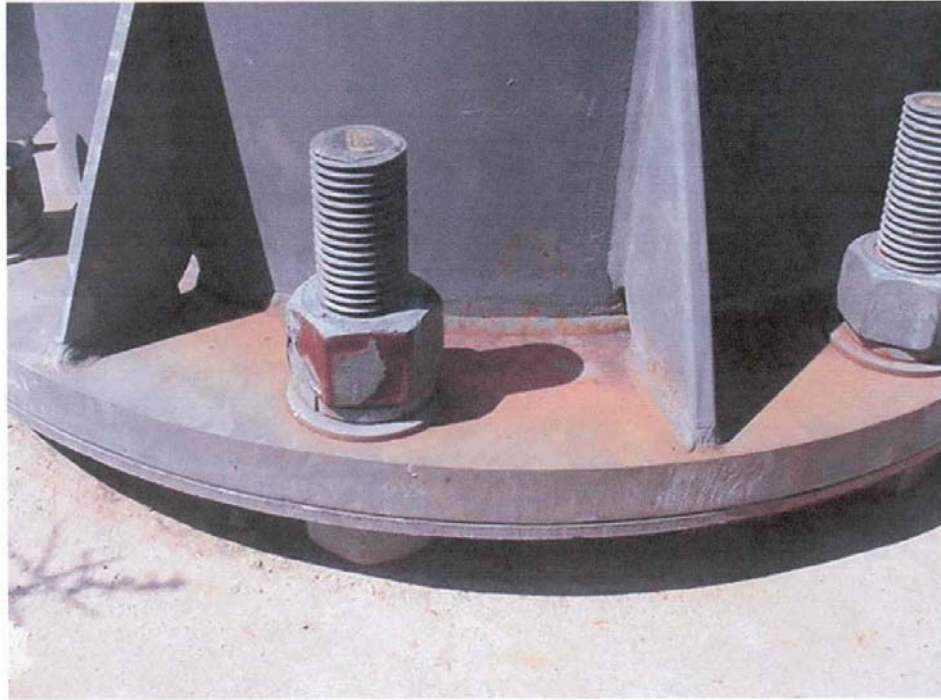
PHOTOGRAPH 5: LIGHT CORROSION ON BASE PLATE
