SURFACE INTEGRITY - A NEW REQUIREMENT FOR IMPROVING
RELIABILITY OF AEROSPACE HARDWARE

by Michael Field

Metcut Research Associates Inc., Cincinnati, Ohio

18th Annual National SAMPE Symposium

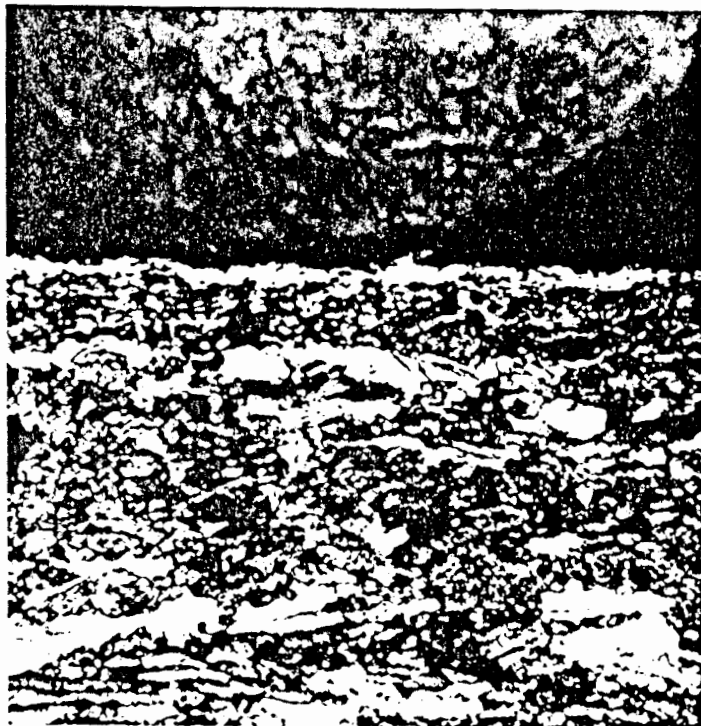
SURFACE CHARACTERISTICS OF
Ti-6Al-4V (Aged, 35 R_c)
PRODUCED BY FACE MILLING

(a) Gentle Conditions - A slight white layer is visible but without detected microhardness change.

(b) Abusive Conditions - An overheated white layer about .0004" deep and a plastically deformed layer totaling .0015" deep are visible. Microhardness measurements show a total affected zone .003" deep.

Additional examples of surface alterations produced by conventional machining are shown in Figures 4 and 5. When abusive drilling of aged 18% nickel maraging steel, 52 R_C an overaged resolutioned layer .001 in. deep was produced at the surface. The hardness of the layer was 37 R_C, Figure 4. Abusive milling of Ti-6Al-4V produced an overheated surface layer about .0015 in. deep. This surface layer was 12 points softer than the base metal. Abusive machining can also produce cracks, laps and tears, or crevice-like defects, see Figure 6.

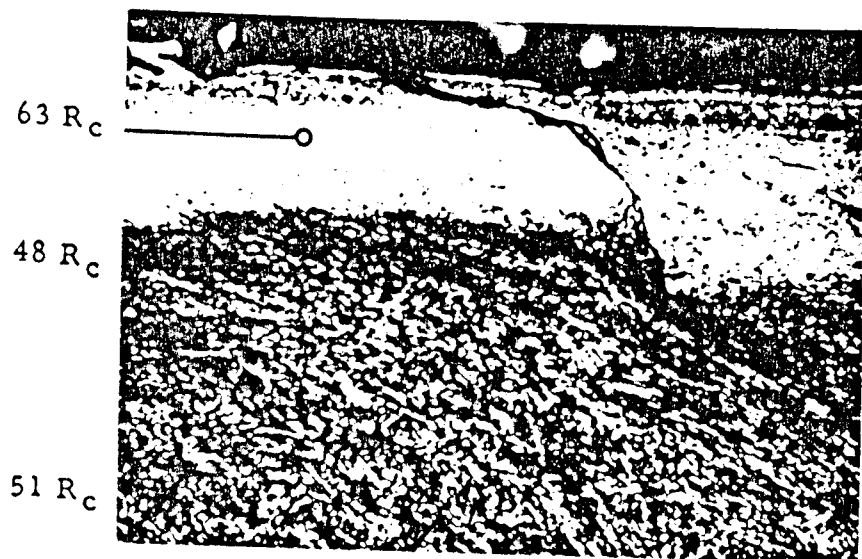
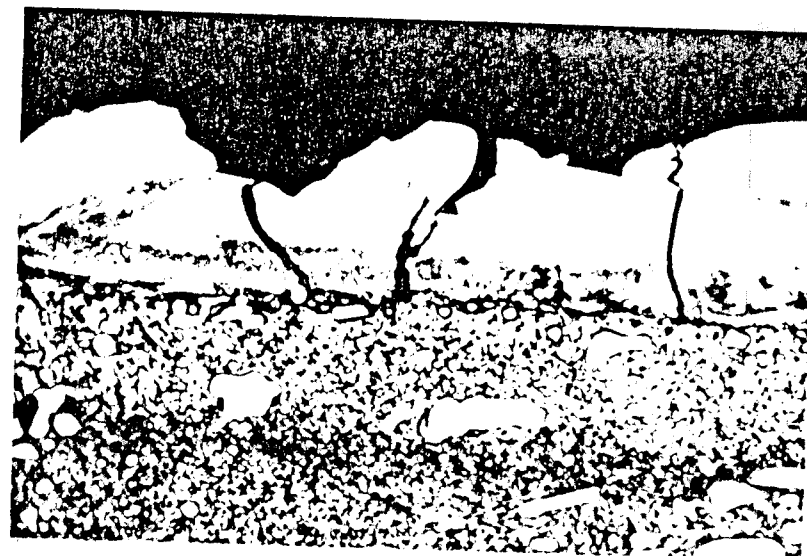
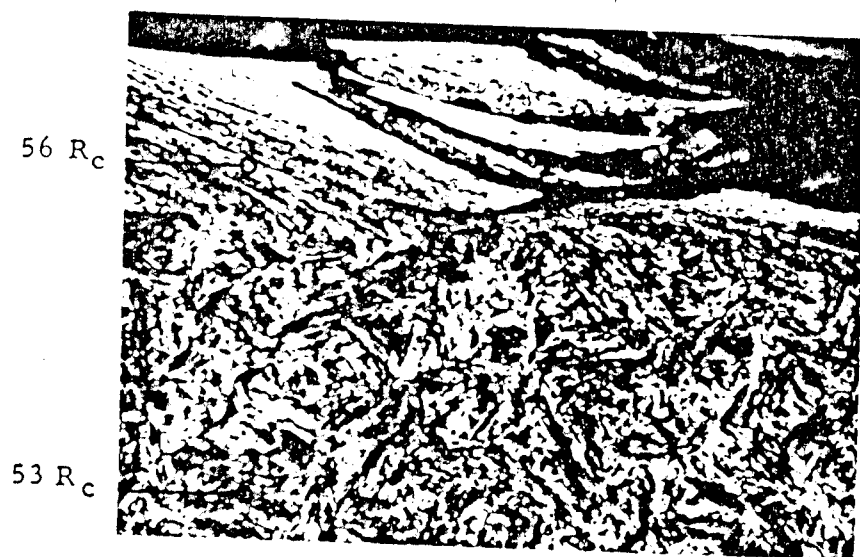
SURFACE ALTERATIONS PRODUCED BY ABUSIVE MACHINING

Drilling 4340, 51 R_c , with Dull Drill
White (Untempered Martensite) Layer

EDM on D2 Tool Steel, 61 R_c
Redeposited Metal on Surface

Reaming 4340, 53 R_c , with Dull Reamer
Tears from Built-Up Edge

ECM of Waspaloy, Aged, 40 R_c
Intergranular Attack

Electrical discharge machining (EDM) tends to produce a surface which contains a layer of recast spattered metal which is usually hard and cracked. This recast metal is generally quite porous and in many cases contains cracks. The cracks sometimes extend into the base metal, see Figures 6 and 7. Below the spattered and recast metal, it is possible to have the same

Electrochemical machining (ECM) is capable of producing a surface which is essentially free of metallurgical surface layer alterations. However, when ECM goes out of control, selective etching or intergranular attack can occur, Figure 6. Abusive (out-of-control) ECM conditions also tend to promote surface roughness. Accidents in ECM can also lead to dangerous surface alterations. A short circuit between the electrode and the work can cause extreme overheating and intergranular cracks. Electrochemical machining also has a tendency to produce a soft layer at the surface. Surface softening of .001 in. to .002 in. deep is also produced by electropolishing and by chemical milling.
