AFWAL-TR-80-4005

**EFFECTS OF MULTIPLE SHOT PEENING/CADMIUM PLATING ON HIGH STRENGTH STEEL**

*METCUT RESEARCH ASSOCIATES INC.  
3980 ROSSLYN DRIVE  
CINCINNATI, OH 45209*

TECHNICAL REPORT AFWAL-TR-80-4005  
Final Report for period 15 September 1978 — 15 December 1979

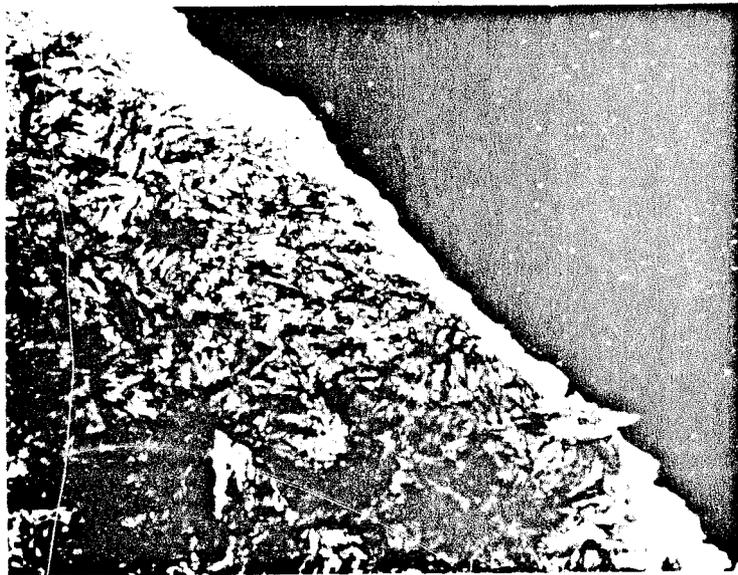
Figure 11 - Microstructural features observed on fatigue Specimen 71 (Cycle 1)

Top: Surface alterations at origin areas (View A)  
Bottom: Surface alterations at corner (View B)

Etchant: Nital

<u>Specimen Number</u>	<u>Failure Location</u>	<u>Surface Features</u>
71; Cycle 1	Corner	<u>At origin area:</u> white deformed layer. <u>Corner cross section:</u> thin discontinuous white layer, instances of deformed metal, slivers and microcracks.
31; Cycle 5	Corner	<u>At origin area:</u> microcracks; deformed layer. <u>Corner cross section:</u> similar features as above but more severe overall.
48; Parent	Side	<u>At origin area:</u> no damage, but few isolated instances of light etching deformed layer and slivers were noted on the surface away from origin.
76; Cycle 2	Corner	<u>At origin area:</u> no obvious damage. <u>Corner cross section:</u> few isolated slivers and deformed scallops.
7; Cycle 5	Side	<u>At origin area:</u> thin white layer; incipient fatigue crack associated with scallops of deformed metal, white layer and laps.
93; Parent	Side	<u>At origin area:</u> no damage; but isolated instances of light etching deformed metal and microcracks were observed away from origin.
