Thermal Stability of residual stress induced by heavy deformation on SUS316L Stainless Steel

ABSTRACT

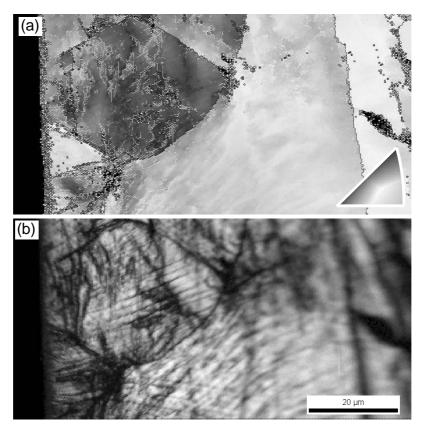
Cross sectional view of the shot peened specimen is shown in Fig. 1, in which the left side is the shot peened surface. Distribution of crystal orientation is shown in (a) as an inverse pole figure (IPF) map, while crystal lattice imperfection is shown in (b) as an image quality (IQ) map. Dark contrast in IQ map corresponds to strained region, so the straight sharp lines and diffused line would be slip bands and sub-boundaries, respectively. Such crystal defects cause gradations in color in the IPF map (a). The surface region are highly strained, while slip bands are observed up to about 80 μm in depth from the surface.

Fig. 1 SEM-EBSP analysis on the cross section of the shot peened specimen. (a) IPF map, and (b) IQ map.

In order to evaluate the residual stress at different depth from the shot peened surface, SR diffraction analyses were carried out with changing the incident bema angle to the surface from 3 to 25 degrees. Calculation showed that the depth of the gauge volumes were about 0.3, 1.0 and 2.0 μm when the incident beam angles are 3, 10 and 25 degrees, respectively. Plots of $2\theta\text{-}sin^2\psi$ obtained with each condition are shown in Fig. 2. The residual stresses near the surface with 0.3 and 1.0 μm are similar one another, while the value obtained at 2 μm depth was larger by a factor of two than those for surface regions. Stress would be relieved near the surface. Although strained image was observed by SEM-EBSP analysis (Fig. 1), it shows deeper areas than those measured by SR diffraction method.

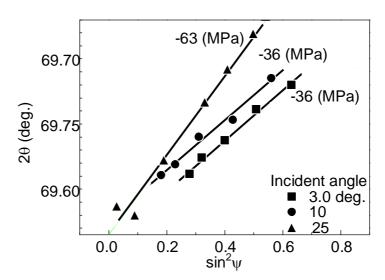
Fig. 2 2θ -sin² ψ plots for the areas near the shot peened surface. Incident angle of 3, 10 and 25 correspond to 0.3, 1.0 and 2.0 mm depth, respectively.

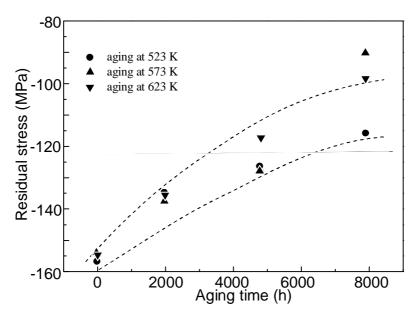
The compression residual stress is due to metal flow induced by shot peening, and the metal flow is caused by dislocation motions and multiplications to form a dislocation substructure which would be recovered by heating. The temperature of the water around the shroud, 561 K, seems to be relatively low, however it is in the temperature range for tempering steels in practical processes. Changes in residual stress in the shot peened specimens during aging at 523, 573 and 623 K are shown in Fig. 3. The compression stress was decreased with increasing aging time at all the temperatures.

Fig. 3 Change in residual stress on the specimens aged at various temperatures.

The decrease in stress tends to be saturated except the highest value on the specimen aged at 537 K for 8000 h, because the dislocation substructures become stable at each temperature. Recovery of the dislocation substructures are caused by self diffusion of iron, volume diffusion of nickel and chromium. However, diffusion
