# Cautionary Tale: Marketing of Extension Springs

The best way to market extension springs is to claim that your company's springs outperform your competitors'. If this marketing is based upon research results, it should be sound. However, very little research has been done to quantify the performance of extension springs until now. A systematic study of extension spring loops has been conducted within Techspring, a European research project of which I was the project manager.

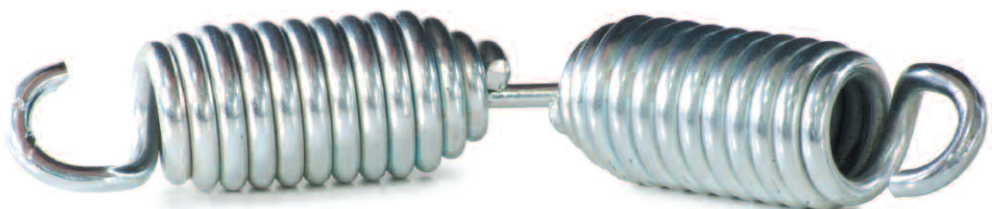
Figure 1 Fatigue fracture always occurs in this region

better than those that did not. In other words, when the end hooks protruded outside the space envelope made by the body coils, the hooks failed prematurely on test. When the loops protruded, the springs "rocked and rolled" on the bench. While rock 'n' roll has its place, it is not best for extension spring life. The research results were very similar for English or German loops for extension springs of index 8 and larger, when these hooks were accurately made. So claims A and B cannot be justified. Many think that the sharp bend required to form the English loop is a stress raiser, and indeed it is (especially when the index is small), but this is not the position of maximum stress. The loops all failed at the position shown in figure 1, whether they were German or English loops.

The bending stress at the failure position should be calculated. The Techspring project studied the formula used by IST, which is as follows:
