# Prevention of Fatigue Failure

**Alten F. (Skip) Grandt, Jr.**

**School of Aeronautics and Astronautics**

**Shot Peening and Blast Cleaning  
Workshop**

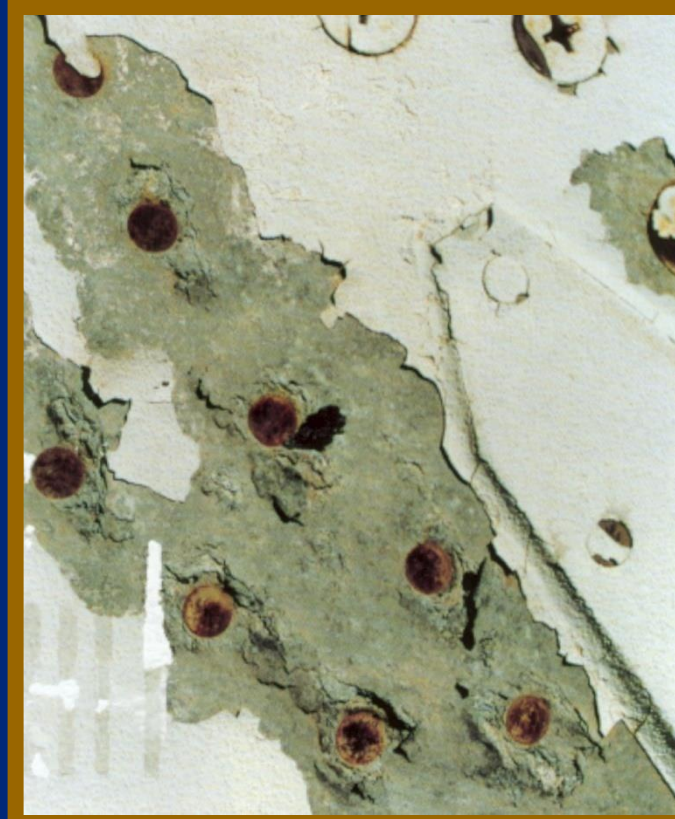
- Time dependent chemical reaction between material & environment
- Many forms: uniform, pitting, galvanic, stress corrosion, hydrogen embrittlement
- Causes general and/or local material loss
  - thickness loss > increased stress
  - local pits > stress concentrations
- Prevent by design, coatings, material selection
- Maintenance critical

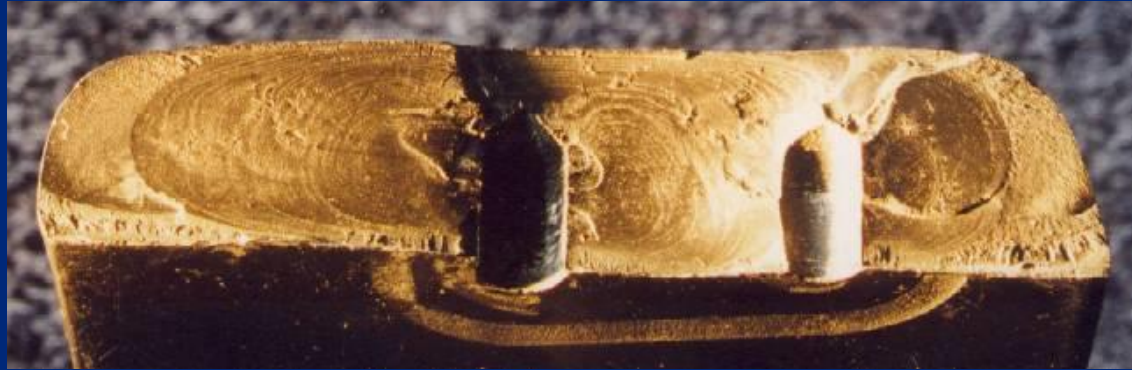
# Fatigue Failure of Toilet Seat

## Note:

- Fatigue cracks started at stress concentrations
- Characteristic beach marks

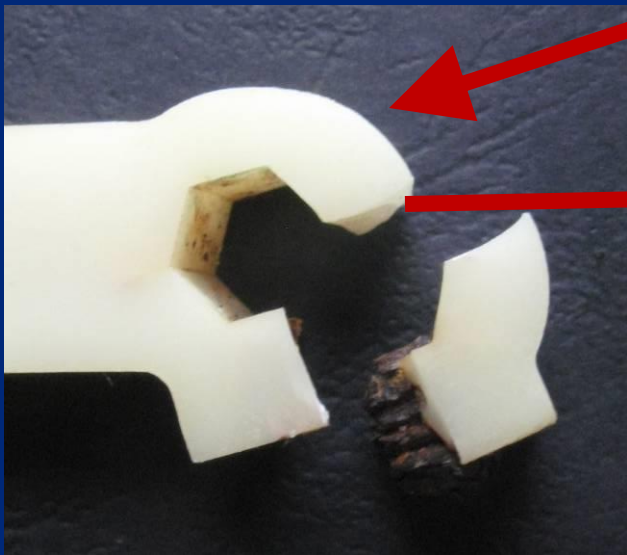
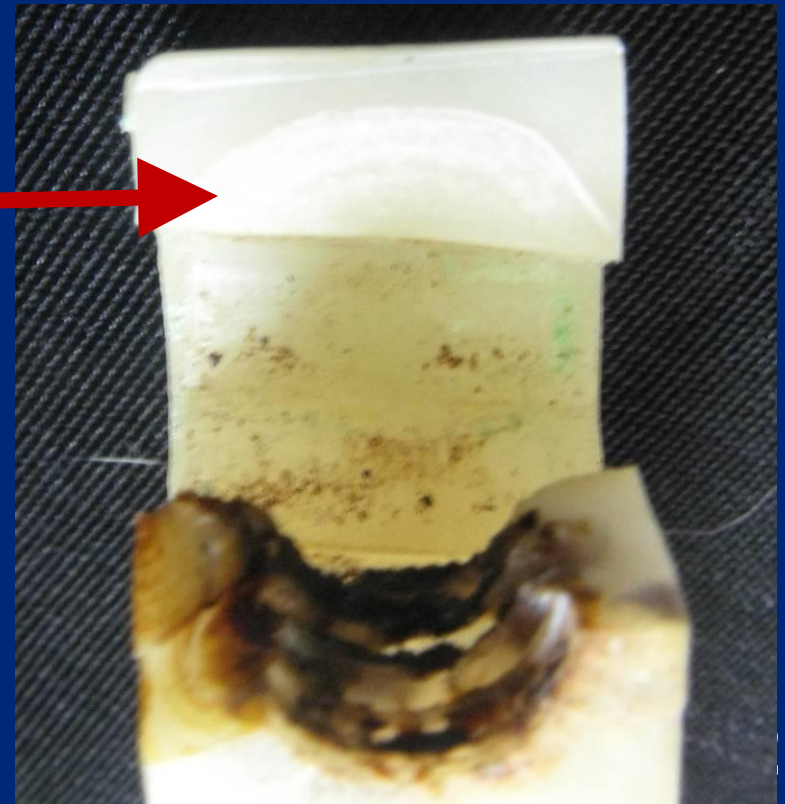
Note beach marks on fracture surface

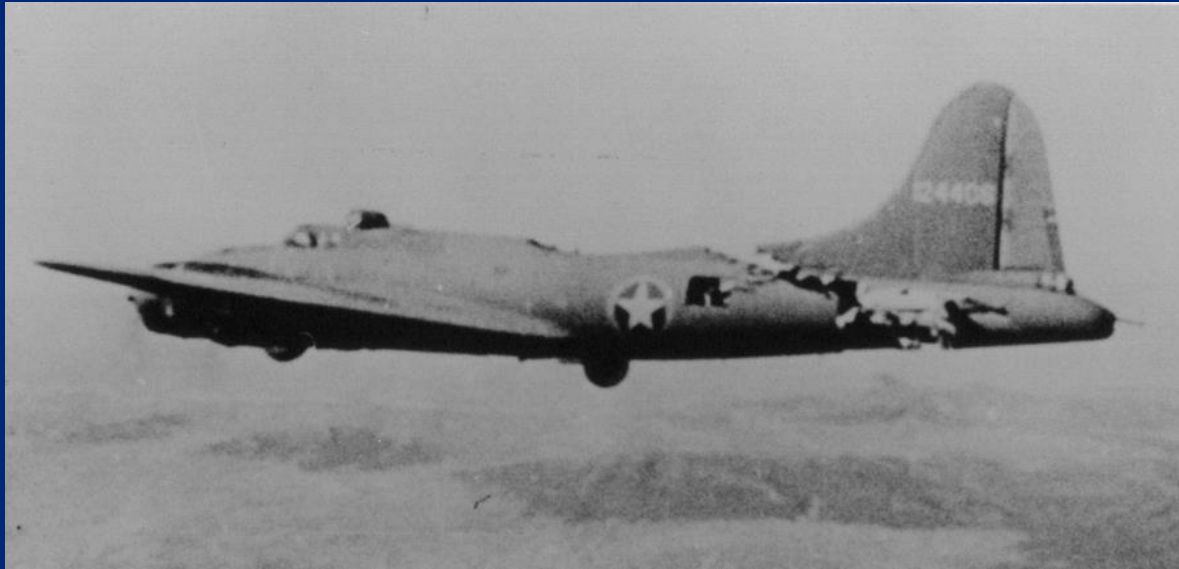
**Fig. 1.1 USAF Museum photographs**

**B-17F/Bf-109 midair collision on February 1, 1943 over Tunisia**

**B-17 flew 90 minutes and landed safely**

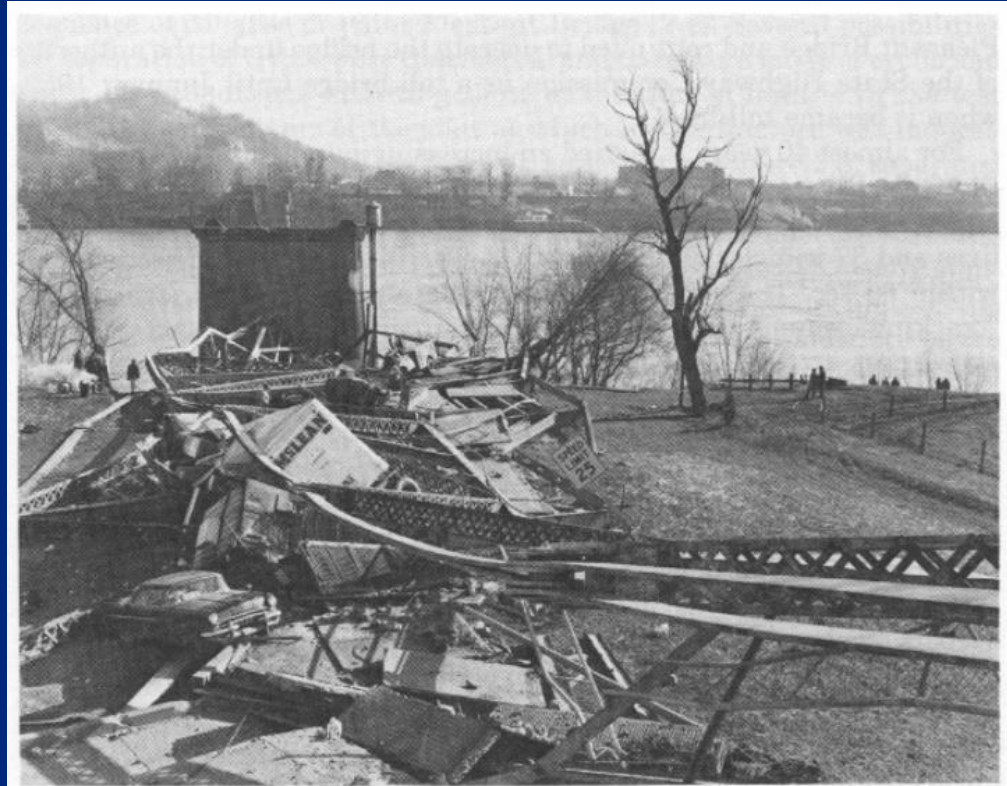
- Point Pleasant, W. VA
- Operated 19 May 1928 – 15 Dec 1967 (39 years)
- Sudden Collapse at 5:00 p.m.
  - 3 spans fell within 1 minute
  - 46 deaths/ 37 vehicles
- Stress Corrosion cracking failure
- Critical crack size ~ 0.12 in.

Figure 2.6 Point Pleasant Bridge after collapse (courtesy of Federal Highway Administration).

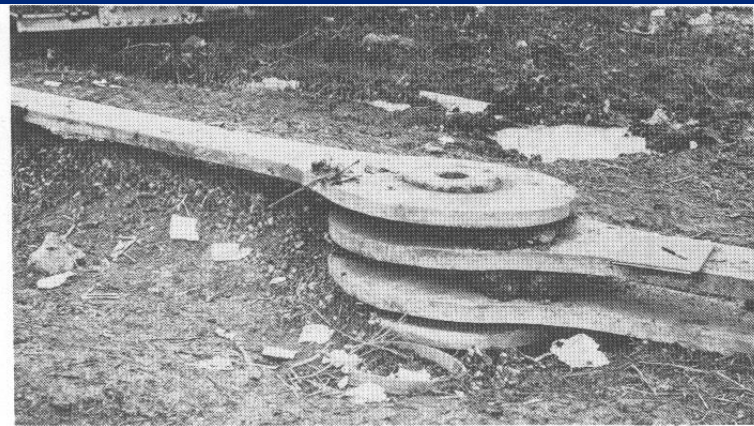
**Figure 2.7** One of the eyebar joints after collapse (courtesy of Federal Highway Administration).

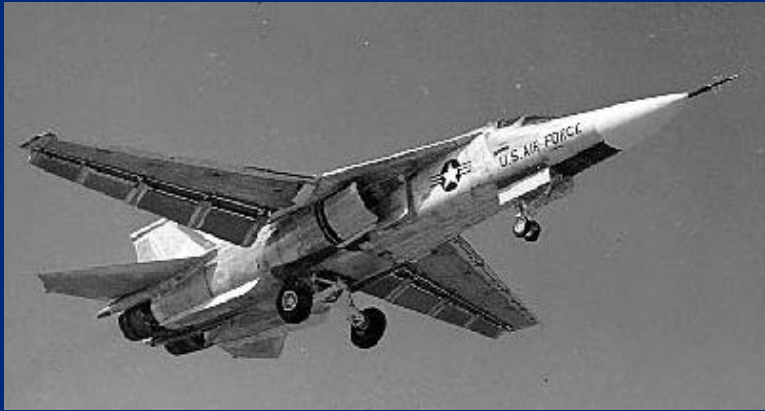
Fig. 1.4

- Forging defect in wing attachment
- Caused failure after 100 flight hours
- Promoted advances in damage tolerant design

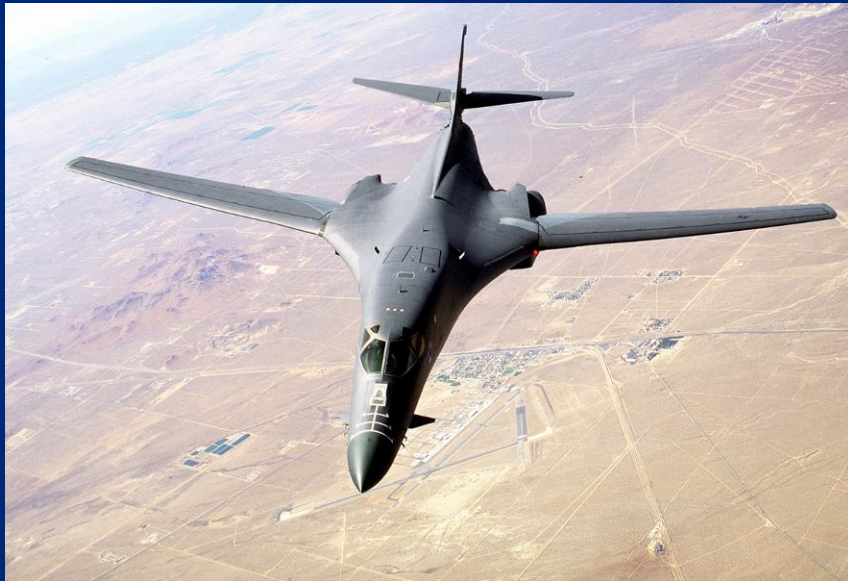
# Damage Tolerant Design of B-1 Bomber

**First aircraft designed to damage tolerance**

- Requirements defined Feb. 1970
- Mil-Spec-83444, 1974
- Assumed initial crack ~ 0.05 inch

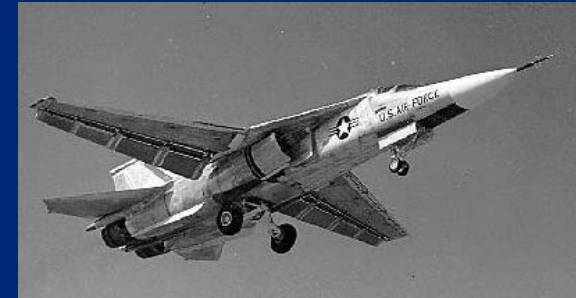
# F-111 Lessons Learned

- **Safe-life design inadequate**
  - (6000 hrs with scatter factor of 4)
  - Full scale fatigue test of 16,000 hrs
- **Safe-life design did not protect against manufacturing or service induced defects**
  - Not damage tolerant
  - Allowed use of low ductility materials
  - Inspection procedures inadequate
- **Led to new additional damage tolerance requirements in 1974**

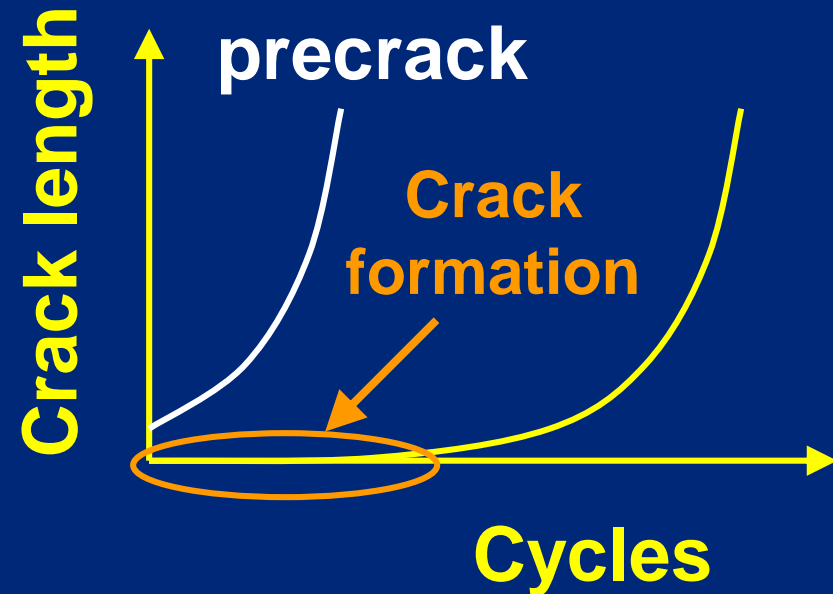
- **Safe-life defeated by pre-existent damage**
  - F-111 “safe-life” 4000 hrs (failure at 104 hrs)
  - Not allowed by FAA (commercial transport), USAF
- **Not damage tolerant**
