# **Preventing Stress Corrosion Cracking and Enhancing Corrosion-Fatigue Performance of Steel and Aluminum by Laser Peening; deployment on nuclear spent fuel canisters.**

A Lloyd Hackel<sup>1</sup>, B. Jon Rankin<sup>1</sup>, C Matt Walter<sup>1</sup>, D Brent Dane<sup>1</sup>

<sup>1</sup> Curtiss-Wright Surface Technologies, 222 Mountain Vista Parkway, Livermore, California, 94551, USA

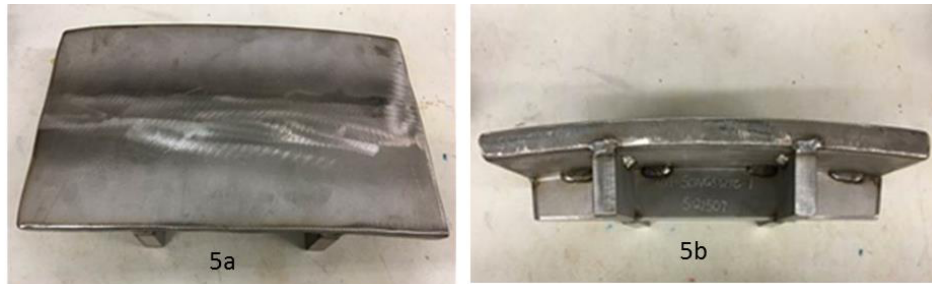
Figure 2. 5a. Canister test panel welded across width. 5b. Side-on view shows stiffening ribs used to help prevent straining as would be the case in the constraint of a canister

Using the Holtec International preparation process of roll forming and welding, test panels of 316L stainless steel of 250 mm size by 16.5 mm thickness were fabricated. Figure 2 (5a) shows a plan view of a panel that was roll formed and welded per spent fuel canister fabrication procedures. The weld runs left to right. (5b) shows strongbacks that were lightly stitch-welded to the back of the plate to help provide similar constraints as found in the canisters, thus to hold the cylindrical shape from straining during the laser peening. Stitch welding was used to minimize stress generated during attachment of the stiffeners.

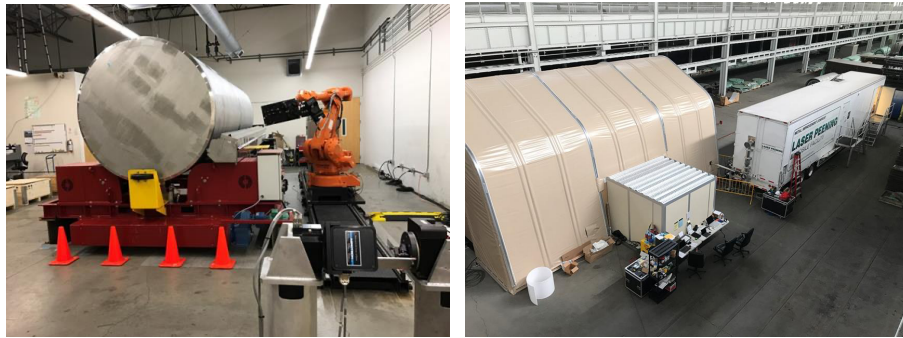
*Figure 15. Laser peening system configured for treating welds of nuclear spent fuel canisters. At left beam director mounted on the robot (orange) for canister processing. At right system configured for field operation.*

Taking the technology beyond the qualifying laboratory tests and evaluations to field deployment was an important step for fully demonstrating the capability of the laser peening process to support nuclear applications. A highly automated laser and robotic system was configured to peen the welds of 75 MPCs for the San Onofre Nuclear Power Plant at the Holtec International canister fabrication facility. The right hand photo of Figure 9 shows the beam delivery hardware and robotics that precisely positioned the laser beam spots onto the canister. A rotation system rotated the canisters to peen the hoop welds and with rotation fixed, the delivery robot translated along a track for peening the longitudinal welds. Individual spots were placed on the canister with 0.1 mm precision and recordings made of laser energy and pulse duration for each shot. The canisters were peened with a 100 mm (4 inch) wide coverage at 4 GW/cm<sup>2</sup> irradiance, 18 ns pulse duration and 3 layers of coverage. The photo at right shows the laser peening system as deployed at the manufacturing facility. The UL qualified laser system is housed in a trailer and its output beam is propagated into a light safe tent and to the beam controller mounted on the delivery robot. The beam controller precisely conditions the spot and directs it on to the canister. The water delivery nozzle is attached to and move with the controller. Processing is controlled by operators at the external control station. Canisters were peened at the rate fabricated and the laser system returned to California home base when peening was completed.
