Proposal of Pre-post Fatigue Crack Maintenance that Can Be Carried out during Repainting Process on Existing Steel Bridges

Fukuoka University Koji Kinoshita, Gifu University Yuki Banno
Yamada Infra Technos Co., Ltd. Shohei Yamada, Motohiko Tsuruta
Toyoseiko Co., Ltd. Yoshihiro Watanabe

1. Background

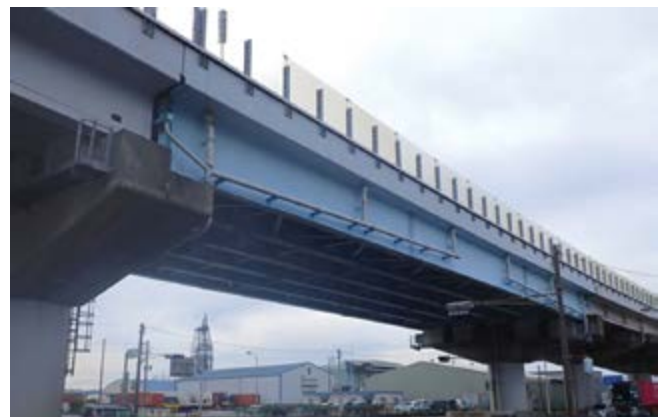
The bridge targeted in this paper is shown in Fig.2, and its specifications are listed in Table 1. The bridge was constructed in 1974, approximately 50 years ago, and is part of a regional expressway. It is a heavy traffic route with frequent trailer traffic, and fatigue damage has been confirmed.

Fig.2 Bridge appearance

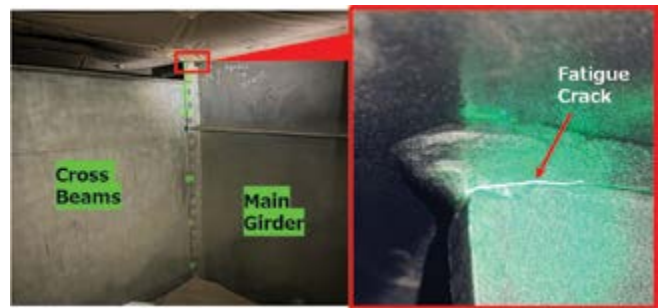
Fig.3(b) Fatigue crack (main girders with cross beams)

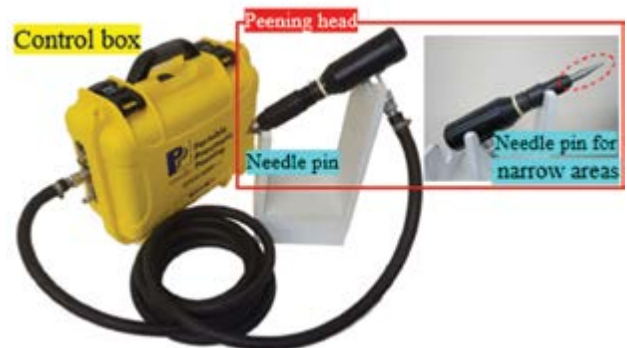
- As a post-defect maintenance measure, crack closure treatment using portable pneumatic needle peening* (PPP) was proposed to suppress fatigue crack propagation. A PPP device developed by Toyo Seiko was used for the treatment, as shown in Fig.4.
- As a preventive maintenance measure, a shot peening method was applied to improve the fatigue strength of welded joints with the same shape as those where cracks had occurred. A circulating shot peening method* (Fig.5), which can be applied in parallel with repainting work, was used.

Fig.4 Portable pneumatic needle peening device

The needle peening method proposed in this paper closes fatigue cracks by inducing plastic flow and generates compressive residual stress. The system uses a 60 mm-long needle pin with a tip curvature radius of 1.5 mm, enabling access to narrow areas such as scallops. Moreover, the device is equipped with a control box that regulates compressed air flow to control the needle impact force, allowing stable operation regardless of the operator's skill level. When applied to fatigue cracks that have not yet reached the base metal,

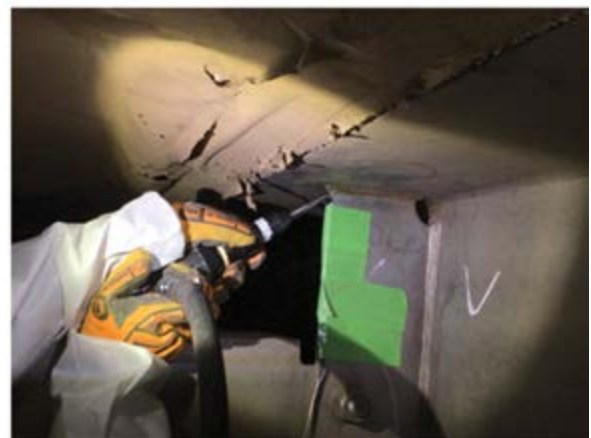
The construction process is shown in Fig.7. The locations and extent of the cracks were identified in advance using MT. Before the treatment, the areas to be peened were marked with a special pen-type highlighter (PEENSCAN PEN 220-6) from Electronics Inc. to visually confirm whether the treatment had been properly applied. Peening was performed on the crack area, within ± 2 mm of the crack line, and a black light was used to detect any untreated regions. As shown in Fig.6, this method is expected to be highly effective in extending the service life of structures by repeatedly striking and closing fatigue cracks⁵⁾. If any untreated areas were found, the cracks were retreated to ensure complete closure. Finally, penetrant testing (PT) was conducted to confirm that all treated areas had been fully closed.

Fig.7 Crack closure treatment status

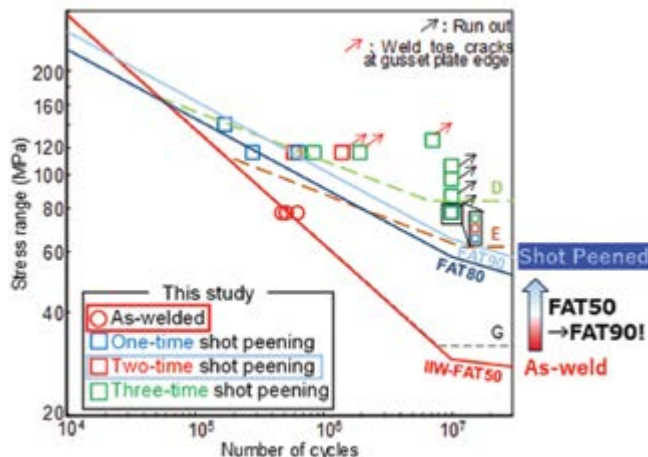
In this paper, the circulating shot peening method was adopted to introduce compressive residual stress into welded joints and thereby improve fatigue strength. The circulating shot peening method utilizes the same circulating blast method* used during repainting for paint removal. By replacing the abrasive media with conditioned cut wire conforming to JIS G 0951, and using existing scaffolding and protective equipment, this method can be implemented efficiently. It is an environmentally friendly maintenance technology for existing steel bridge welded joints, enabling the recovery and reuse of shot. This method is less dependent on operator skill than grinder finishing, and consistent construction quality can be achieved by managing the shot and peening conditions. Fatigue test results⁽⁶⁾⁽⁷⁾⁽⁸⁾ on out-of-plane gusset welded joints show that this method improves fatigue strength from FAT50 to FAT90, according to the classification defined by the International Institute of Welding (IIW) as shown in Fig.8. These results satisfy the fatigue design curves proposed for HFMI treatment in the IIW recommendations⁽⁹⁾.

Fig.8 Fatigue test results of shot peening⁶⁾⁽⁷⁾⁽⁸⁾

carried out under treatment conditions (a coverage rate of 90% or more and a nozzle speed of 72 seconds per meter (Table 3)) that satisfy the fatigue test results shown in Fig.8.
