TECHNICAL REPORT NO. 420

M9 ACE TRANSMISSION OUTPUT
SHAFT FAILURES

R. DAVIS MENTZER, JR.

APRIL 1986

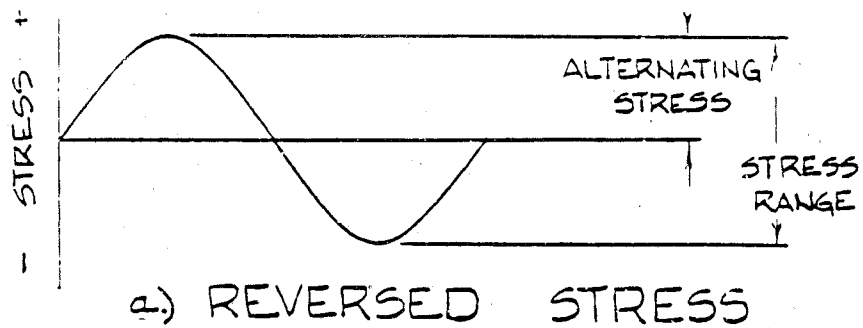
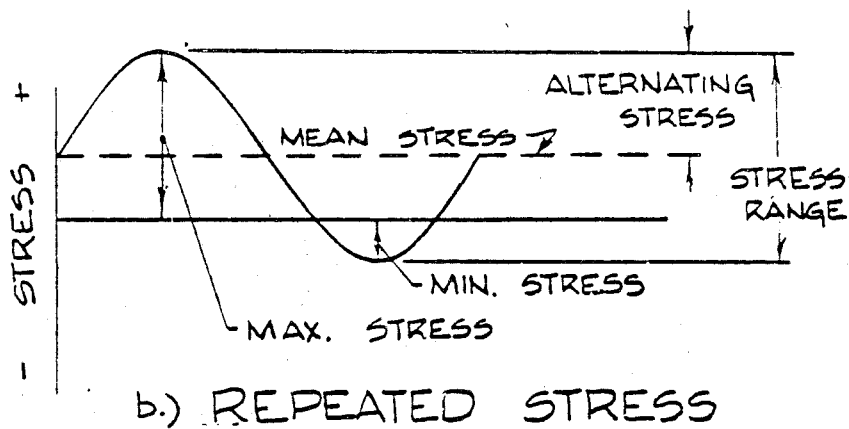
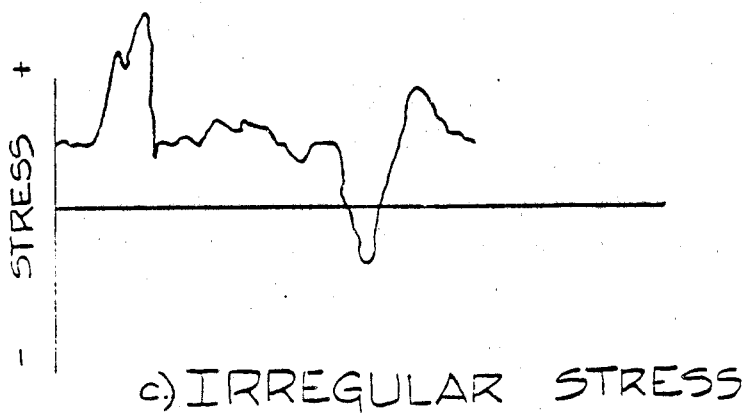
TYPICAL FATIGUE STRESS CYCLES
FIGURE 1

Cyclic loadings that lead to fatigue failures can be applied in a variety of ways. Figure 1 demonstrates typical fatigue stress cycles generated by various types of alternating loading. Figure 1A illustrates a sinusoidal, completely reversed cycle. This is an idealized situation but can be approached by rotating shafts, operating at a constant speed with no overloads. The magnitude of both the tensile and compressive stress for each cycle is equal producing a mean stress of zero. Most fatigue data available in literature is generated from this type of stress cycle.

A more common type of fatigue loading found in engineering practice is a situation where the maximum tensile and compressive stresses are not equal in magnitude, but alternate between constant values. This cycle, referred to as a repeated stress cycle, is illustrated in Figure 1B. This includes an alternating stress which varies around a mean or steady stress. As the mean stress becomes more positive, the allowable alternating stress decreases.

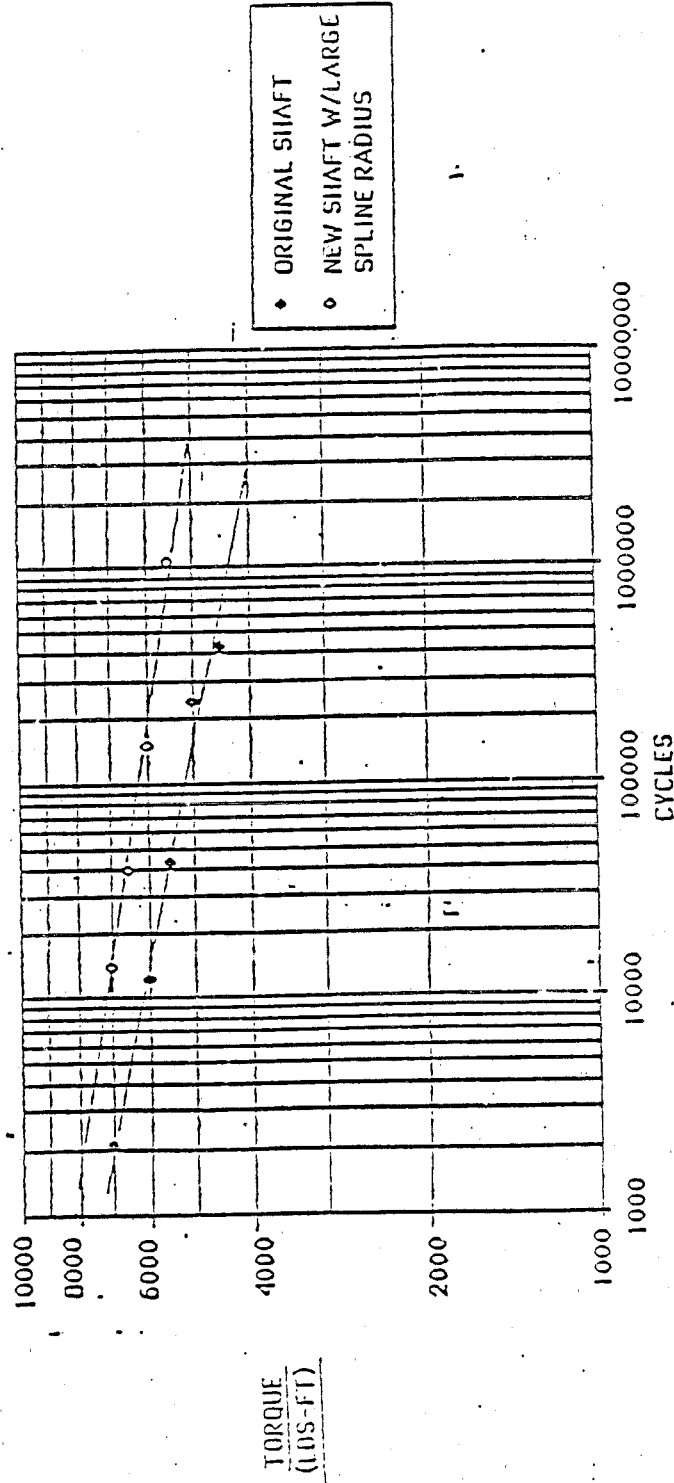
FIGURE 2

TORSIONAL FATIGUE S-N CURVES (ON FULL REVERSE CYCLES)

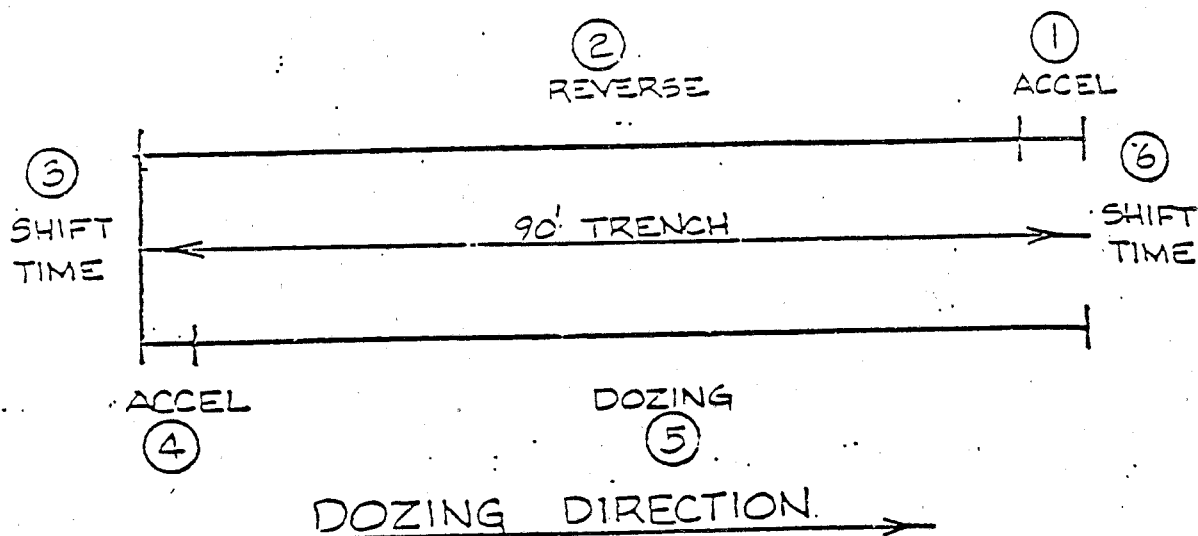
FIGURE 3

Calculations indicate that at an engine speed of 2000 rpm the speed in reverse will be reduced from 4.6 to 3.1 mph. This may produce a slight adverse effect on the productivity of the M9. The maximum impact of this change will be noticed in high stress dozing operations. Figure 3, Production Time Line, illustrates the minimum time required to doze a slot trench 90 feet in length. Acceleration time from 0 mph to the maximum reverse speed was calculated using tractive effort data and a soil strength of 120 RCI, dozing speed was assumed to be 2.0 mph, and shift times were assumed to be 0.5 seconds. These assumptions were substantiated by typical bulldozer performance and contractor testing. A comparison of cycle time was made using the geared steer mode, the preferred steer mode in reverse, and the clutch brake mode, the proposed steer mode to be used in reverse. An increased cycle time was estimated of not more than 10 percent, producing an equivalent decrease in productivity. At the maximum engine speed of 2800 RPM, maximum reverse speeds are reduced from 6.3 to 4.3 mph. This also produces a decrease in productivity of not more than 10 percent. This is a worst case estimate, which would only be expected during high stress operations. No productivity loss is anticipated during normal operations.

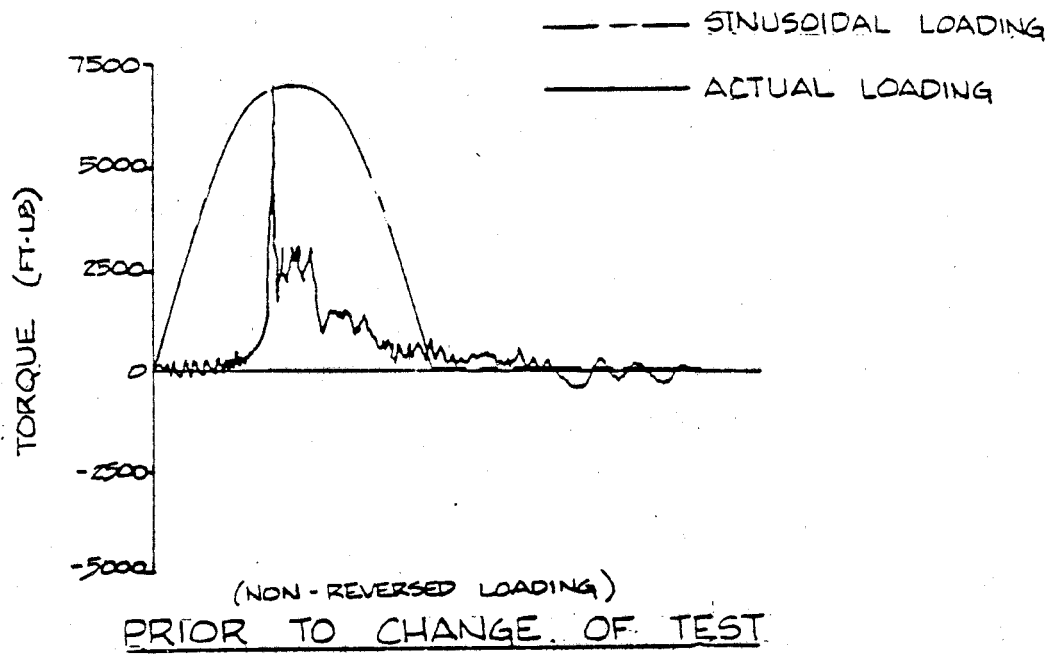
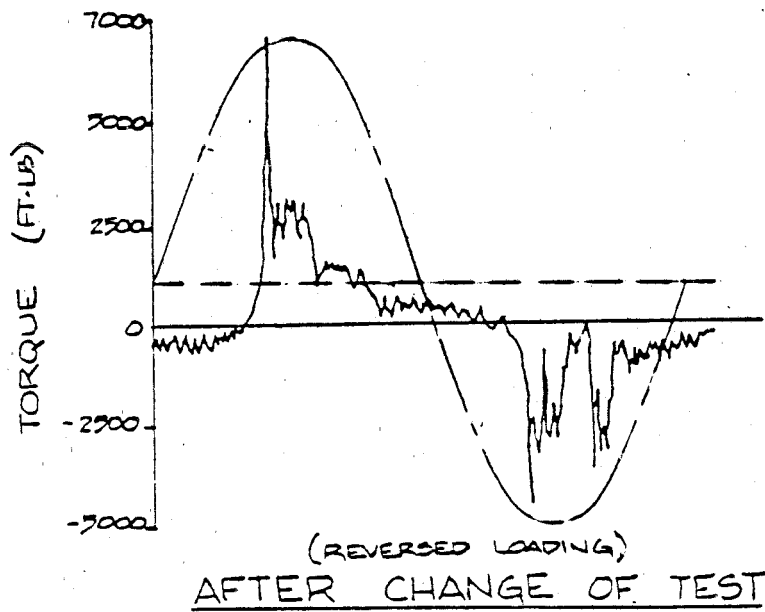
FIGURE 4

b. The loadings were applied in a sinusoidal cycle. Figure 4 illustrates the difference between a sinusoidal cycle and the cycles which were actually produced during testing both before and after the test plan was changed. It is apparent that the actual test data approach a random type cycle.

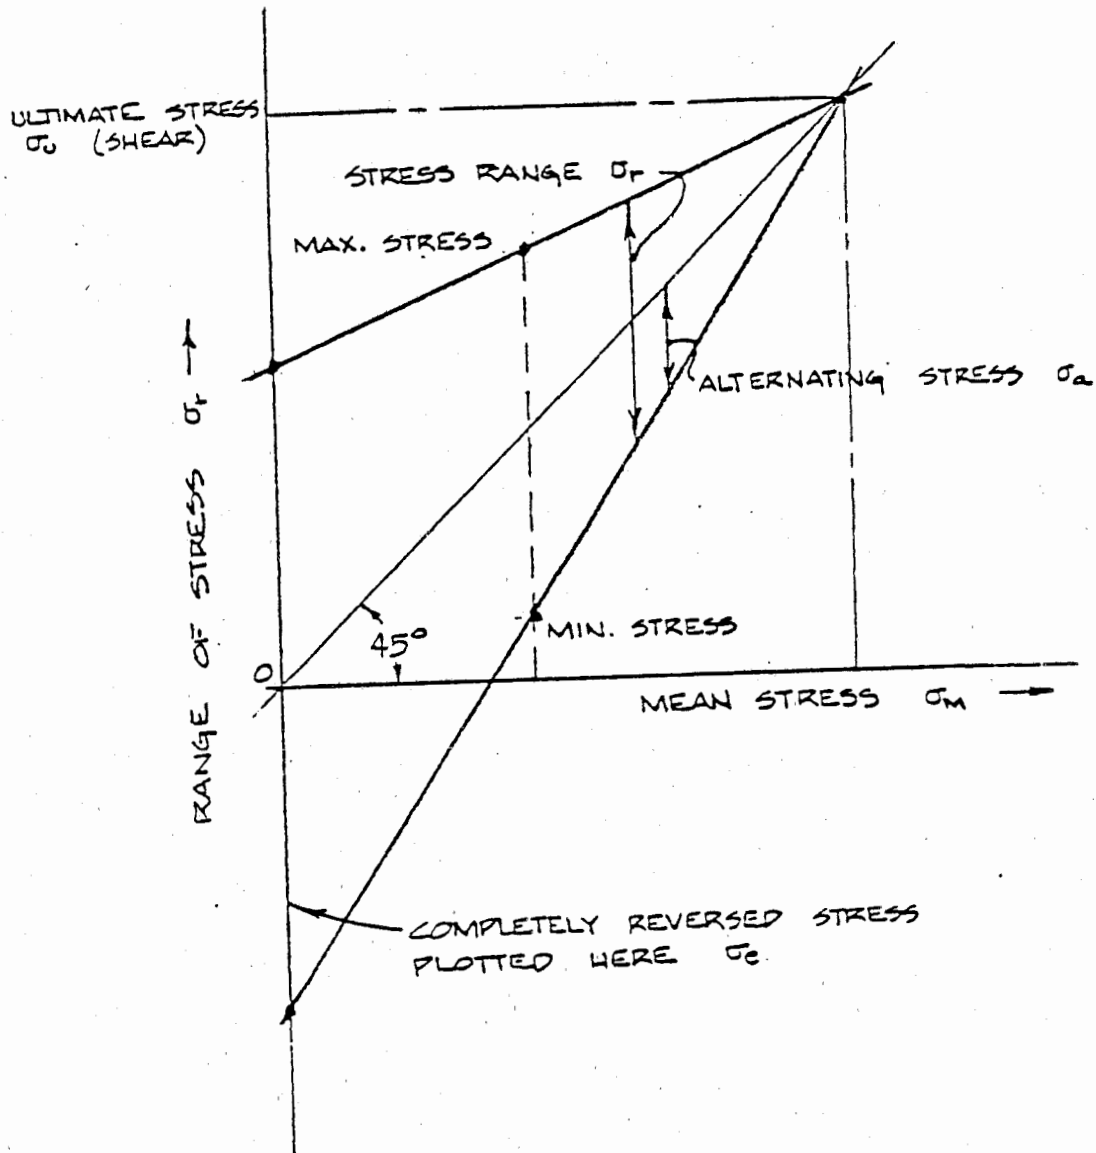
FIGURE 5

The fatigue life of a component exposed to non-reversed loading can be estimated using the S-N curve and a Goodman Diagram. The Goodman Diagram (Figure 5) illustrates the effect of the mean stress on the alternating stress levels and the stress range. It can also be used to predict an equivalent fully reversed loading which produces the same effects as a non-reversed loading. The estimated fatigue life can be read directly from the S-N curve using this equivalent fully reversed loading.

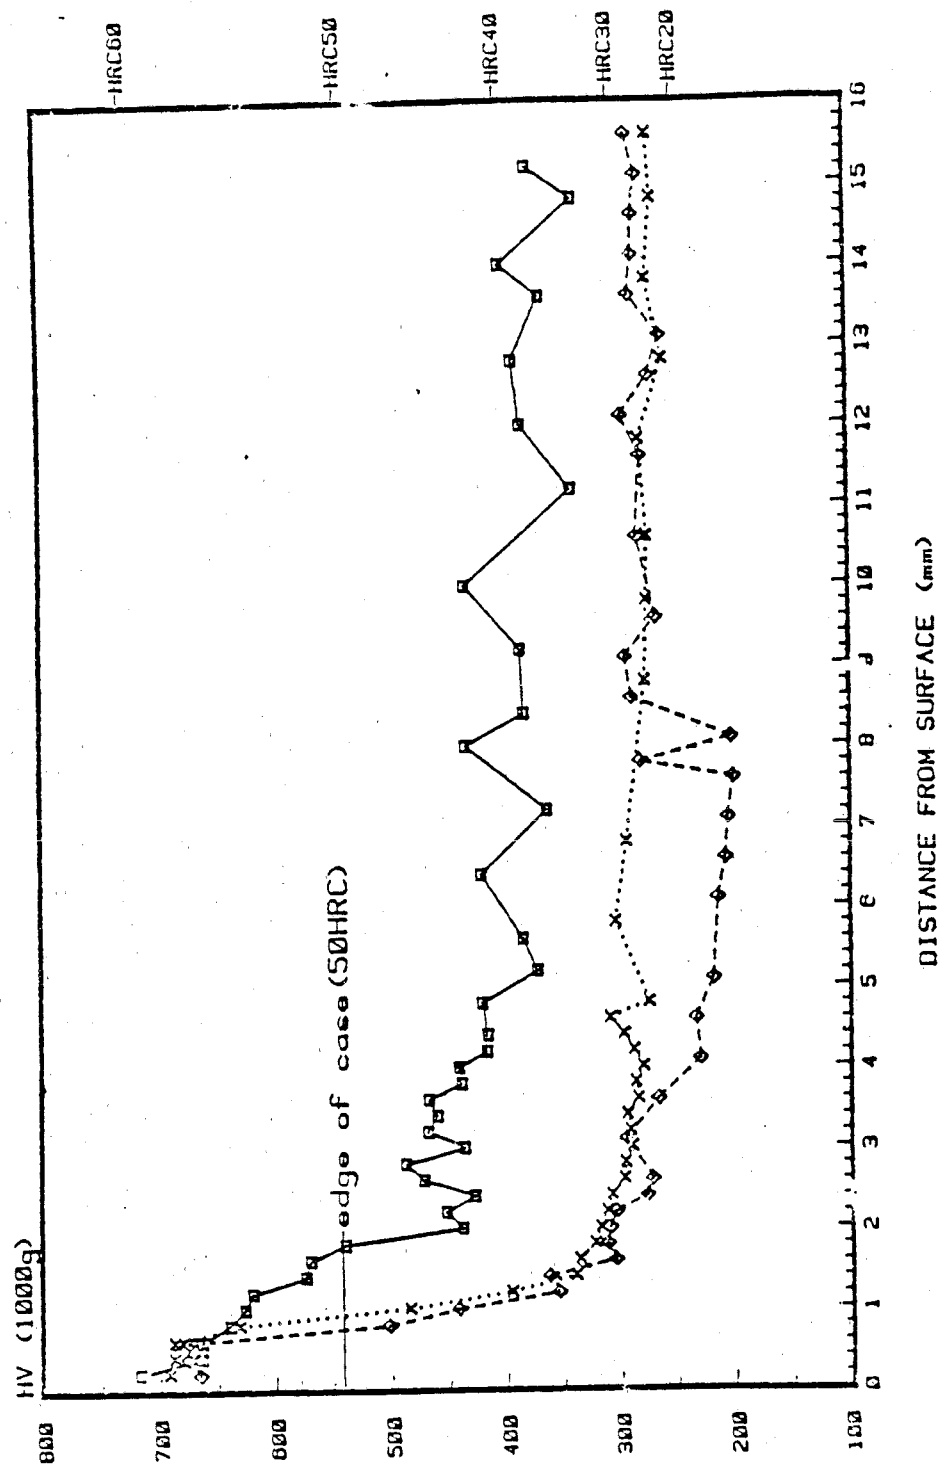
5. Microhardness profiles of the three shafts are shown in Appendix III, Figure 1. The hardness measurements were made close to the fillets and progressed from the surface to the core of the shafts. The microhardness profiles of shafts B and C were similar to previous failures. The shafts of this investigation were compared directly to previous failures for the same region. The microhardness data are given in Appendix III, Figure 2 and 3. The hardness profile of shaft A indicated a significant increase in case depth. Shafts B and C and the previous shafts possessed a case depth of approximately 1.0 mm. The case depth of shaft A was 1.8 mm.

GRAPH 2. Microhardness Traverse

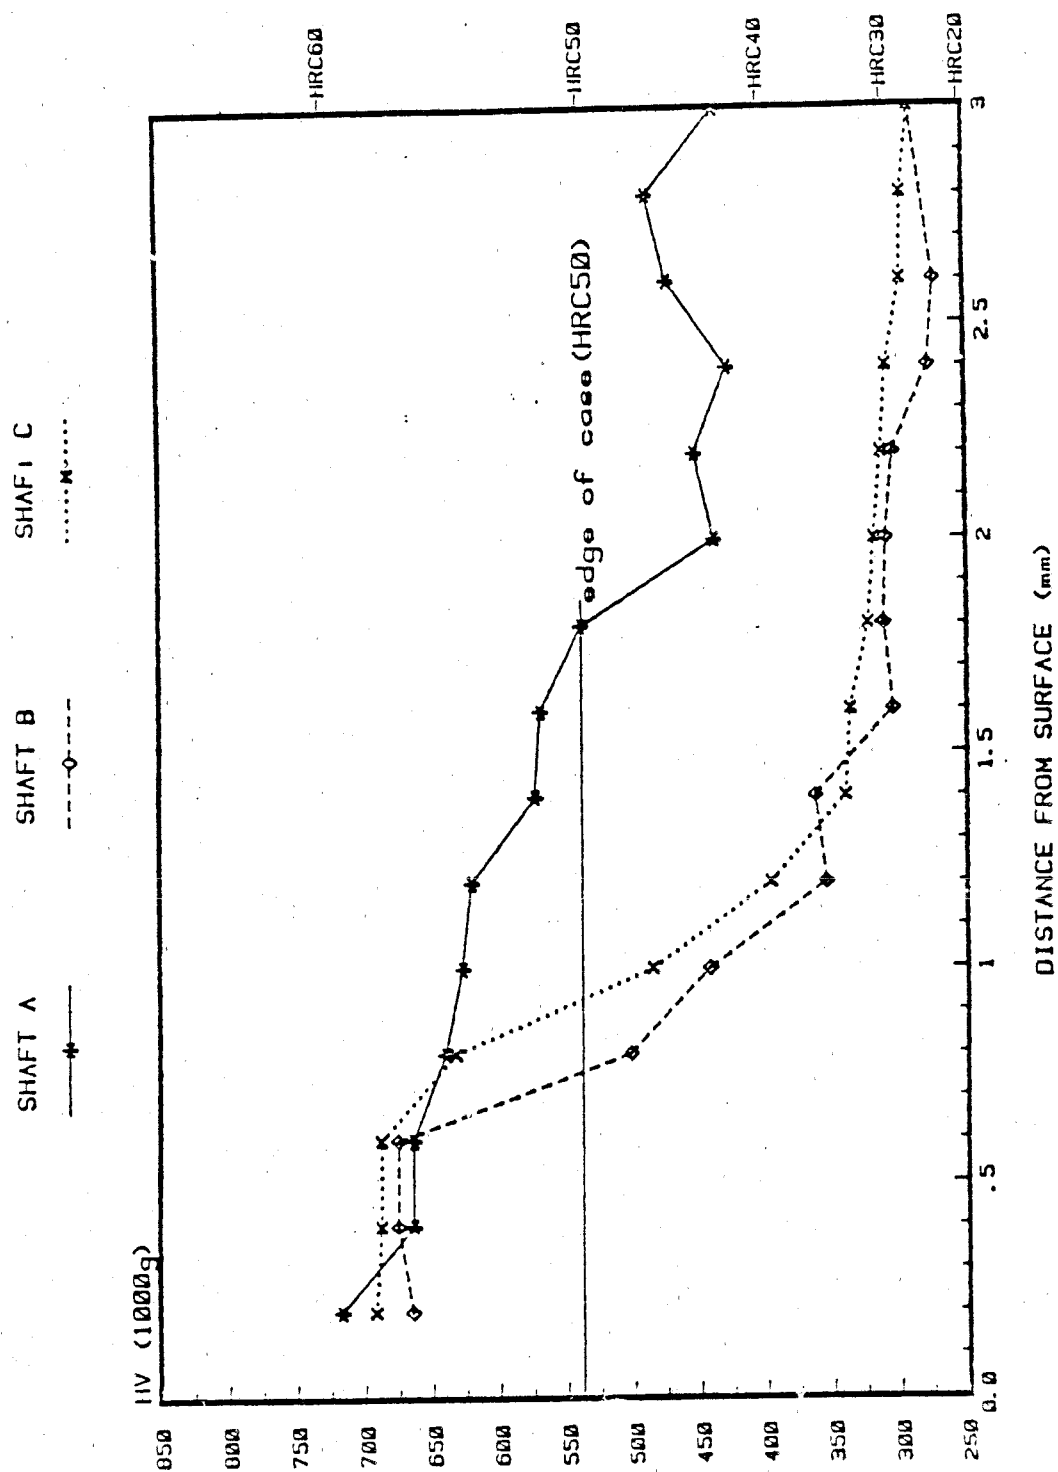
GRAPH 3. MICROHARDNESS TRAVERSE FOR PREVIOUSLY FAILED N9 ACE SHAFTS
