1. Report No. FHWA/TX-06/5-4178-01-2		2. Government Accession No.	3. Recipient's Catalog No.	
4. Title and Subtitle Application of Ultrasonic Impact Treatment to In-Service Signal Mast Arms		5. Report Date June 2005, Rev. November 2005

## **Application of Ultrasonic Impact Treatment to In-Service Signal Mast Arms**

CTR Research Report:	5-4178-01-2
Report Date:	June 2005
Research Project:	5-4178-01
Research Project Title:	Ultrasonic Impact Treatment (UIT) for Traffic Signal Structure Fatigue Details
Sponsoring Agency:	Texas Department of Transportation
Performing Agency:	Center for Transportation Research at The University of Texas at Austin

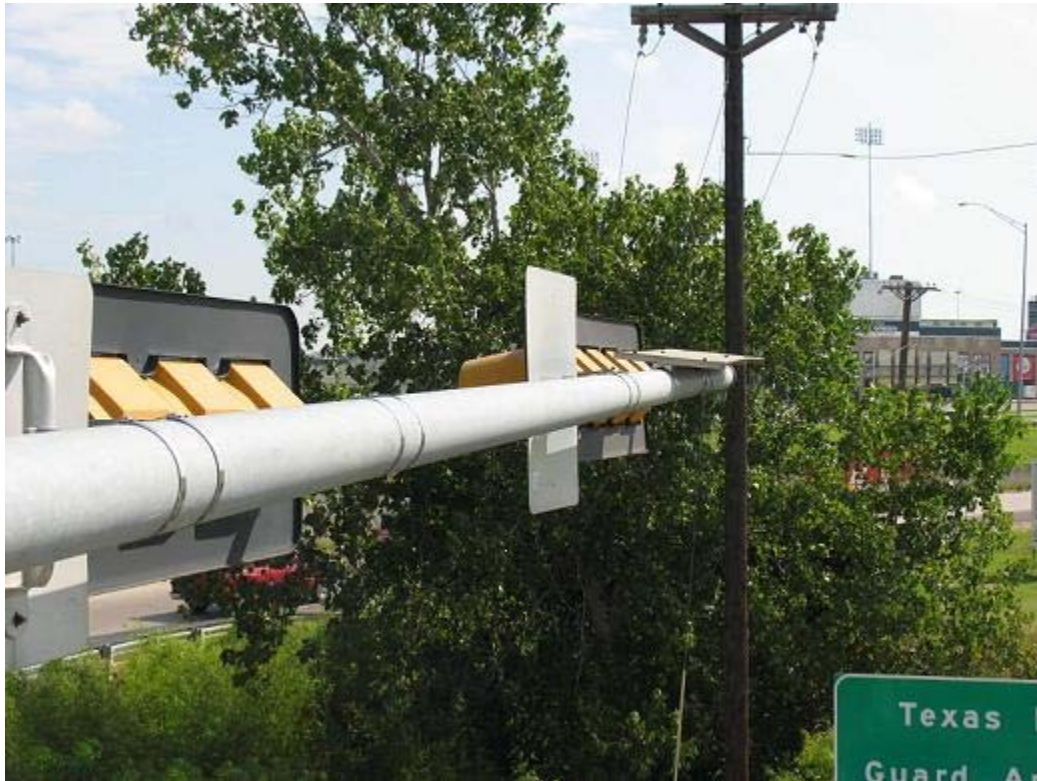
*Figure 2.4 Horizontal Damping Plate on Mast Arm 2*

Mast arm 2 has a street sign right next to the mast, followed by a one-way sign. Next is a three light signal, followed by another sign. At the end of Mast arm 2 is a five light signal. A horizontal rectangular damping plate is behind the five light signal. The damping plate on Mast arm 2 is shown in Figure 2.4.

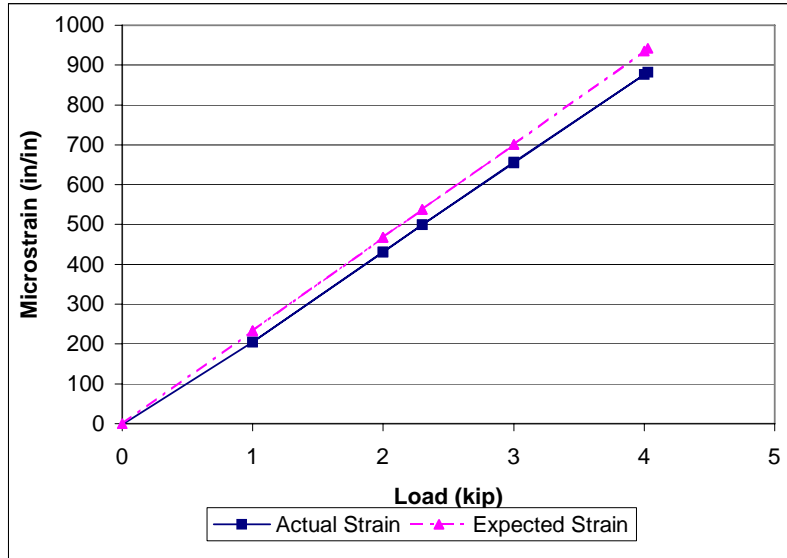
Figure 3.5 Actual and Expected Strain at 3 Inches from the Mast Arm Weld Toe of Specimen DU

The results of the strain measurements at 3 inches from the mast arm-base plate weld were within 7.8% of the expected strains for the DU specimen and within 15.8% of the expected strains for the DN specimen. Figure 3.5 is a plot of load vs. strain for the DU static test, showing both measured and expected strains. Figure 3.6 is a plot of load vs. strain for the DN static test, showing both the measured and expected strains. Since the strain gauges were attached 3 inches from the mast arm weld toe, expected strains were calculated using the moment arm and diameter at the location of the strain gauge. The variation of the measured strain from the calculated strains is due to the local bending of the mast arm tubing wall due to the deformation in the end plate.

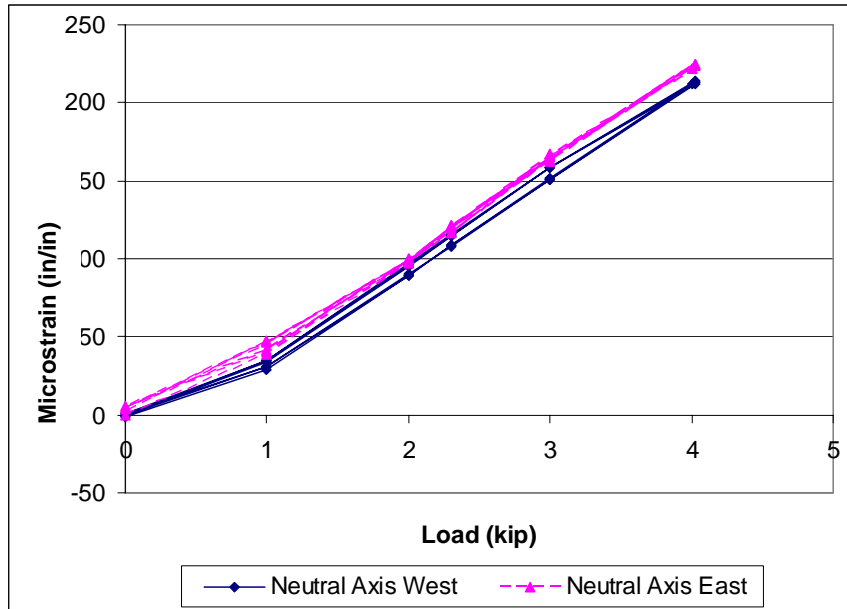
Figure 3.7 Strain at the Mid-Height of Baseplate DU

Limited analytical studies at the University of Texas at Austin into the effects of end plate thickness on mast arm fatigue life have been performed and further work is underway [1]. In an effort to gather information for future research, strains were also measured along the mid-height of the end plate during static tests to measure the bending strains in the end plates. Figure 3.7 shows the strains on both the East and West side of the mid-height of the DU end plate.

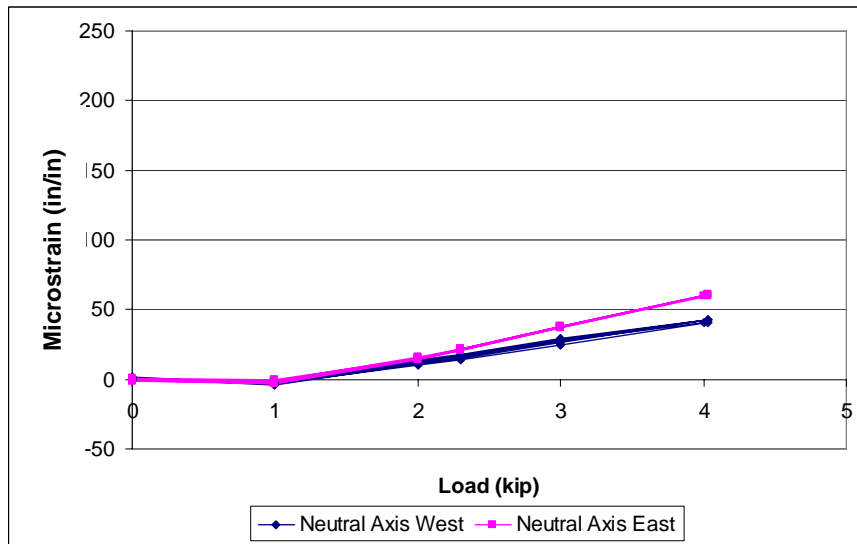
Figure 3.8 Strain at the Mid-Height of Baseplate DN

Figure 3.8 shows the strains on both the East and West side of the neutral axis of the DN end plate. Notice that the DU end plate has strains ranging to 225 in/in at 4.03 kip, while the thicker DN end plate has strains ranging to only about 61 in/in at 4.03 kip. The DU end plate was only 1 inch thick, while the DN end plate was 1-1/4 inches thick. The additional 1/4 inch of the DN end plate increases the stiffness of the end plate that reduces the stress at the mast arm weld toe.

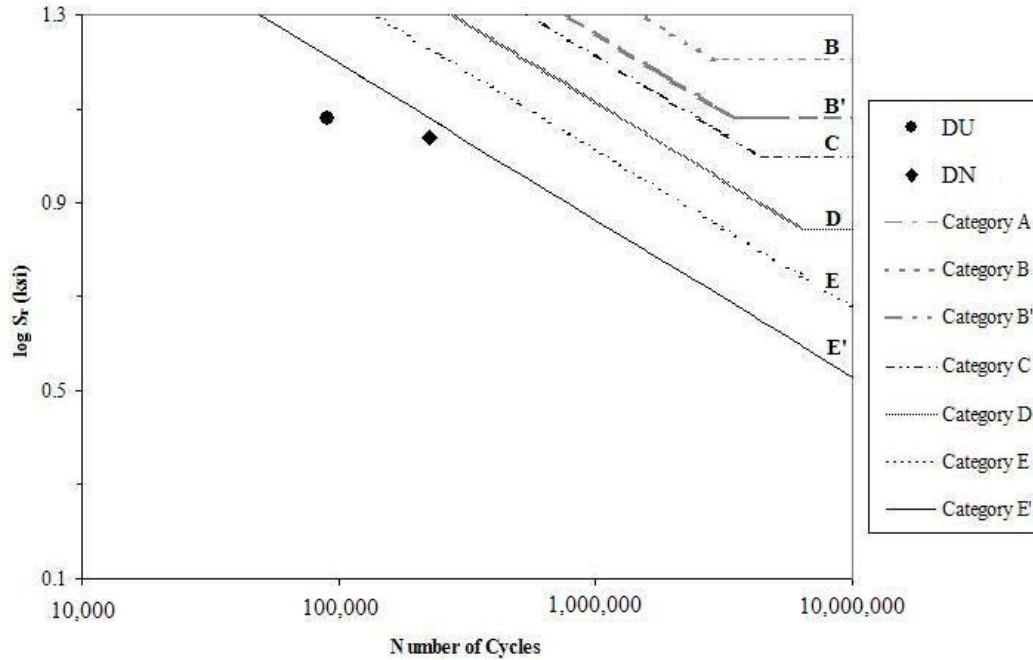
Figure 3.15 S-N Plot of DU, DN, and AASHTO Fatigue Categories

Figure 3.15 shows that neither mast arm DU nor mast arm DN reached Fatigue Category E'. The S-N plot for mast arm also shows that DN had a slightly better fatigue resistance than DU. These results do not indicate that field UIT retrofit of specimen DU improves its fatigue performance as much as expected. However, the difference in base plate thickness and arm size between these two specimens makes it impossible to directly compare these test results.

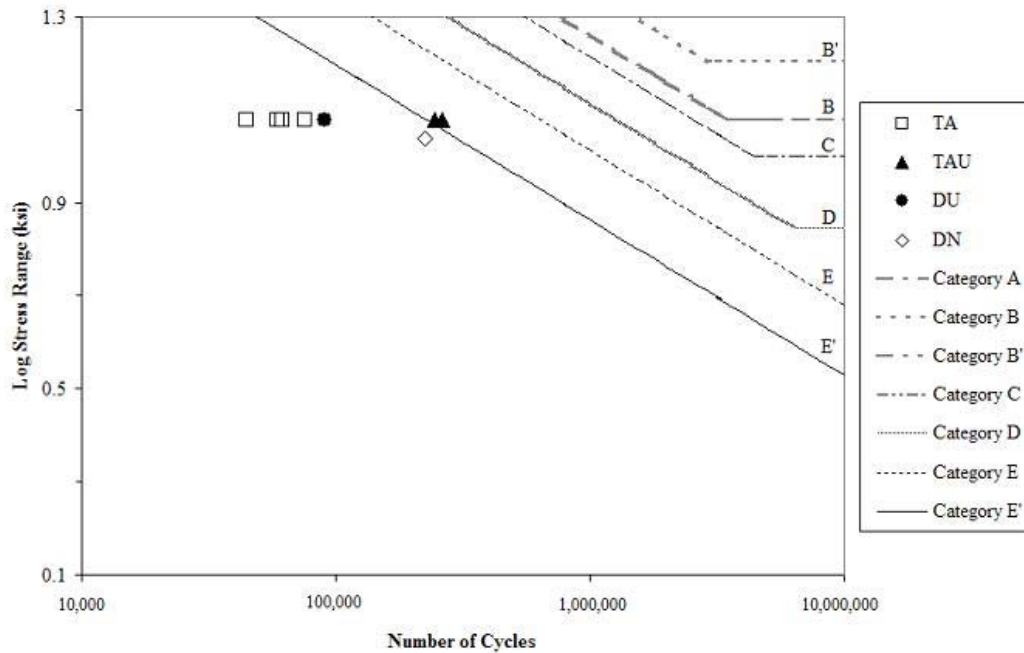
Figure 3.16 S-N Plot for DU, DN, and the TAU Series

As can be seen in Table 3.3 and Figure 3.16, UIT application at the fabrication yard increased fatigue life of TransAmerican mast arms to above Category E'. Mast arm DN that was not treated produced a fatigue life that was comparable to the TAU specimens. Mast arms DN and TAU have the same end plate thickness but the diameter of mast arm DN is smaller than TA

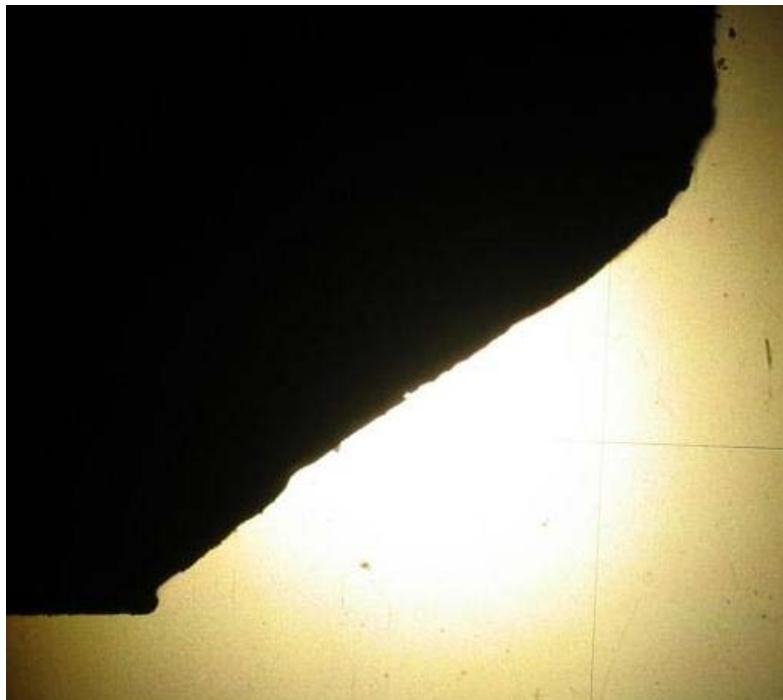
*Figure 3.19 10x Magnification of Mast Arm Weld Before UIT*

Molds were made of mast arm weld profiles before and after UIT application. The molds were made as described in reference 1. Figure 3.18 shows a typical weld, pointing out the locations of the long and short leg. All measurements of the weld legs were made with the Mitutoyo Profile Projector, Model PJ250. The Profile Projector projected a 10x magnification of the weld mold onto a screen with cross hairs. From this projection, a digital readout with accuracy of 0.0001 inch was used to measure the lengths of the weld legs. Figure 3.19 shows the weld profile of a typical mast arm at 10x magnification.
