EXFOLIATION CORROSION LOCATED BY SEARCH PEENING

W. WÜBBENHORST

Metal Improvement Company, Inc; Haan-Gruiten, Germany

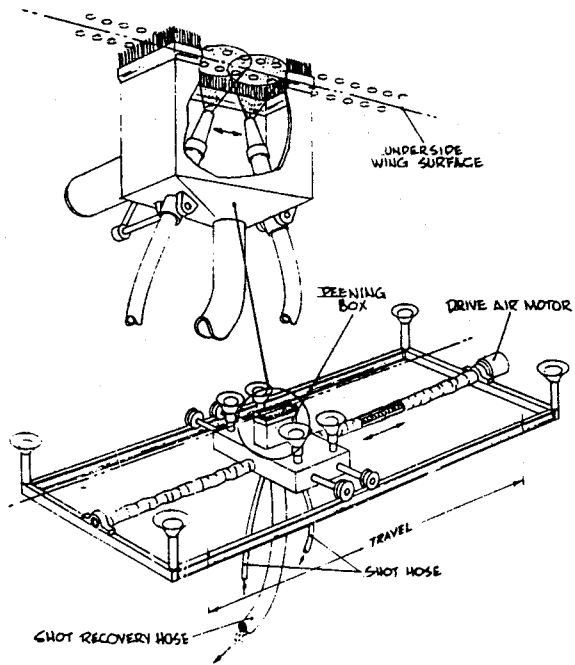
Fig. 2 Design of „Wing Walker“ machine for fully automated shot peening along rivet runs

One of the major areas of concern are the fasteners along the spar skin attachment lines where there are long runs of rivet heads. It is necessary, whilst not by choice, to use dissimilar materials such as steel and aluminium on aircraft structures. Unfortunately fasteners plated to provide insulation, suffer subsequent surface degradation which will allow water to penetrate with the initiation of intergranular and exfoliation corrosion. - Figure 2 illustrates automated microprocessor controlled equipment for controlled and repeatable processing along such spar skin rivet lines.

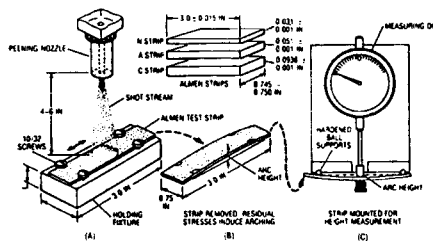
This is understandable since shot peening causes the surface layers to stretch as clearly illustrated in figures 7 and 8 of [1] and separate along the weakened corrosion paths beneath the surface.

Fig. 8 The Almen Strip System
