## **Cold Work Quality Assessment and Fatigue Characterization Using Conformable MWM<sup>®</sup> Eddy-Current Sensors**

James M. Fisher, Mechanical Engineer  
WR-ALC/LBRS, 265 Ocmulgee Ct, Robins AFB, GA 31098-1647  
(912) 926-6814, [james.fisher@robins.af.mil](mailto:james.fisher@robins.af.mil)

Neil Goldfine, PhD, President; Vladimir Zilberstein, PhD, Metallurgist  
JENTEK Sensors, Inc., 110-1 Clematis Avenue, Waltham, MA 02453-7013  
(781) 642-9666, [jentek@shore.net](mailto:jentek@shore.net)

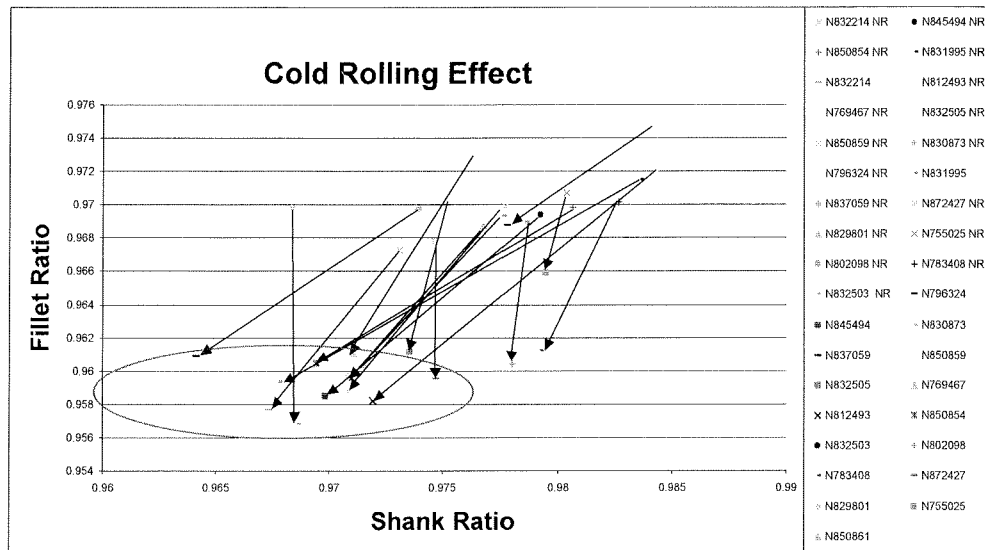
The effects of cold rolling on the conductivity ratio are illustrated in Figure 1, where the results are presented as blade fillet conductivity ratio vs. shank conductivity ratio.

Figure 1. Change in Conductivity Ratio During Cold Rolling Operations.

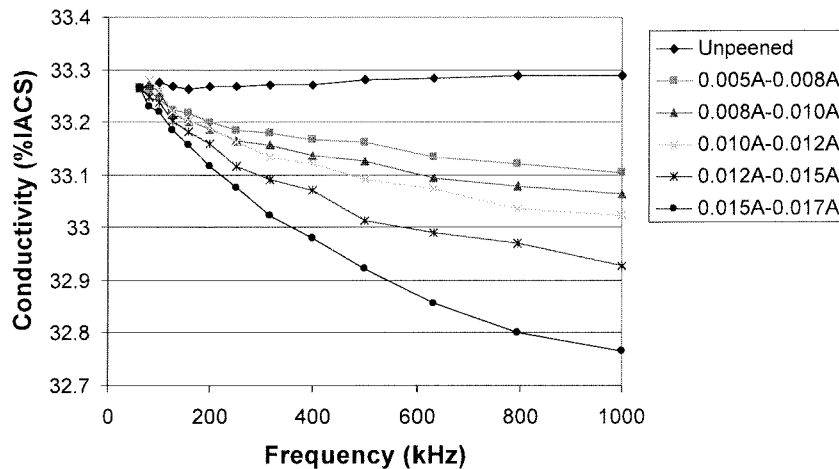
layer of the material. The underlying material not affected by shot peening retains the initial higher conductivity. A module was designed and developed by JENTEK Sensors, Inc. to take conductivity measurements at 19 different frequencies ranging from 63 kHz to 3 MHz. Each of the measurements at these frequencies represents effective conductivity of the various layers from the surface to a specific depth into the material. Components with little or no shot peening will have little or no change in conductivity at any frequency whereas components with high levels of shot peening will have a significant decrease in conductivity at higher frequencies. This module was tested on an airfoil with regions of known shot peening intensity ranging from unpeened to 0.015A – 0.017A as shown in the Table 1. Figure 5 shows the results of multi-frequency MWM measurements in these regions.

*Figure 5. MWM Measurements on Shot Peened Propeller Coupon.*

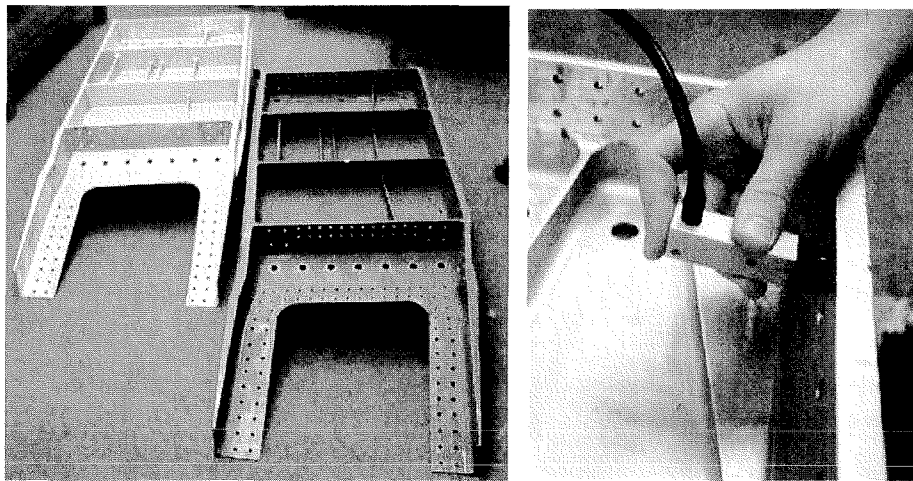
assess advanced nondestructive inspection techniques. This fitting is on the horizontal stabilizer and ties the left and right horizontal stabilizer aft spars together as well as providing the support structure for attaching the aft of the horizontal stabilizer to the vertical stabilizer (Figure 6). Although the design stresses throughout this fitting are quite low, cracks have been identified across the upper flange and in the spar cap attachment arms, which have required extensive repairs. The damage was sufficiently severe on the C-5A fleet that the fittings are being 100% replaced during programmed depot maintenance (PDM). The same fittings on the C-5B have not been replaced because cracks have not been detected on these aircraft. Several explanations for this phenomenon have been suggested but no conclusions have been made as to why the C-5A fittings crack and the C-5B fittings do not. One of the most likely explanations is that the C-5B fittings are 17 years newer and the fasteners appear to have been installed with more sealant, reducing their susceptibility to stress corrosion cracking.

*Figure 6. Left: C-5 Tie Box Fittings, and Right: MWM Scanning Bolt Hole Locations.*

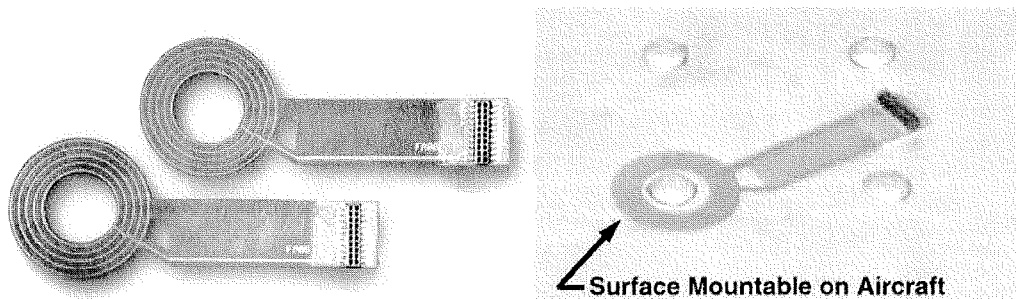
1. MWM was able to detect all crack indications detected with conventional NDI techniques.
2. At a total of four locations on two different fittings, MWM was also able to detect anomalies that were previously undetected using conventional NDI. These anomalies were determined to be subsurface cracks using conventional means (visual inspection and bolt hole eddy current). **These latter conventional inspections required removal of fasteners, while the MWM inspection could be performed without removal of the fasteners.**
3. For inaccessible bolt hole locations, surface mountable MWM-Rosettes might be used to inspect these locations without requiring disassembly (see Figure 9).

*Figure 9. Surface Mountable MWM Rosettes for In-Service Detection of Cracks in difficult-to-access locations around fasteners.*

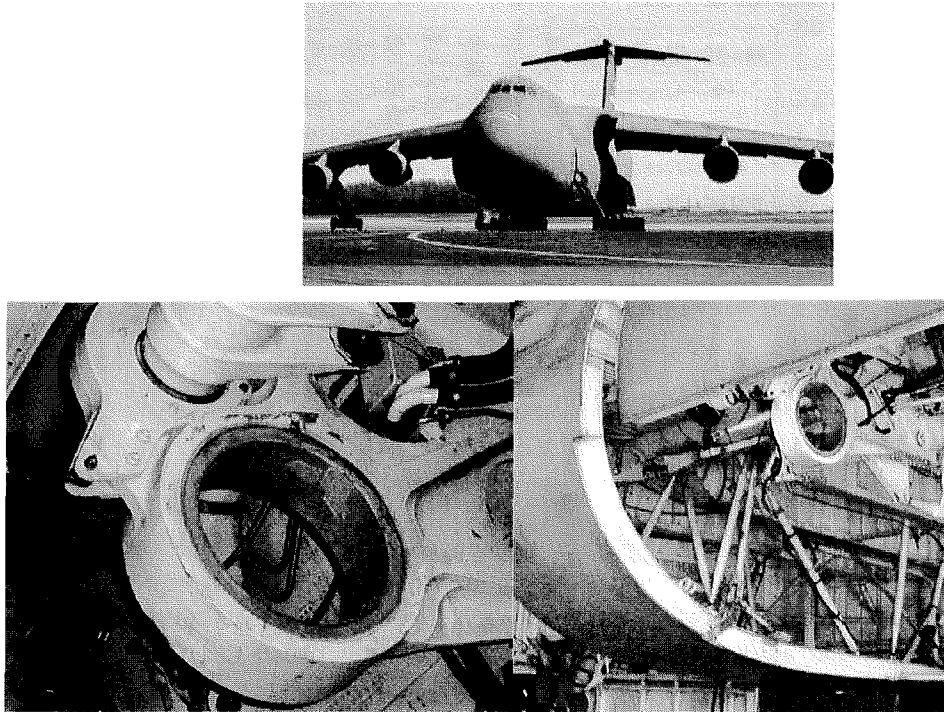
The C-5 main landing gear system has large trunnion fittings to support the strut assemblies which are virtually impossible to remove from the aircraft (Figure 10). During programmed depot maintenance, thorough inspections are made of all the surfaces on the trunnions to identify damage. Corrosion often found in the bore area must be removed either by localized grind out or reaming. Maintaining the integrity of the residual stress originally imparted by shot peening is critical; however, process controls for localized rework of these areas is difficult. As with most shot peening operations, Almen strips are used by the operator to establish the proper pressure and incident angle for the size of shot being used. Unlike the C-130 propeller blade taper bore, the internal area of the bore is relatively large. However, as all operations must be accomplished on the aircraft, the use of an automated booth is impossible.

*Figure 10. C-5 Landing Gear Trunnions.*
