EFFECT OF ULTRA SHOT PEENING ON CONTACT SURFACE STRENGTH

ABSTRACT

Ultrasonic Shot Peening, Fatigue strength, Micro pitting, Residual Stress, Spalling

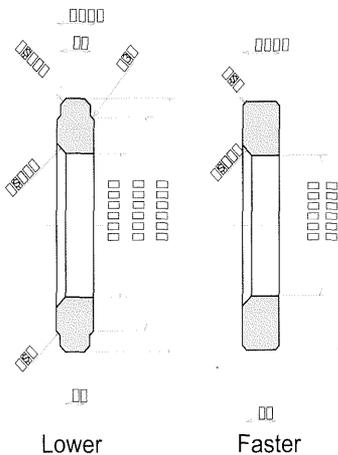
Fig.1 Shape and dimension of test roller

The material of roller specimens in this study was JIS SCM420, which is equivalent to SAE4120. Roughly machines specimens were carburized and then machined to the roller shape. And after quenching and tempering, roller specimens were polished by grinder to improve the surface roughened by machining. The geometry of specimen is shown in Figure 1. Here the surface hardness of material was 700HV and the depth of carburized layer was 0.9mm. Shot peening was carried out by Stressonic® and conventional air peening device. Table 1 shows the shot peening conditions. In this study, we used polished bearing ball 1.4g weight for Stressonic® peening device. The amount of shot at Ultrasonic shot peening (hereunder USP) was extremely low compared to that at conventional air type peening (hereunder ASP) device. However, shot peening treatment time at ASP was one tenth of USP, because the density of shot projection stream was quite small at USP.

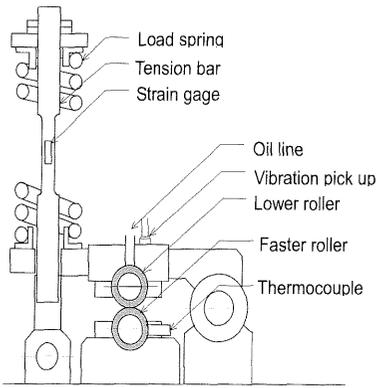
Fig.2 Schematic drawing of testing machine

Figure 2 shows the schematic drawing of testing machine. Load stress was controlled by load spring and trusting screw. The viscosity of lubricator in this study was 206.3csT at 311K and the petrol pump controlled the amount of lubricator 4.17ml/s during testing. Temperature was 318K. In order to clarify the effect of shot peening treatment, the contact fatigue testing was carried out with Not-peened specimens (hereunder UNP), ASP and USP as mentioned before.

The rotating speed was 1,500r.p.m. and slip ratio was 0.162 at Lower roller and 0.139 at faster roller. The maximum load was 1.6, 1.8, 2.0GPa and observed the surface damage at every 2.0×10^6 cycles.

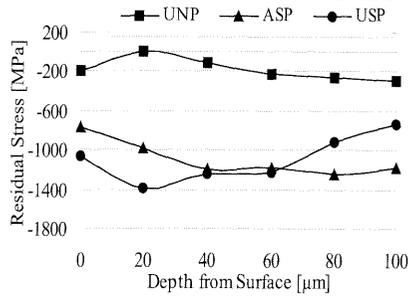
Fig.3 Residual Stress distribution

Fig.3 shows the residual stress distribution of each specimens. The residual stresses were determined by X-ray diffractometer using the $\sin^2\psi$ - method. The residual stress distribution was obtained by repeating the X-ray measurement and electrochemical polishing. The surface residual compressive stress of USP was higher than that of ASP. The difference was about 200 MPa and surface value reached to $-1,000$ MPa. However the effective layer at USP was considered to be smaller than ASP. This difference was caused by shot peening energy. In any case, both shot peening treatment induced higher compressive residual stress compared to UNP. Surface roughness after peening is shown in Fig.4. As shown in the figure, the surface roughness of USP specimen was smoothest compared to other specimens. And the roughness value of ASP was almost twice than USP. As mentioned before, the reason of this result was considered to be the polished ball at USP treatment with low shot velocity.

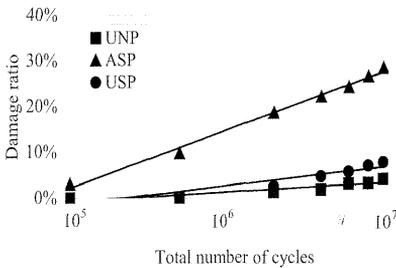
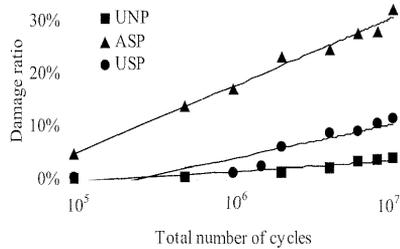
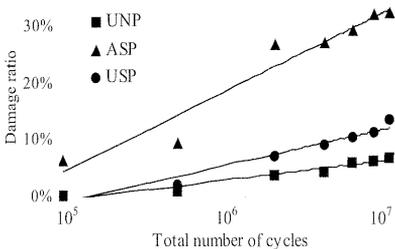
Fig.5 The results of damage ratio

After fatigue test, we observed a lot of micro pitting on the surface and lack at the edge of roller. In recently studies, it was pointed out that micro pitting is an important phenomenon for the fatigue damage of gears and also the lack at the corner could not be ignored. So in this study, micro pitting and the lack was observed to investigate the effect of shot peening treatment. In order to evaluate the damage ratio, we observed the surface situation at every 2.0×10^6 cycle as mentioned before. The damage ratio was determined as (the area of all damage / all contact area). Further, to obtain the precise data, we used the computed image analyzer to calculate the damage ratio at 1,200dpi definition. Fig. 5 shows the relation between damage ratio and the numbers of cycle at each Hertzian stress. The results show the same tendency at every Hertzian stress. Namely, as increasing the number of cycles the damage ratio increased. And obviously, the damage ration at ASP was highest compared to another specimen's condition. Further, at all conditions of contact stress, the damage ratio at 1.0×10^7 cycle was about 30% in ASP, about 10% in USP and roughly 5% in UNP. Once micro pitting was induced, the amount of total pitting number was increased until the specimen would be destructed. Fig.6 shows the number of cycles at 5% damage ratio. The contact fatigue strength can be easily compared using S-N curves. The contact fatigue strength of Not-peened specimen was higher than that of every shot peened specimens. And we could find that strength of Ultrasonic peened specimens was higher than conventional peened specimens.

Fig.5 (a) 1.6GPa

Fig.5 (b) 1.8GPa

Fig.5 (c) 2.0GPa

- (1) It was confirmed that micro pitting occurs before creating the spalling formation and the chipped edge was observed at the roller.
- (2) The damage ratio of shot peened specimens was bigger than the not-peened specimen. That means that the contact fatigue strength declines due to shot peening treatment.
- (3) Especially the damage ratio of ASP corresponding to the highest roughness at the surface was worst. It was considered that micro pitting occurs due to increased friction coefficient by uneven surface instead of the concentration at the edge of roller.

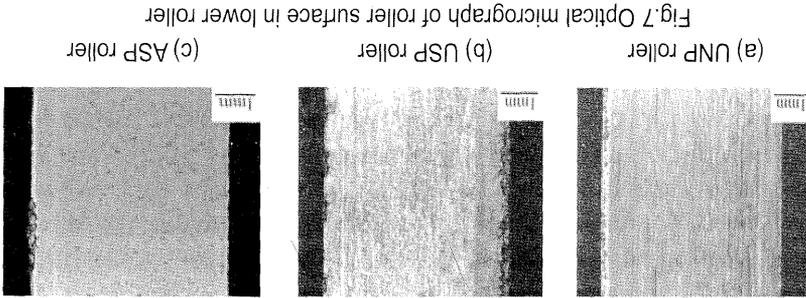
Fig. 7 Optical micrograph of roller surface in lower roller

Fig. 7 shows the optical micrograph of test specimens after fatigue testing at 2.0GPa. At every condition it was observed that the damage mainly occurred at edge of roller specimen and also micro pitting at entire contact area. Especially we could find a lot of micro pitting on shot peened specimens, so surface brightness disappeared compared to Not-peened specimen. SEM micrograph of central part and edge of roller and side view of sectioned roller tested at 2.0GPa is shown in Fig. 8, 9, 10. At UNP specimens, a few micro pitting was observed on the central surface of the roller (a). On the other hand, big damage like lack was observed at the edge of roller as shown in this figure (b). Further the base of

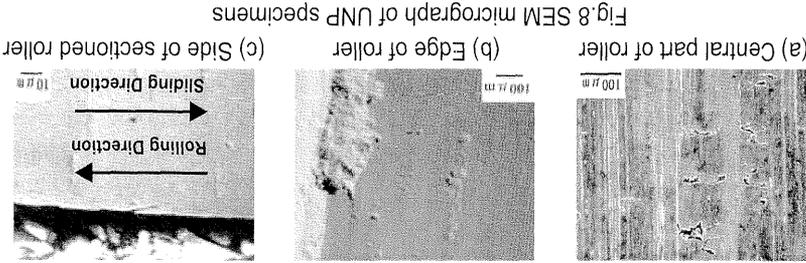
Fig. 8 SEM micrograph of UNP specimens

chipped part was almost parallel to the surface of roller. The reason of this phenomenon was explained by a cracks initiation at its maximum shear stress site due to stress concentration at the edge of roller. Photo (C) displays a few small crack that initiate at the surface and a length of 2 to 3 micrometers. This means that the crack occurs at the surface and propagates in sliding direction. And finally micro pitting occurred due to the lack of material at crack site.

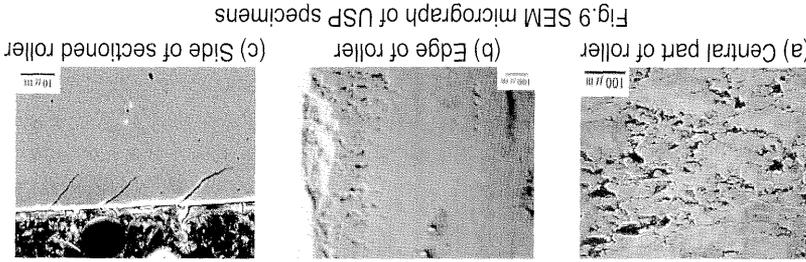
Fig. 9 SEM micrograph of USP specimens

On the other hand, a lot of micro pitting is observed on the center area of USP specimens (Fig.9 (a)). And chipped edge of specimen about 100 micrometers long and also a lot of micro pitting at the corner edge with the width of 300 micrometer was observed. Fig. 9(c) shows a crack like for UNP specimens as mentioned before. This means that micro pitting at USP occurs by the same mechanism as the UNP condition.

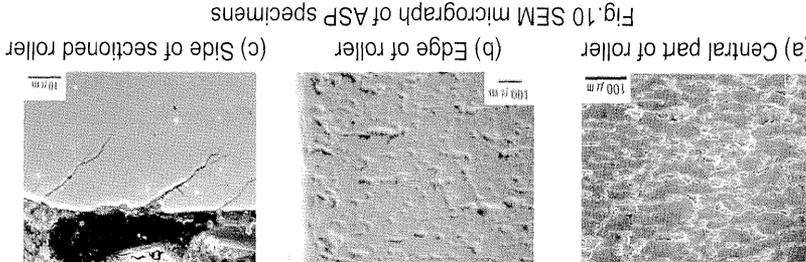
Fig. 10 SEM micrograph of ASP specimens

Further at ASP specimen (Fig.10 (a)) a lot of micro pitting is observed, as for USP specimen, however the chipped edge was not confirmed. The different mechanisms can be considered depending the specimens. Namely, micro pitting occurs due to increased friction coefficient by large uneven surface instead of the concentration at the edge of roller, because the surface roughness of ASP was highest as shown before figure.
