Influence of shot peening and superfinishing on gears as a repair tool of damaged faces of teeth generated by overheating when grinding.

Abstract

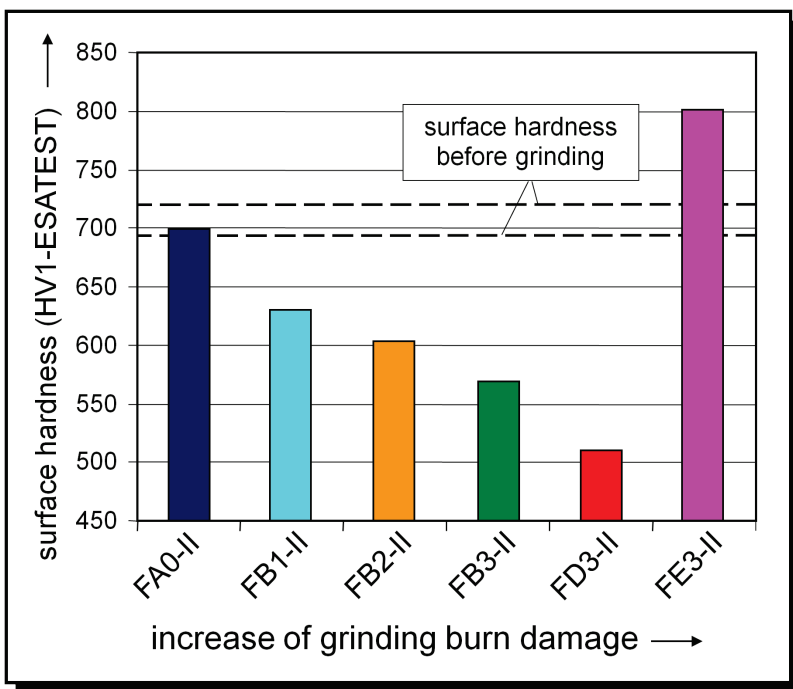
$m_n = 5 \text{ mm}$, generative grinding

ESATEST durometer

Fig. 2: Surface hardness as a function of increased grind burn damage

In the first process, we choose the high intensity and the coverage of 300 % to increase the surface hardness and to introduce residual compressive stress. Fig. 2 shows the reduction of the surface hardness as a function of increased grind burn damage. The flank hardness increases from 510 HV to 590 HV.

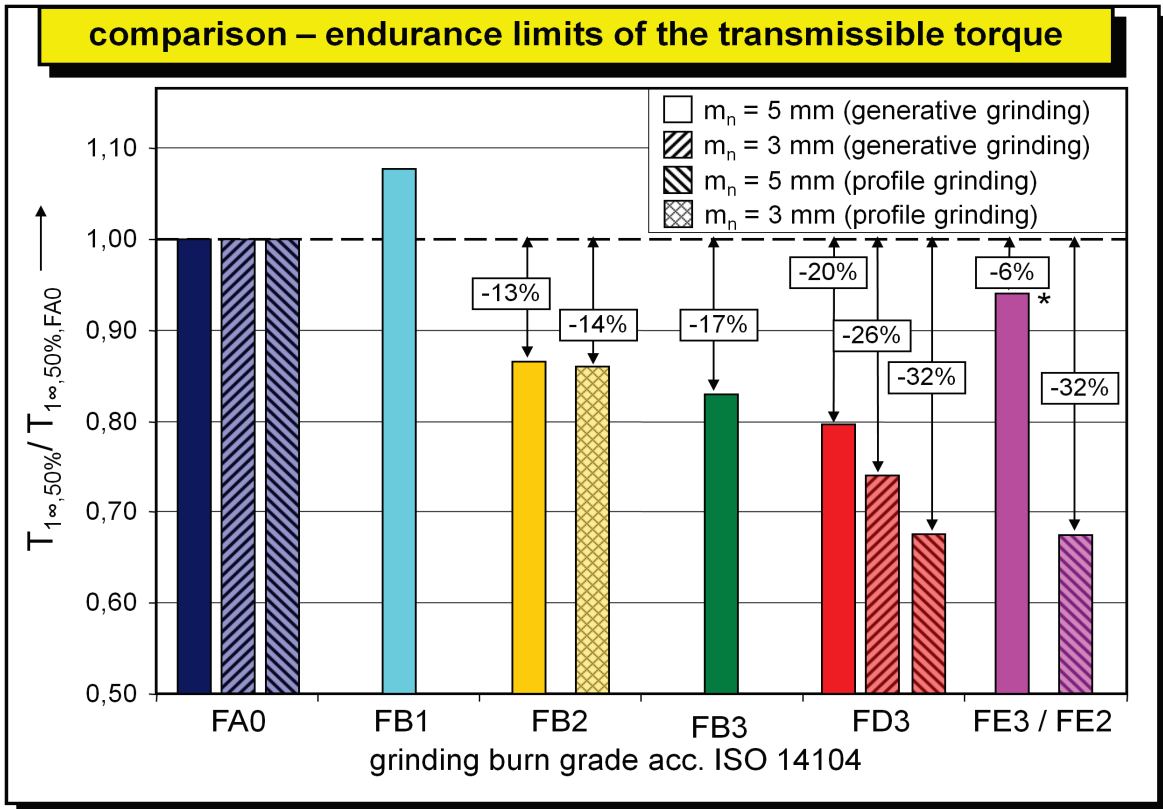
Fig. 3: Comparison of the experimentally determined endurance limit for the transmissible torque.

Figure 3 shows the experimental endurance limit concerning the transmissible torque (50 % failure probability) for each test series related to the endurance limit of the corresponding reference test series without grinding burn effects. There is also a significant difference regarding the grinding operation.

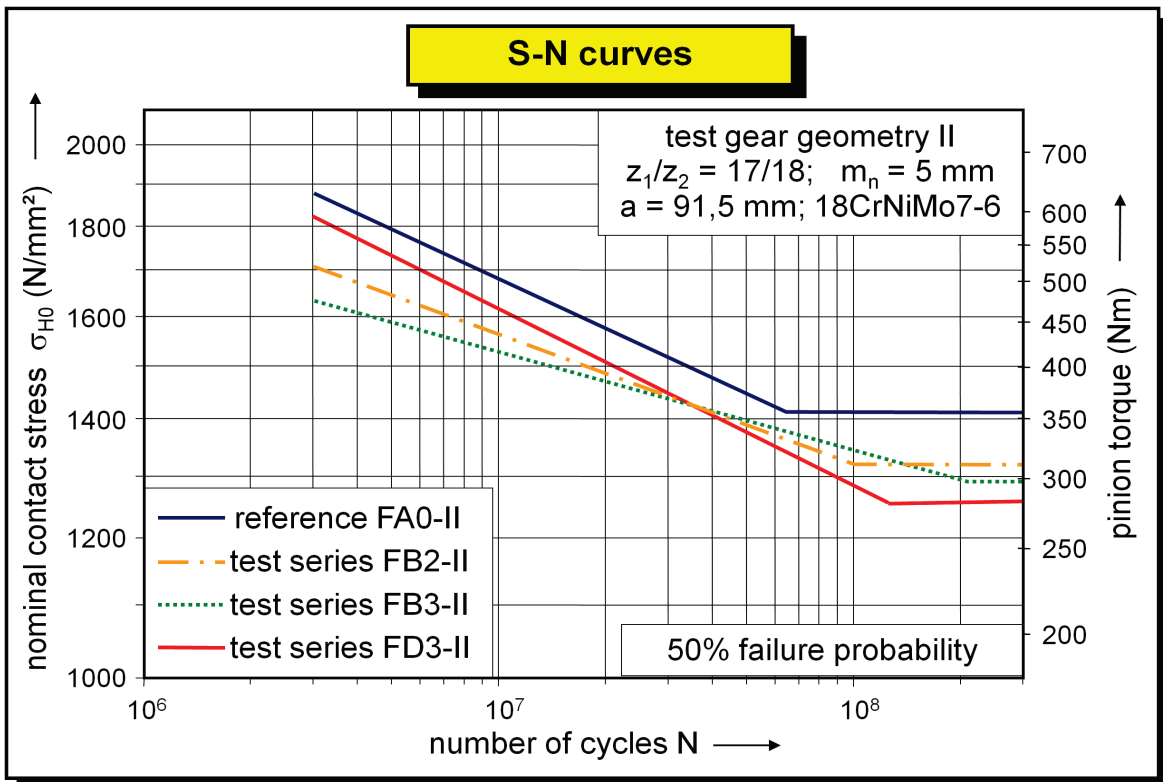
Fig. 4: Reduction of the nominal contact stress as a function of increased grind burn damage.

The Fig. 4 shows the reduction of s-n-curve, especially of the nominal contact stress, regarding the increase of the grind burn damage. The not damaged reference gear FA0 is on the level of $\bar{\sigma}_{H0} = 1410$ MPa.

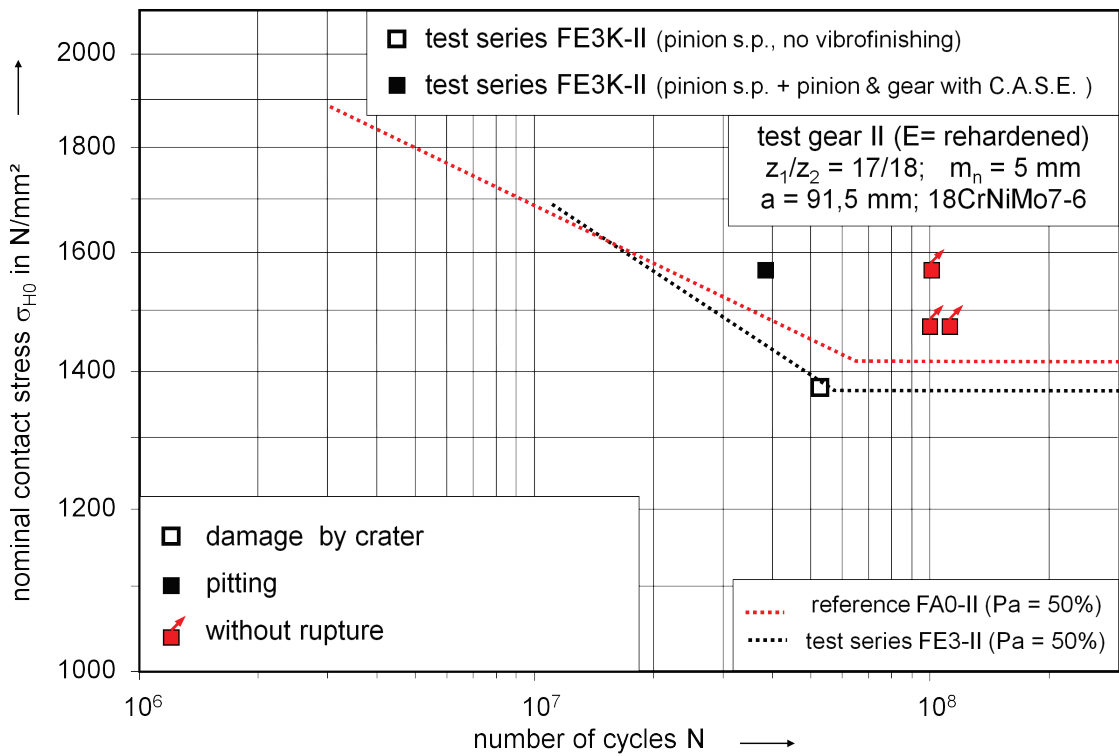
Fig. 5: S-N-curve comparison: no grind burn FA0 $\delta_{H0} = 1410$ MPa / rehardened FE3 versus the shot peened plus superfinished version

By using shot peening plus superfinishing, the grind burn damaged gears, type FB2 showed an increase of nominal contact stress from $\bar{\sigma}_{H0} = 1320$ MPa to $\bar{\sigma}_{H0} \geq 1480$ MPa. Also the gears with re-hardened face show the same effect, see Fig. 5.

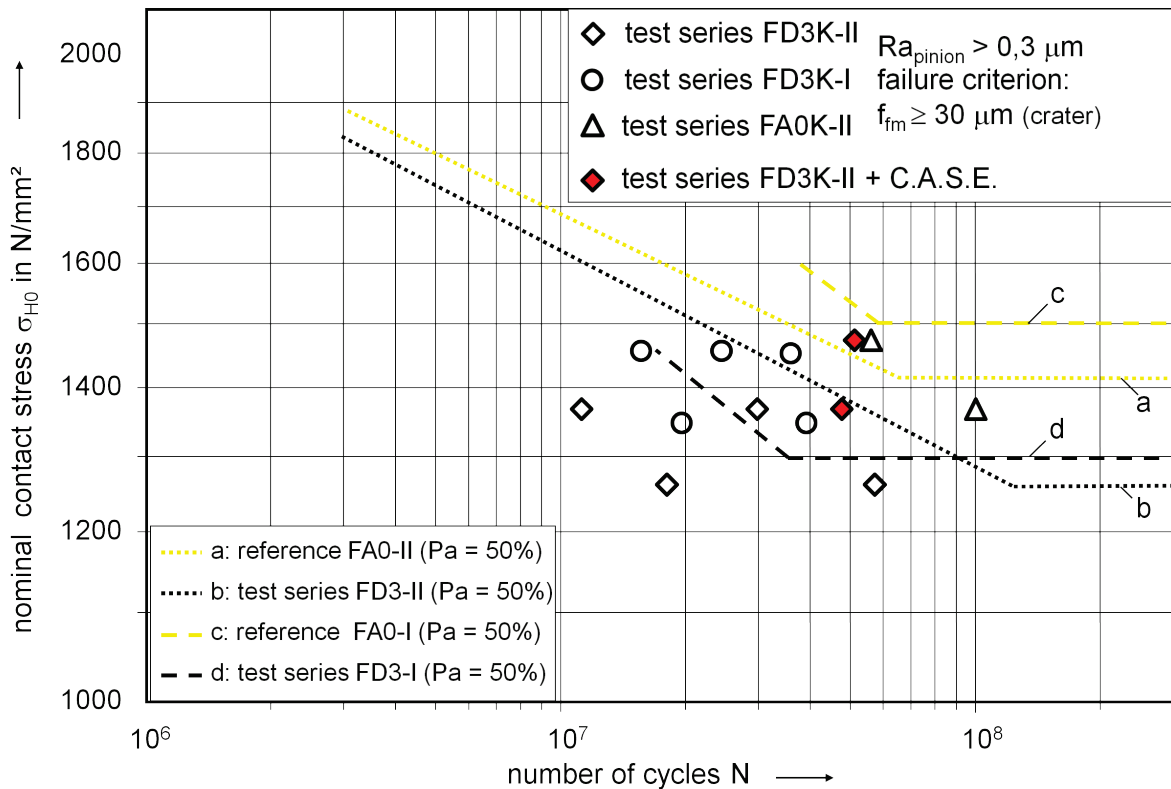
Fig. 6: S-N-curve comparison: no grind burn FA0/heavy tempered FD3 versus the shot peened plus superfinished version.

Fig. 6 shows the S-N-curves of the not tempered gears - reference (a & c) as well as the curves of the heavy tempered gears (b & d). The sampling test with shot peened plus superfinished processed gears shows that the gears reach the level of the not tempered gears. So the combination of shot peening and chemical assisted vibrofinishing is an excellent repair tool of gears.
