FATIGUE CRACK INITIATION IN SURFACE GROUND Ti-6Al-4V

Dr. John T. Cammett III
Metcut Research Associates Inc., 3980 Rosslyn Drive
Cincinnati, Ohio 45209 U.S.A.

Abstract

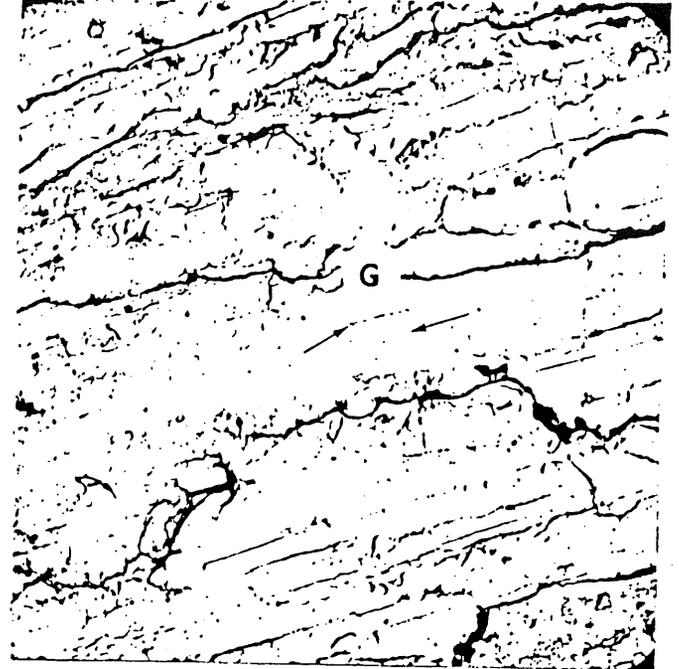
G = Grinding Cracks

Figure 7 - REPLICA TRANSMISSION ELECTRON MICROGRAPHS OF GENTLY AND ABUSIVELY GROUND Ti-6Al-4V SURFACES

Specimens were also examined by scanning electron microscopy and replica transmission electron microscopy. Representative photographs are shown in Figures 6 and 7. The scanning electron microscopy photographs give an excellent photographic representation of the surfaces. As can be seen, the greater smearing which occurs when abusive grinding is readily apparent. No grinding microcracks, known to be present, were resolved by the scanning electron microscopy technique. On the other hand, the replication transmission electron microscopy technique did not permit as good a photographic representation of the surfaces as did the scanning electron microscopy technique. The replica transmission electron

microscopy technique, however, did reveal grinding cracks even smaller than those which were observed optically. Examples of these may be seen in Figure 7.
