Special Edition
"THE AGING AIRCRAFT FLEET"

Fall, 1991

Shot Peening Plays a Major Role in the Rejuvenation Process

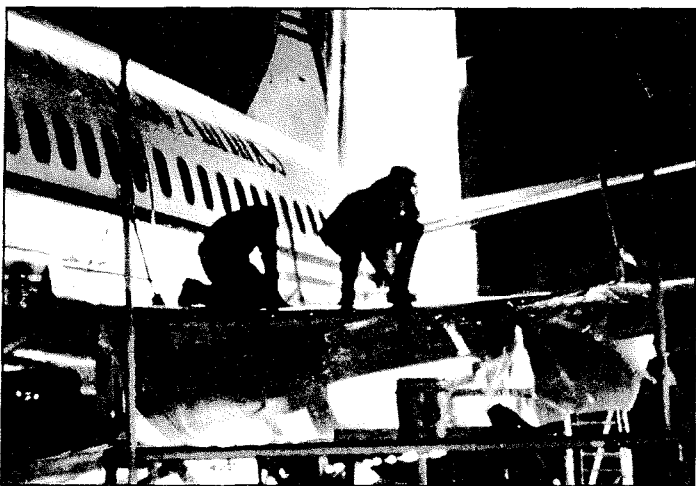
MIC field crew prepares to peen form B-737 replacement wing panel.

Implied (but not stated) is that these panels must be peened formed on the aircraft, a procedure that requires considerable experience and skill. Any distortion or even over-forming cannot be corrected once it has happened, so that the panel would have to be replaced and the process started over again. MIC crews have developed forming techniques so that the spring-back value is less than 0.01 inch and no shimming is necessary.

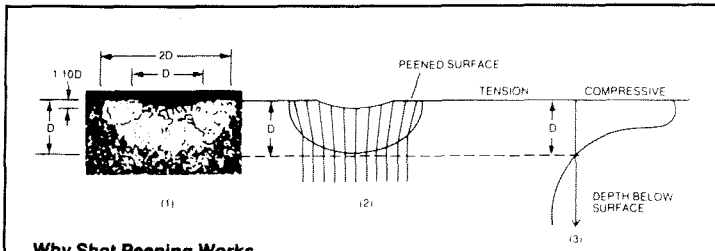
Why Shot Peening Works

1. Impact of a high speed pellet creates a dimple of diameter "D". The depression is about 1/10 D.
2. The surface is stretched by the impact. The depth of the stretching is approximately "D".
3. The "not stretched" core exerts a compressive force in attempting to restore the surface to its original condition.

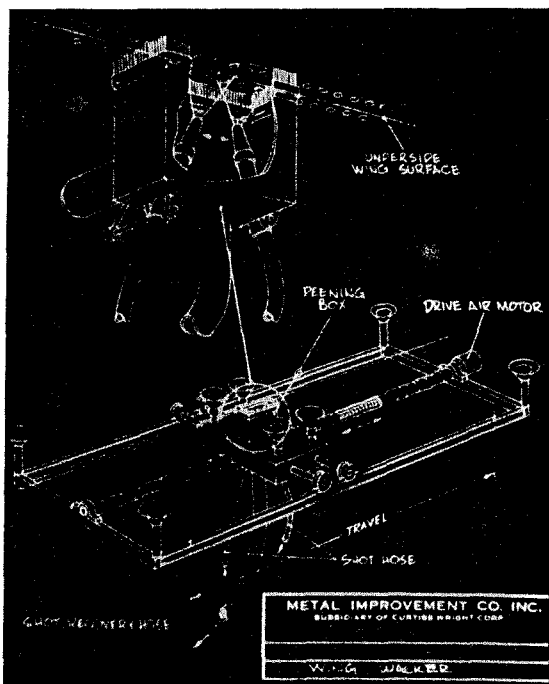
Design of "Wing Walker" machine for fully automated shot peening along rivet runs.

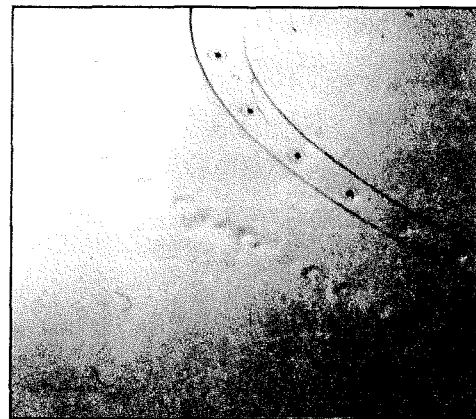
Wing surface showing fastener areas after dressing to remove exfoliation.

Controlled shot peening is of little value in preventing Exfoliation Corrosion but it can be very effective in the process of both identifying and repairing the damage. Service manuals normally call for the removal of the fasteners and then for the use of rotary discs to sand away the corroded material followed by blending the area and polishing out the tool marks. Aircraft structural engineers have used MIC's controlled peening after polishing to compensate for the lower fatigue strength of the newly reduced cross-section. The action of the peening, however, will cause the surface to blister again where deeper exfoliation is present. The surface can then be redressed and repeened until no further blistering occurs. This process, now called "Search Peening," provides a reliable Non Destructive Testing of the exfoliated material. The action of the peening on the thin exfoliated layer is essentially the same as that employed in the process of Peen Forming, used to generate the aerodynamic curvatures in the wing panels of most commercial airliners. Peening of corroded surfaces can be accomplished using special enclosures to contain the media. It is essential to maintain extreme control on the intensity of the peening so as not to cause distortion of the skin itself, rather than just the blistering of the exfoliated layers. MIC has applied for a patent on our "Wing Walker" machine which is used to undertake automatic and fully controlled Search Peening for exfoliation corrosion along the fastener runs on the wing and tail surfaces.

When using rotary sanding disks to remove exfoliated material, we have always been careful to preserve a minimum width to depth ratio of 20:1 with well blended edges. This operation is always followed by a saturation peening to introduce the residual compressive stresses for fatigue and stress corrosion cracking protection.

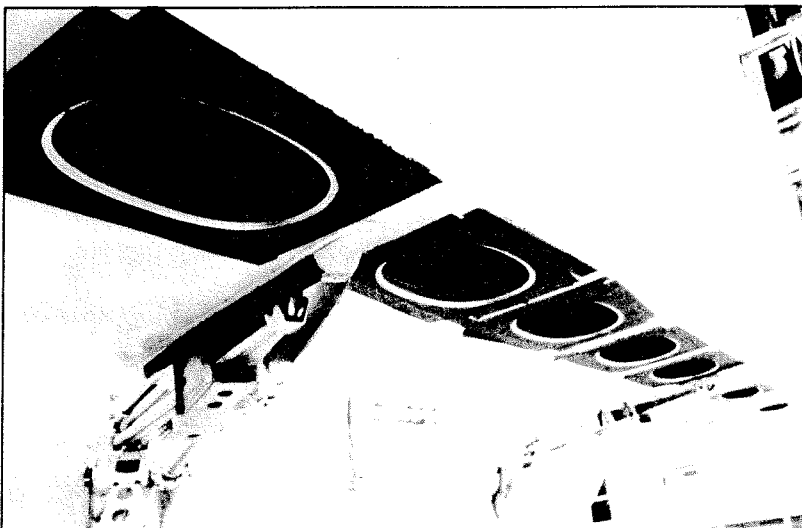
Fuel tank access ports masked before shot peening in door recesses.

B-757 Hardly an "old" aircraft but fretting corrosion followed by exfoliation corrosion has been found extensively in the recesses of the fuel access ports, where the cover plates fit. This seems to be more common with the 757s but we have also treated 747s and 737s in the 20-25 access ports under each wing. Special tooling and masking techniques have been developed by MIC that allow us to be very efficient at this job.
