# United States Patent [19]

[54] **LASER SHOCK PEENING FOR GAS TURBINE ENGINE WELD REPAIR**

[73] Assignee: **General Electric Company**, Cincinnati,  
Ohio

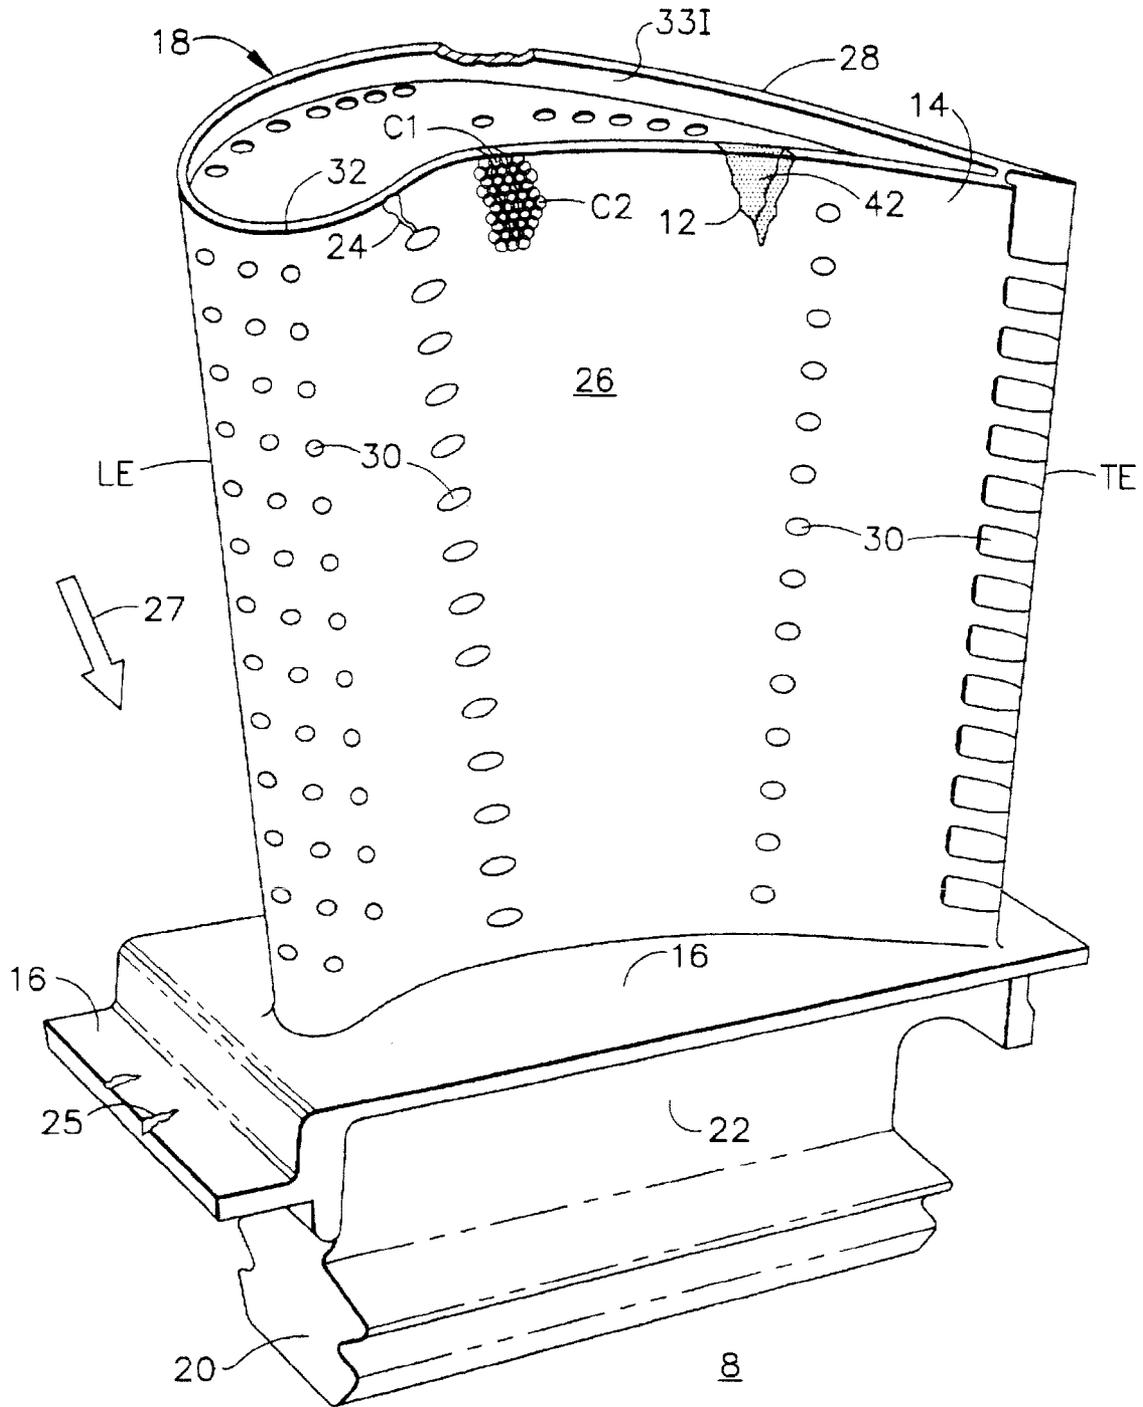
FIG. 1 is a perspective illustrative view of an exemplary aircraft gas turbine engine turbine blade in accordance with the present invention.

Illustrated in FIG. 1 is a turbine blade 8 which is typically circumscribed by a shroud (not shown) against which it seals and is illustrated as having a squealer type tip 18 that is often used in the high pressure turbines. The turbine blade 8 includes an airfoil 14 extending radially outward from a blade platform 16 to the blade tip 18. The turbine blade 8 includes a root 20 connected to the platform 16 to by a blade shank 22. The airfoil 14 includes a pressure side 26, facing in the general direction of rotation as indicated by an arrow 27, and a suction side 28. Cooling holes 30 are disposed through an outer wall 32 of the turbine blade 8 on its leading edge LE, trailing edge TE, and the pressure and suction sides 26 and 28, respectively.

The turbine blade 8 rubs on the shroud causing tip damage in the form of blade tip cracks 12 shown filled with a filler in the form of a metallic weld material 42 in accordance with the present invention. Cooling hole cracks 24 and blade platform cracks 25 also form due to normal wear and engine usage. All of these types of cracks have been and continue to be repaired by welding and brazing in other types of crack repairs for gas turbine engine components. These repairs are generally done by filling the an empty void 40, illustrated in FIG. 2, of each of the cracks with the metallic weld material 42, illustrated in FIGS. 3 and 4, to produce a filled void 48 bonded to an inner crack surface 44. Often the crack surface 44 is prepared in some time consuming manner and the crack repair is subject to fatigue failure of portions of the filled void 48 often along the crack surface itself. The blade 8, as well as many other gas turbine components, is subject to extreme thermal cycling which causes thermal fatigue and oxidation damage generated during engine operation. These repairs, even when filled with the braze or weld material 42 are subject to thermal fatigue failure.

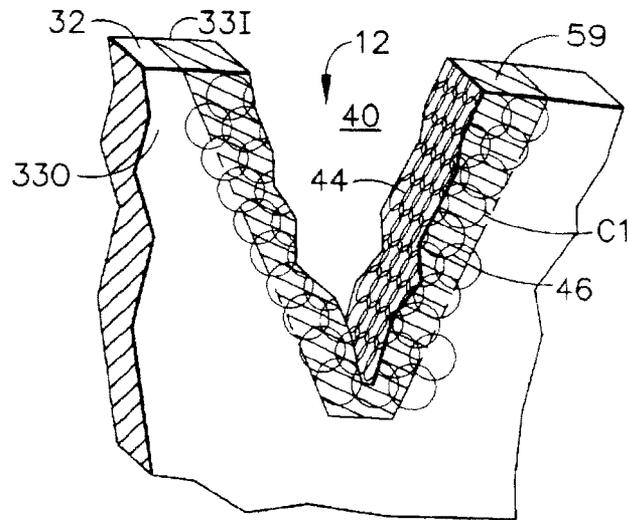
FIG. 2 is a cross-sectional illustrative view of a tip of the turbine blade in FIG. 1 showing a partially repaired crack in accordance with the present invention.

The present invention counters this fatiguing process by laser shock peening the crack surface 44 as well as the areas on an outer side 330 and preferably on an inner side 331 of the outer wall 32 at the tip 18 to form a laser shock peened surface 46 that includes all of the crack surface 44. The present invention produces laser shock peened surfaces, such as the laser shock peened surface 46, with laser beam induced shock waves generally indicated by overlapping laser shock peened circular spots indicated generally by a circle labelled C1 for a first set of circles or spots and C2 for a second set of circles or spots in FIGS. 2, 3 and 4 and, therefore, are referred to as laser beam shocked surfaces. The filled void 48 extending between surface areas of the metallic body, of the blade or other metallic component, that bounds the void is filled with a metallic repair material which is bonded to the laser shock peened surface 46 and indicated by the first set of circles C1. A corresponding first laser shock peened region 59 extends into the body from and bounds the filled void 48 and from the outer side 330 and the inner side 331 along the laser shock peened surface 46. The first laser shock peened region 59 has deep compressive residual stresses imparted by laser shock peening extending into the body from the laser shock peened surface 46. Even if the laser beam cant be directly impinged on the entire

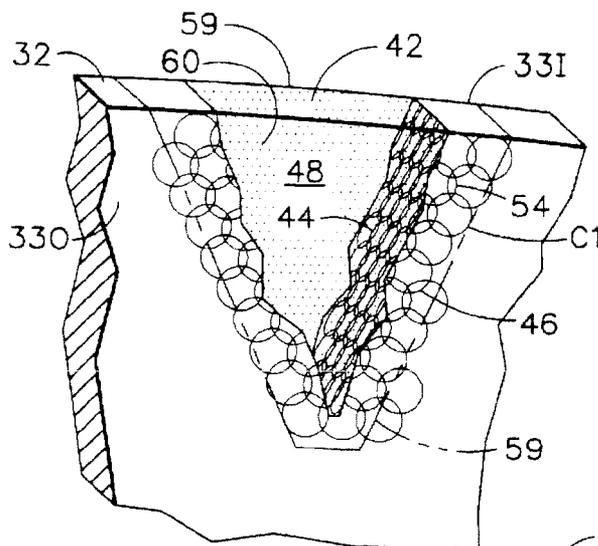
FIG. 3 is a cross-sectional view of the partially repaired crack in FIG. 2 illustrating a further step in the repair of the crack in accordance with the present invention.

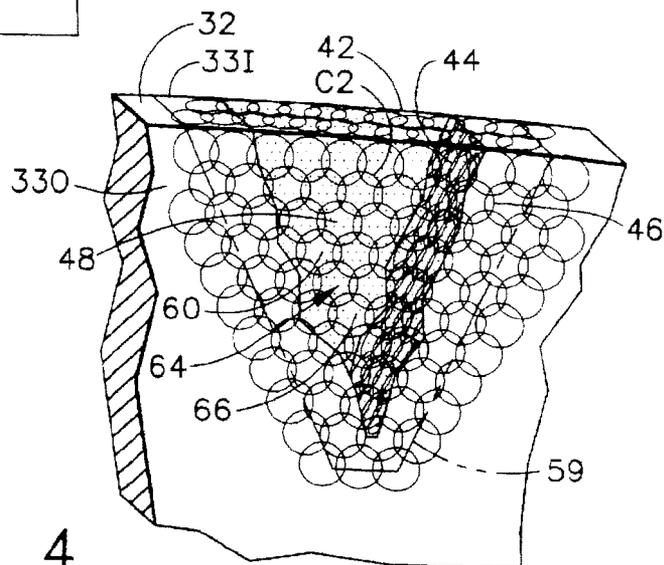
FIG. 4 is a cross-sectional view of the repaired crack in FIG. 3 illustrating a further step in the repair of the crack in accordance with an alternative embodiment of the present invention.

It is well known in the art to construct gas turbine engine components such as the turbine blade 8 from Cobalt and nickel-base superalloy materials. The components are often cast with a process to produce directionally solidified components, with grains aligned parallel to the axis of the airfoil, or a single crystal component, with no grain boundaries. The weld material 42 or braze material is preferably also made of these alloys and the weld or braze repair does not restore all of the original properties, particularly single crystal and directionally solidified mechanical properties, in the repaired areas of the blade 8. Therefore, the present invention provides an alternative embodiment that is more particularly illustrated in FIG. 4. To counter the loss of material and process properties and capabilities the filled voids 48 are laser shock peened on their outside surfaces 60 forming a second outer laser shock peened surface 64 as indicated by second set of circles C2 and a second laser shock peened region 66 beneath it. This further strengthens the entire weld repair.
