What Is Your Machine Trying to Tell You?

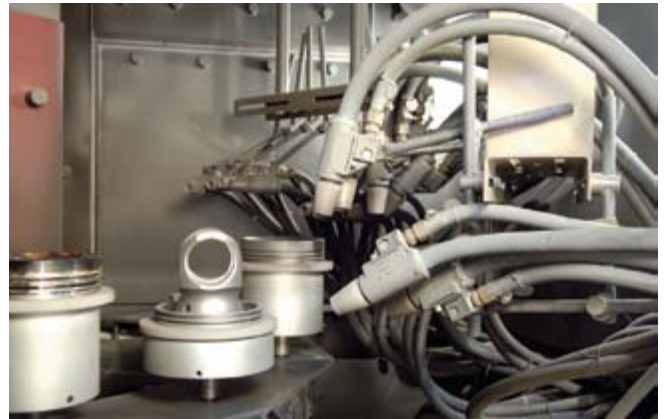
Fig 1. Nozzles targeting specific areas on the component and away from the door.

A well-designed machine will attempt to direct media from a nozzle or blast wheel away from an access door, work door or protected opening (Fig. 1). In addition, most cabinets are lined with wear-resistant material for protection from the incidental media stream or rebound media bouncing off the component. However, these features don’t always prevent media leakage and then we must look into the causes.

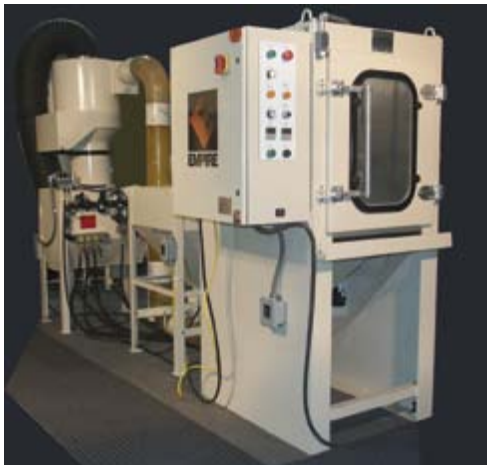
A lip below the access door will reduce media leakage onto the floor.
