Shot peening for surface topography optimization to avoid micro pitting

C. Peyrac ^a, D. Ghribi ^a, F. Lefebvre ^a, J. Samuel ^b

^aCetim, 52 Av. Felix Louat 60304 senlis, France, Catherine.peyrac@cetim.fr, Dhafer.ghribi@cetim.fr, Fabien.lefbvre@cetim.fr; ^bWinoa, 528 Avenue de Savoie, 38570 Le Cheylas France, mailto:joan.samuel@winogroup.com

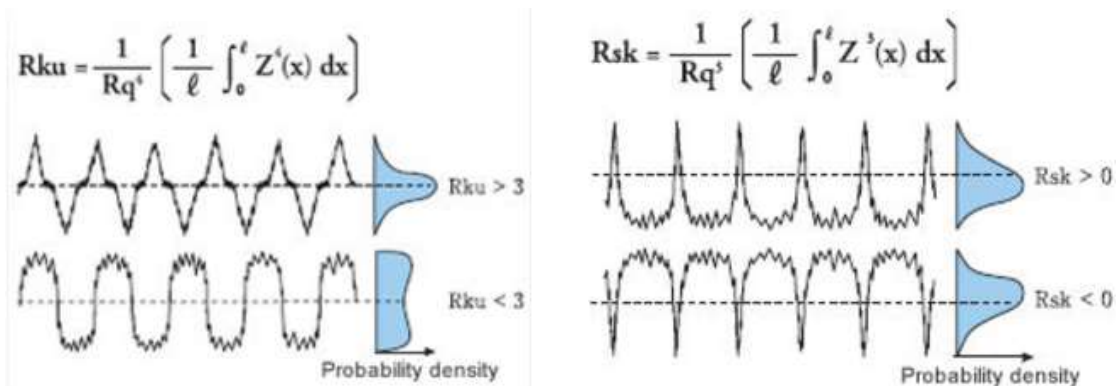
Figure 3 : Definition of roughness profile parameters: Kurtosis (R_{ku}) and Skewness (R_{sk})

We have to remind that Rku describes the peaks shape, and Rsk the presence of peaks or valleys (see

Figure 3). $R_{ku} < 3$ and $R_{sk} < 0$ give logically an optimal surface topography to avoid micro pitting. The residual stress profiles obtained with these conditions are presented in Figure 4. They present a typical residual stress profile of shot-peening treatment. Surface analyses have also been performed using optical photography and 3D interferometry. Results are summarized in Figure 5.

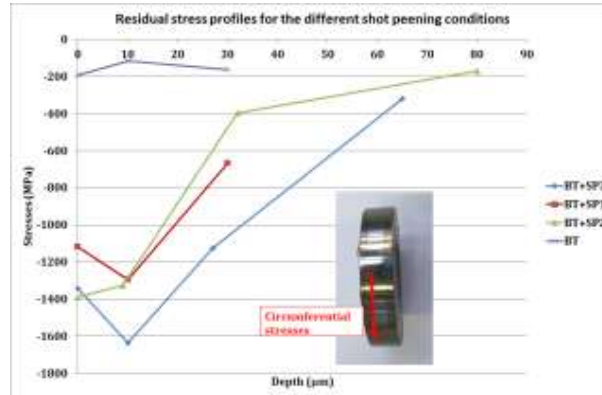
Figure 4 : Residual stress profiles after shot peening

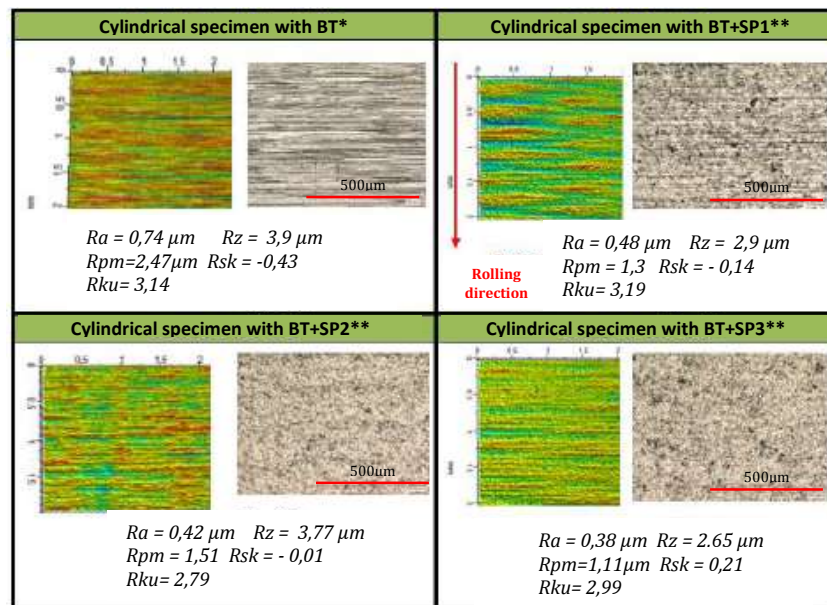
Figure 5 : Surface topography characteristics for the different treatments

* Basic treatment (BT): Case-hardening, quenching, tempering and grinding

** Basic treatment with a specific Shot Peening (BT + SP (1, 2 or 3)): Case-hardening, quenching tempering, grinding and Shot peening.

To be as close as possible to the real contact conditions in gears, as shown in Figure 5, specimen have been machined with grinding direction normal to the rolling one.

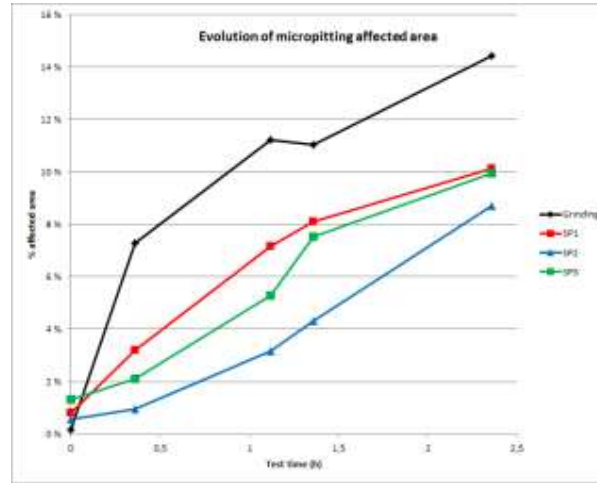
Figure 8 : Micro pitting quantitative evolution for specimen with and without shot peening

To get more quantitative results, all these photos have been treated by image analysis. The curves in Figure 8 present the evolution of micro pitting affected area along the fatigue test.

It is clear on these curves that micro pitting is more important on grinding specimen, and it occurs very quickly.

By adding the shot peening (SP1, SP2 and SP3), it appears that the micro pitting is reduced, compared to the carburized-grinded specimens. One of these solutions, SP2, seems to be more efficient to reduce micro pitting. Moreover, for all the micro pitting increases continuously during the first 156mn of test.

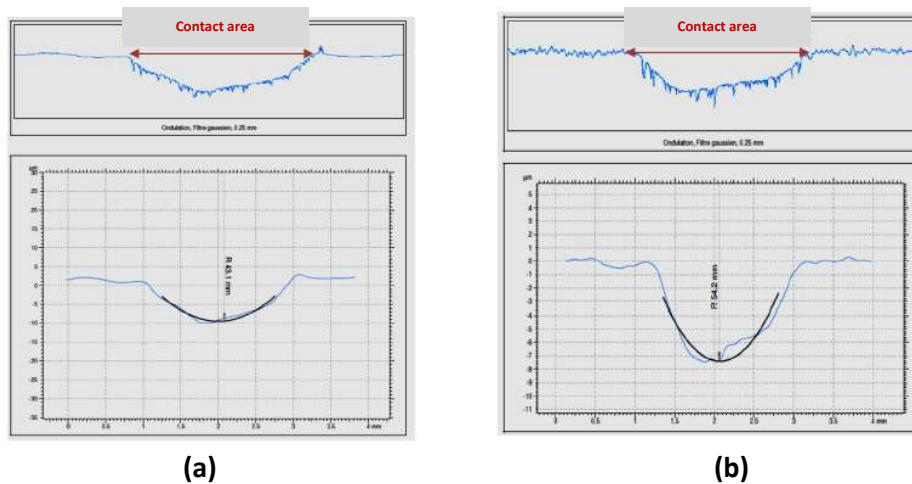
Figure 9 : Surface deformation on grinded (a) and SP2 (b) cylindrical specimen after 50h rolling contact fatigue

In order to explain these deviations, complementary measurements of the surface profile of the cylindrical specimens are carried out. A relatively large surface deformation is thus observed (see Figure 9). This deformation has to be taken into account to determine the effective contact pressure, which is finally 20% lower than the theoretical one. The contact pressure decreased from 2500 to 2000 MPa for which the time of appearance pitting is greater than 100 h ($> \approx 10^7$ load cycles), according to the ISO 6336 [6].

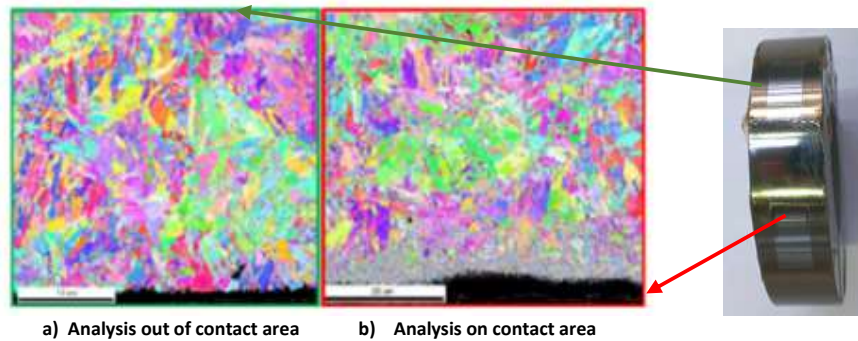
Figure 10 : EBSD analysis on grinded specimen after 2,5 hrs rolling contact fatigue

In order to understand and explain the surface deformation, EBSD (Electron BackScatter Diffraction) analysis [7] has been performed on grinded specimen, on and out of rolling contact area (Figure 10), after 2,5hrs of rolling fatigue contact under 2500MPa theoretical pressure. The picture on the right side shows the presence of very small sized grains on the surface layer (until a depth of $15\mu\text{m}$). This is the consequence of plastic deformation [8] which occurs during the early cycles.
