Enhancing High Cycle Fatigue Performance Of Electron Beam Melted Ti6Al4V: A Study On Shot Peening And Hot Isostatic Pressing

ENHANCING HIGH CYCLE FATIGUE PERFORMANCE OF ELECTRON BEAM MELTED Ti6Al4V: A STUDY ON SHOT PEENING AND HOT ISOSTATIC PRESSING

Naghmeh M. Mojb¹, Dwayne Arola², and Ramulu Mamidala¹

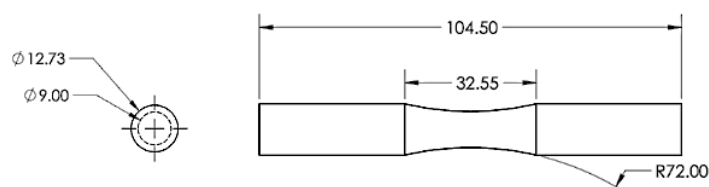
Figure 1. The final dimensions (in mm) per ASTM E466.

in the hoppers. The samples were fabricated on an ARCAM A2X Electron Beam AM system (Mölnadal, Sweden) using powder batch #P1143 at the 10th reuse cycle. 10 mm samples were fabricated and machined to the final dimensions shown in Figure 1.

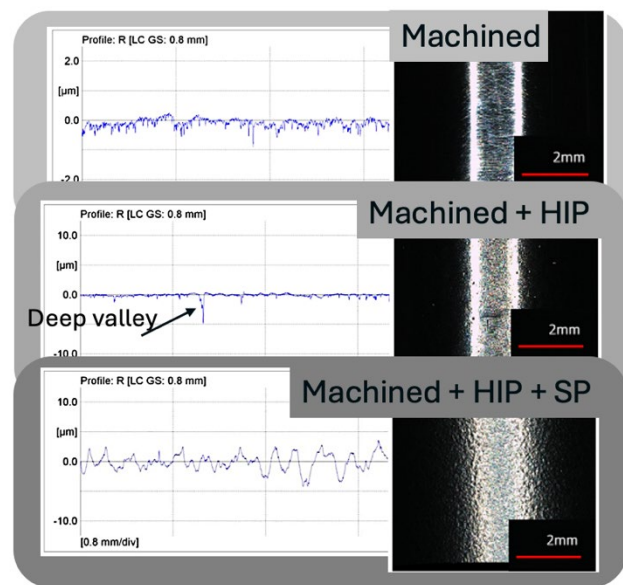
Figure 2. Optical surface morphology

The 3D surface morphology is provided in Figure 2 as a function of metal and surface condition. Small defects were observed in the machined samples that underwent a HIP treatment. Lastly, SP samples exhibited a deformed surface due to the shot peening process. However quantitative analysis was required to fully understand the influence of surface roughness.

Table 1 summarizes the surface roughness parameters including: the average surface roughness values (R_a), ten-point height (R_z), maximum valley to peak height (R_t), skewness (R_{sk}), and maximum valley depth (R_v), as a function of surface and metal condition. Data of samples in the As-Built condition is included for reference from a previous study [15]. R_a , R_z , R_t , and R_v decreased significantly with machining. The negative R_{sk} values across all conditions indicate valley-dominated surfaces, with an increase in uniformity with shot peening application. Furthermore, it is important to note the significant increase in the scatter in data after the HIP treatment indicating a large range of valleys adorning the surface, as observed in Figure 2.

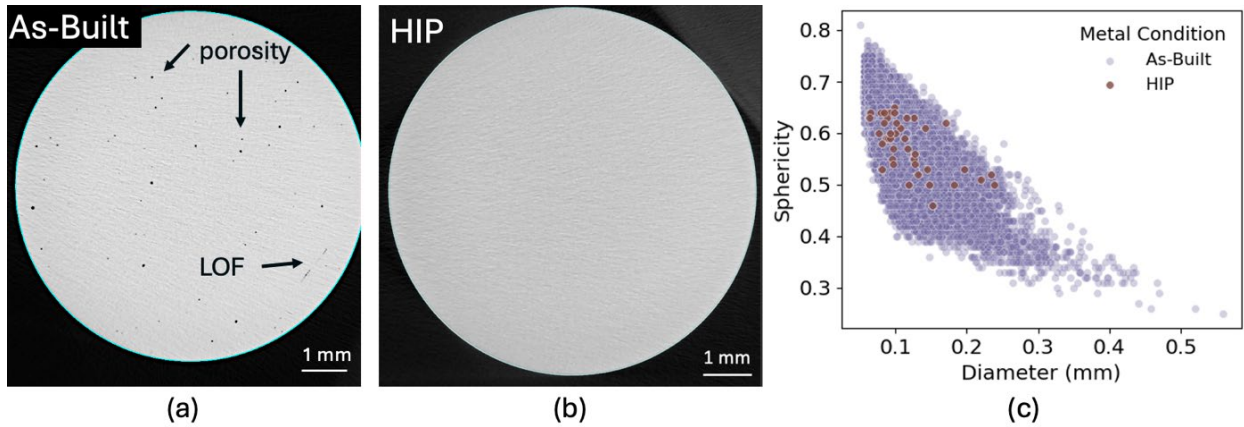
Figure 3. The 3D reconstruction of the internal view of the (a) As-Built and (b) HIP samples. Porosity and LOF defects are observed in the As-Built condition but not HIP. (c) The defect diameter vs. sphericity trends in the as-built and HIP samples.

Figure 3 shows μCT reconstruction and defect trends of PBF-EB Ti6Al4V samples in the *As-Built* and *HIP* condition prior to testing. Non-destructive testing reveals key features of the metal in both conditions. In the as-built samples, two defect types are visible Figure 3 (a): randomly distributed spherical gas pores and irregular high-aspect ratio LOF defects. Defect morphology was quantified using diameter (based on equivalent sphere) and sphericity (ratio of surface area relative to a sphere of equal volume). Sphericity values near 1 indicate spherical pores, while more irregular shapes exhibit lower sphericity. As shown in Figure 3 (c), most defects ranged from 50 μm to 600 μm , with those above 250 μm generally exhibiting low sphericity, corresponding to LOF defects. HIP treatment significantly reduced the number and severity of defects, fully eliminating LOF. While the μCT threshold identified regions of potential internal porosity in HIP samples, no such defects were confirmed upon manual inspection, as shown in Figure 3 (b). Surface-connected defects were excluded from the analysis due to software limitations.

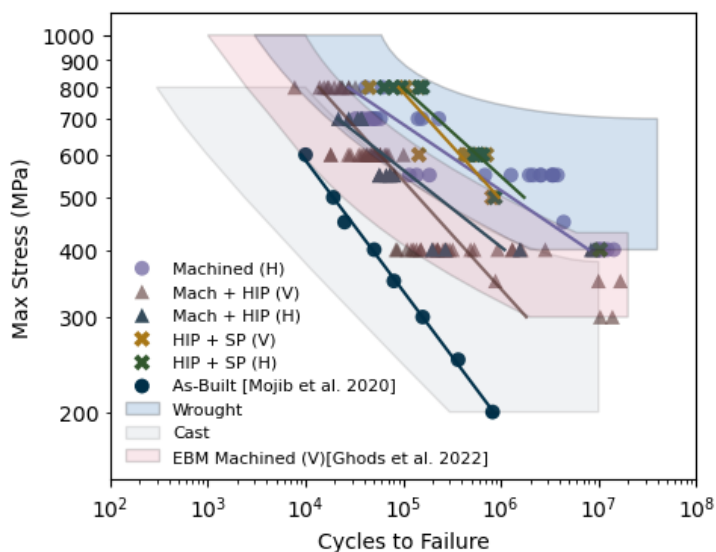
Figure 4. Fatigue stress-life curve as a function of surface and metal condition, in each orientation.

The following section will discuss the various factors influencing PBF-EB fatigue performance. Experimental analysis of PBF-EB in the as-fabricated, surface-treated, and heat-treated condition are evaluated. Figure 4 shows the stress-life curves of post-processed PBF-EB Ti6Al4V as a function of surface and metal condition. The stress-life curves were determined through fitting the experimental data to the Basquin equation for each metal condition and overlaid on published sources for PBF-EB, wrought, and cast Grade 5 Ti6Al4V [15,20,21]. Post-processing significantly enhanced the PBF-EB fatigue performance but heavily depended on the surface condition. Fatigue behavior increased from 200MPa in the As-Built condition to 350MPa with the machining application. Finally, shot peening had the most significant enhancement in fatigue performance, yielding endurance limit up to 400 MPa. In essence, regardless of presence of internal defects, the as-printed surface remained detrimental to the fatigue life of PBF-EB Ti6Al4V. Alternatively, through removal and refinement of the as-printed surface, fatigue life comparable to wrought and cast alloys was achieved.

While the surface finish had the most significant influence on the fatigue behavior of PBF-EB Ti6Al4V, further investigation was necessary for understanding factors influencing scatter in the fatigue behavior. The influence of the print orientation on the fatigue behavior of the PBF-EB Ti6Al4V is shown Figure 4. Overall, the horizontal orientation survived longer than the vertical

orientation, with the largest variation in the untreated condition. With an additional application of shot peening, the orientation-dependent fatigue behavior was nearly eliminated. Effectively, the comparable fatigue properties in the two orientations after the shot peening application means that with surface and heat treatment, the largest sources of variation (surface finish, orientation, internal defects) could be reduced.

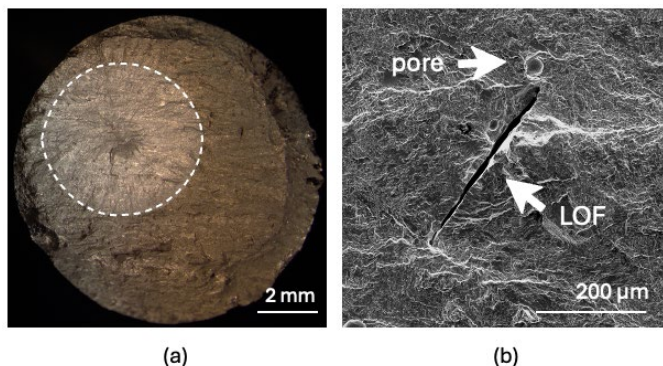
Figure 5. (a) Typical fatigue fracture surface. (b) common defects found in as-built metal.

Fractography was performed after sample fracture using optical and scanning electron microscopes. A typical fatigue fracture surface exhibits three distinct regions shown in Figure 5(a): the source of crack initiation, the area of crack propagation and the area of final fracture. Typically, lines are found radiating away from the crack initiation source until it reached a flat fracture region as the crack grows, until the final fracture, where shear lips and ductile dimpling are observed. Spherical gas porosity and LOF defects were only observed on the fracture surface of the untreated sample shown in Figure 5 (b).

Spherical gas porosity and LOF defects were only observed on the fracture surface of the untreated sample shown in Figure 5 (b).

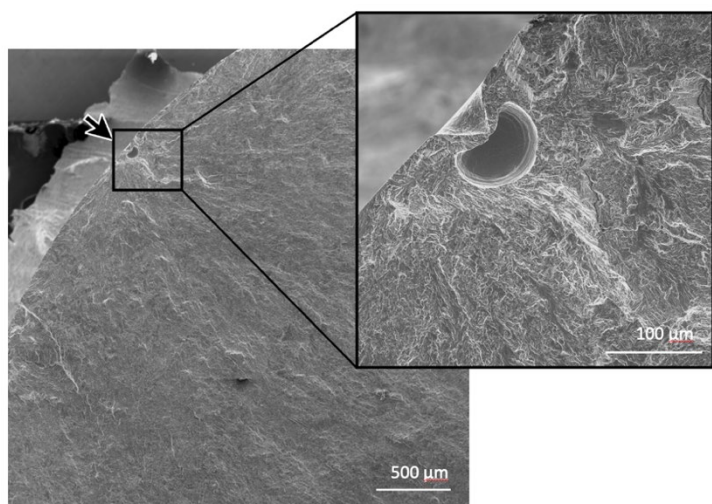
Figure 6. Fractography of the HIP+Machined samples, with the arrows indicate the location of crack initiation.

Figure 6 (a) shows the fracture surface of samples with a HIP treatment. The HIP treatment was successful in removing internal defects, where porosity and LOF defects were not observed on the fracture surface. The subsurface defects located 200 μ m from the surface with μ CT were similarly observed with high-magnification imaging and profilometry. The sharp notch-like defects on the surface of the samples were a result of the high-pressure HIP process deforming preexisting subsurface defects below the external surface. Figure 5(a) exhibits the low magnification fatigue fracture surfaces of the shot peened sample, often failing due to subsurface and internal features.

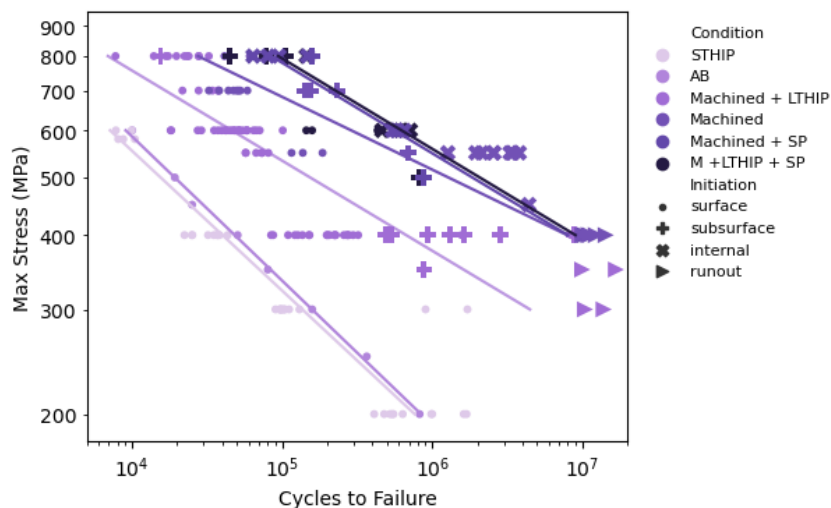
Figure 7. Summary of crack nucleation source of samples for each metal and surface condition.

Fatigue failure originated from three primary nucleation sources: surface, subsurface, and internal defects as shown in **Figure 7**. Failure origins were identified post-fracture and distinguished with the following markers circle (surface), + (subsurface), and X for internal crack nucleation, samples reaching runout at 10^7 cycles are characterized by an arrow. In all as-built specimens, cracks initiated at the surface defects due to the partially melted powder particles, resulting in fatigue limit far below the ~550 MPa reported [6,7,22].

Once the surface was machined, fatigue cracks primarily initiated from subsurface and internal defects. Childerhouse et al. [23] showed fatigue strength doubled when 1mm of surface material was removed, highlighting the critical role of removing both surface and subsurface defects.
