Assessment of “as-printed”, machined & post processed additive layer manufactured (ALM) Ti-6Al-4V for aerospace applications

S. L. Jenkins ^a, D. P. Davies^a, J. P. Fuhr ^b, S. McArthur ^c

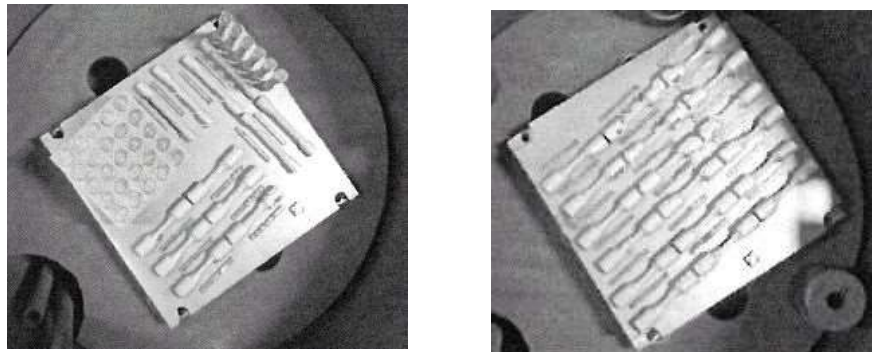
The test coupons were built to the required specimen dimensions (see Plate 1). The machine used to produce these coupons was a 3TRPD M280 400W system which built up these samples in 60 µm layers, using standard Ti-6Al-4V processing parameters.

Plate 1 – Location of ALM Test Coupons on Build Platens

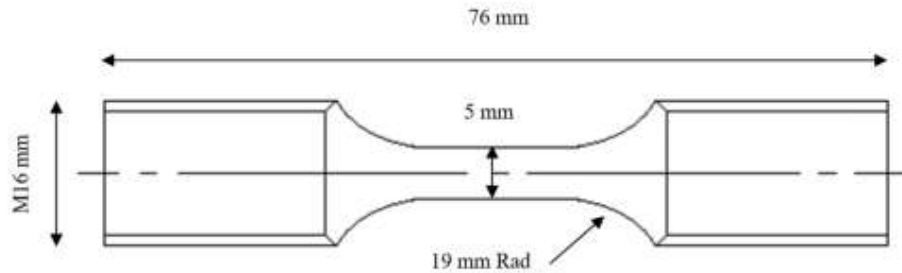
The axially loaded fatigue specimen used during the fatigue evaluation trials was based on a Vibrophore design (see Figure 1). The fatigue test specimens were either manufactured to the defined dimensions (“As Printed”) or were machined down to the dimensions from ALM cylinders (“As Machined”). Regardless of the manufacturing method employed the specimen was designed according to dimensional requirements specified in ASTM E466. In the case of the ALM cylinders the waisted section was machined to a 0.4 µm finish.

Figure 1 - Vibrophore Fatigue Test Specimen Design

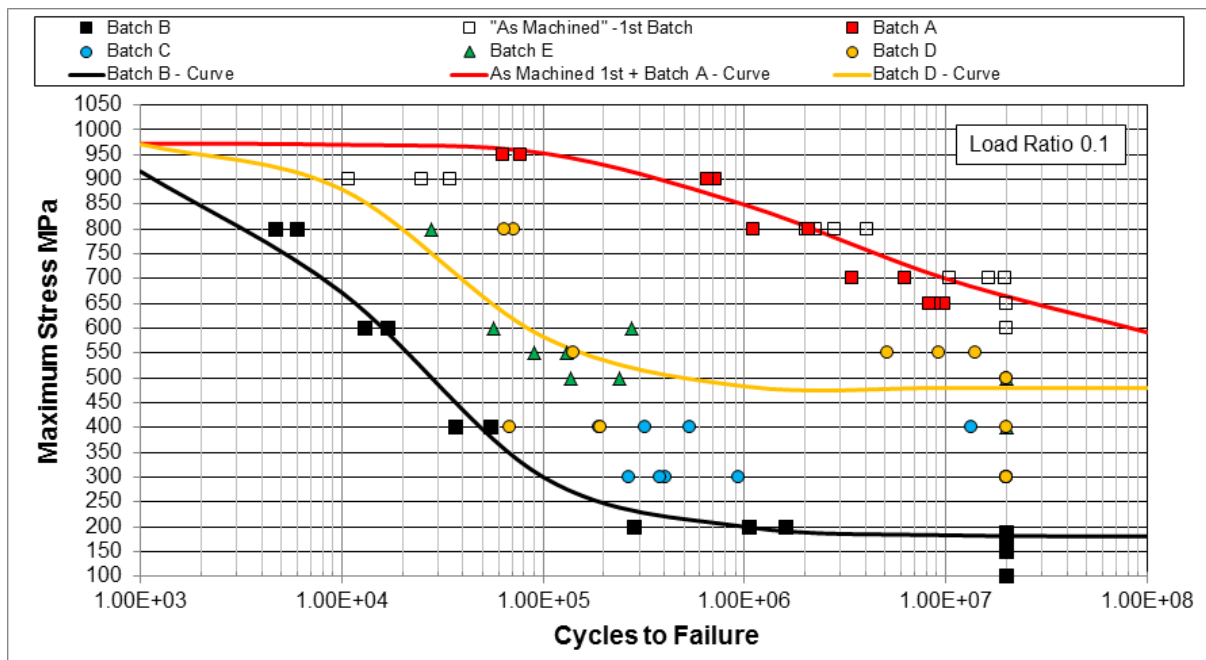
The fatigue results obtained from each group of specimens are shown in the S-N curves produced from the individual data points for each data set are shown in Figure 2.

Note: Samples tested to 20 million cycles are defined as "run outs" (i.e. un-failed samples)

Figure 2 – S/N Curve of "As Printed" [Batch B], "As Machined" [Batch A], Shot Peened [Batch C], Shot Peened/Superfinished/Shot Peened & Superfinished [Batch D] or Superfinished alone [Batch E]

From the S/N curve data shown in Figure 2 it can clearly be seen that the ALM “As Printed” batch was inferior by a factor of three when compared to the ALM “As Machined” batch. The inferiority of the “As Printed” ALM is considered to be due to four main factors:-

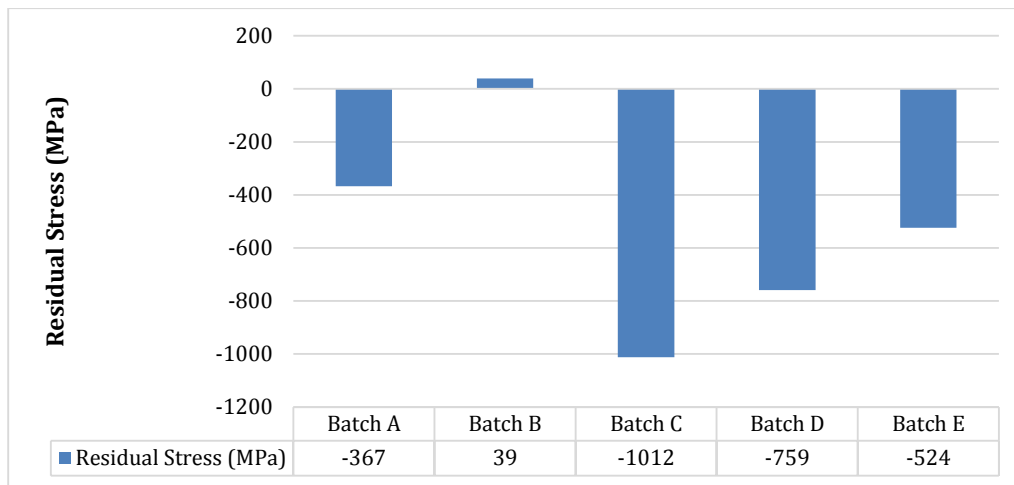
The maximum values of tensile or compressive surface residual stresses obtained from the different conditions are shown in Figure 3.

Figure 3 – Maximum Values of Measured Surface Residual Stress: “As Machined” [Batch A], As Printed” [Batch B], Double Shot Peened [Batch C], Shot Peened & Superfinished [Batch D] or Superfinished alone [Batch E]

- A far higher level of surface roughness.
- The presence of partially melted grains and unfused regions at the surfaces creating surface re-entrant angles/notches at the surface, see Plate 2.
- The surface layer was in a slightly tensile residual stressed state, see Figure 3.
- Evidence of surface oxidation(alpha case contamination), see Plate 2.

By investigating the changes in fatigue endurance in relation to superfinishing, the following observations were made in the relation to Figure 3.

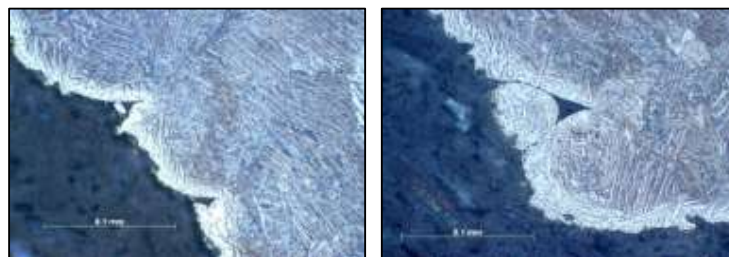
Plate 2 – Micro-section taken through “As Printed” ALM showing Evidence of Surface Oxidation, Un-melted Powder Particles and Re-entrant Flaws/Notches

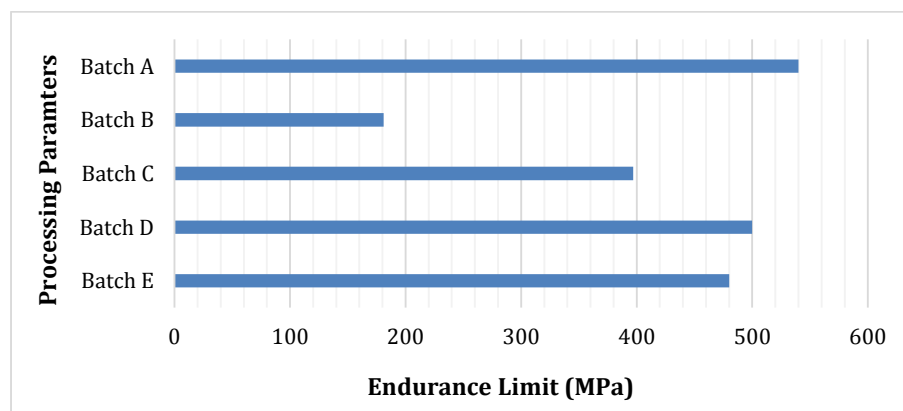
An overview of the influence of all three investigated post ALM treatments showing their largest improvements to the fatigue performance can be seen in Figure 4, in relation to the “As Machined” and “As Printed” conditions.

Figure 4 – Endurance Limit of “As Machined” [Batch A], As Printed” [Batch B], Double Shot Peened [Batch C], Shot Peened & Superfinished [Batch D] or Superfinished alone [Batch E]

Shot peening with different parameters, i.e. size, intensity and type of shot resulted in different fatigue endurance of “As Printed” ALM. Figure 4 shows the largest improvement by using a dual shot peening process consisting of steel shot followed by glass bead peening. Regardless of the type of peening employed, fatigue life of the “As Printed” batch was always enhanced. Although definite conclusions cannot be drawn due to the small sample size, i.e. in most cases single samples, the following general data trends were observed:

The effect shot peening combined with super-finishing had on the fatigue endurance of “As Printed” ALM can also be seen in Figure 4, Batch D. From this figure it is interesting to note that the fatigue endurance limit was approaching the value obtained with the “As Machined” batch. Although the difference in endurance limits between the “As Machined” Batch A and the Shot Peened and Superfinished samples from Batch D would appear to be less than 8%, care must be taken with this assumption due to the curve shape of Batch A. Hence based on Figure 4, a more realistic difference of 15% should be assumed.

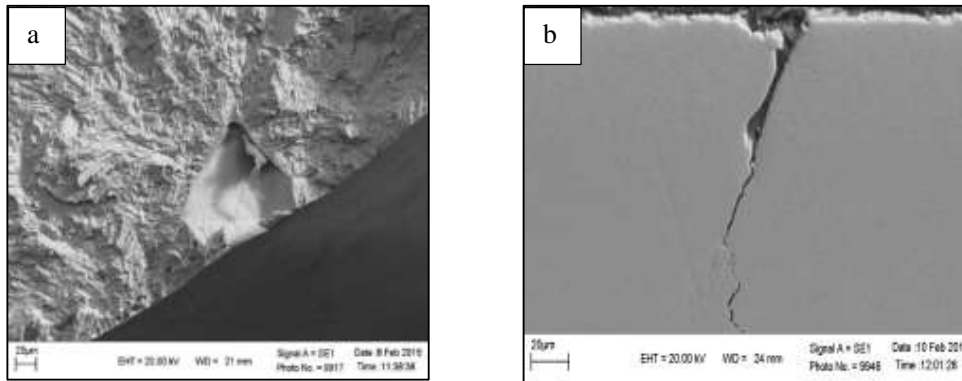
**Plate 3 - Surface Failure from a) Cold Shut/Oxide Film and
b) Micro-section showing a Fatigue Crack Initiating from a Cold Shut**

- While improvements in the “As Printed” fatigue endurance were observed through the use of superfinishing, large variations in fatigue endurance between the two superfinishing processes (i.e. MIC & Fintek) were observed. The most likely explanation for this difference is likely to be due to the amount of material removed during superfinishing. With regards to the Fintek process approximately 0.16 mm was removed per surface, whilst the MIC CASE process removed far less material, i.e. 0.07 mm. However, while the Fintek superfinishing process removed more material, cold shuts/re-entrant flaws/defects from the ALM process were still present, see Plate 3a. Moreover the presence of these ALM processing defects were further confirmed by the fractographic evidence in which the majority of the fatigue failures were still initiated from the surface. The detrimental influence that these cold shuts/re-entrant flaws/defects have on fatigue can be seen in Plate 3b in which a secondary fatigue crack has initiated from one of these features.
